NEW JERSEY DIVISION OF FIRE SAFETY

Firefighter Fatality and Serious Injury Report Series

Volunteer Firefighter Injured Upon Being Struck by Pieces of a Large Diameter Hose Appliance after it Failed Catastrophically

**Hampton, New Jersey
July 27, 2009**

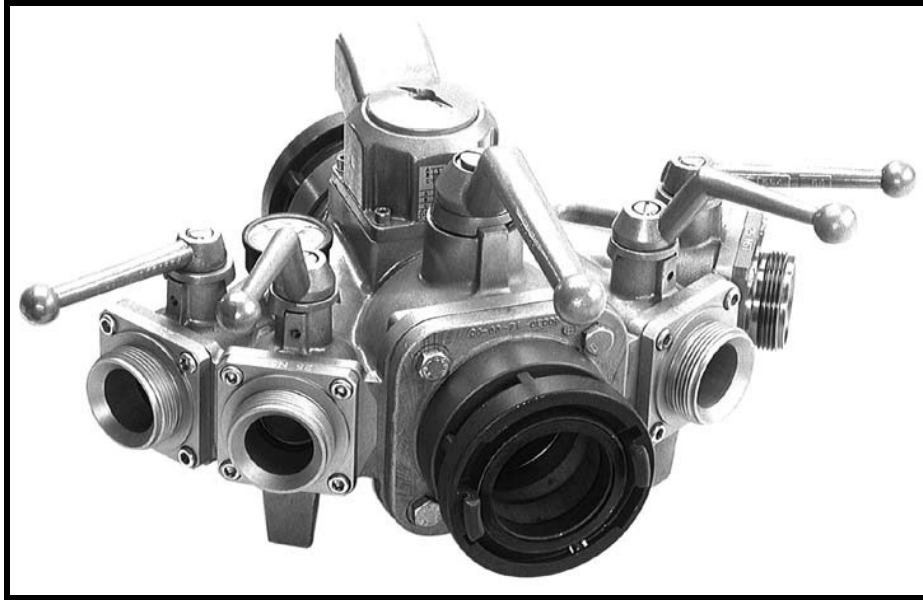
**Figure 1 - Typical example of a Snap-tite Manifold & Relief Valve.
The HTFR manifold was identical to this depiction.**

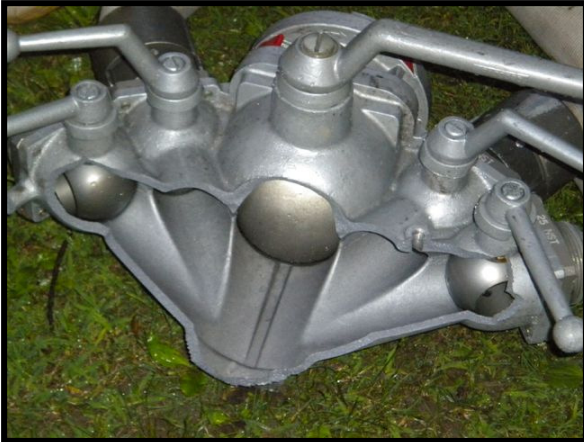
Figure 2 - Main portion of manifold after the failure.

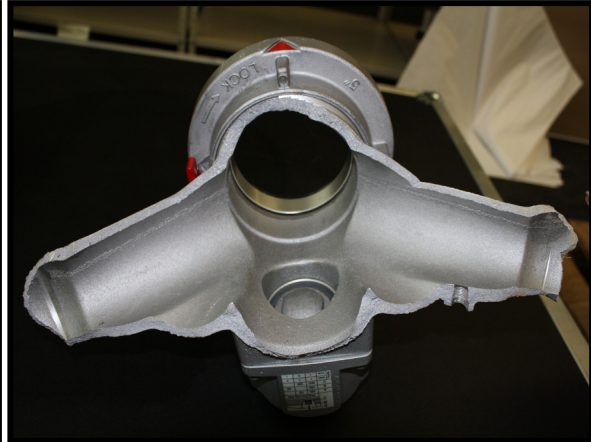
Figure 3 - Upper portion of the manifold after the failure. This is the section that struck FF Crawford (piece is lying upside down).

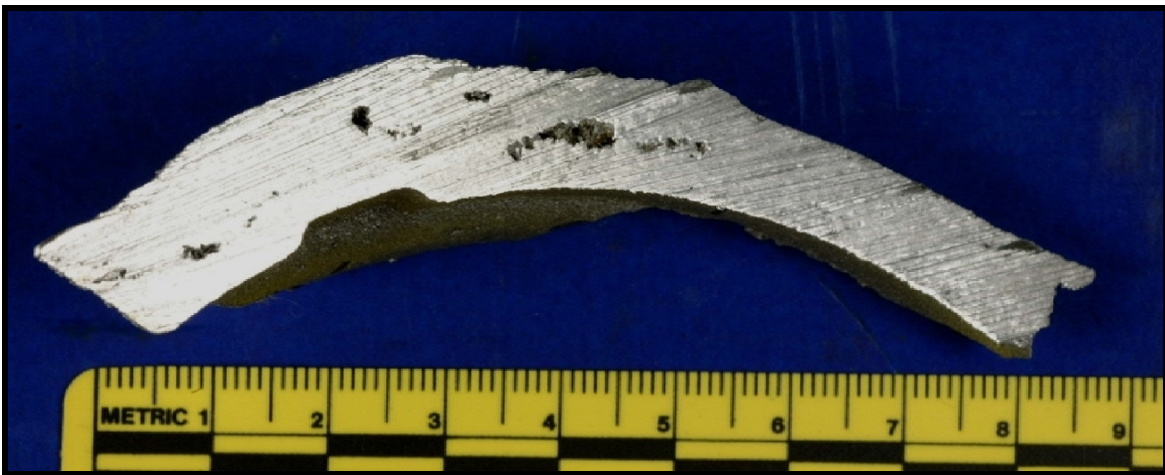
Figure 4 - Note the large voids in the cut surface of the casting wall.

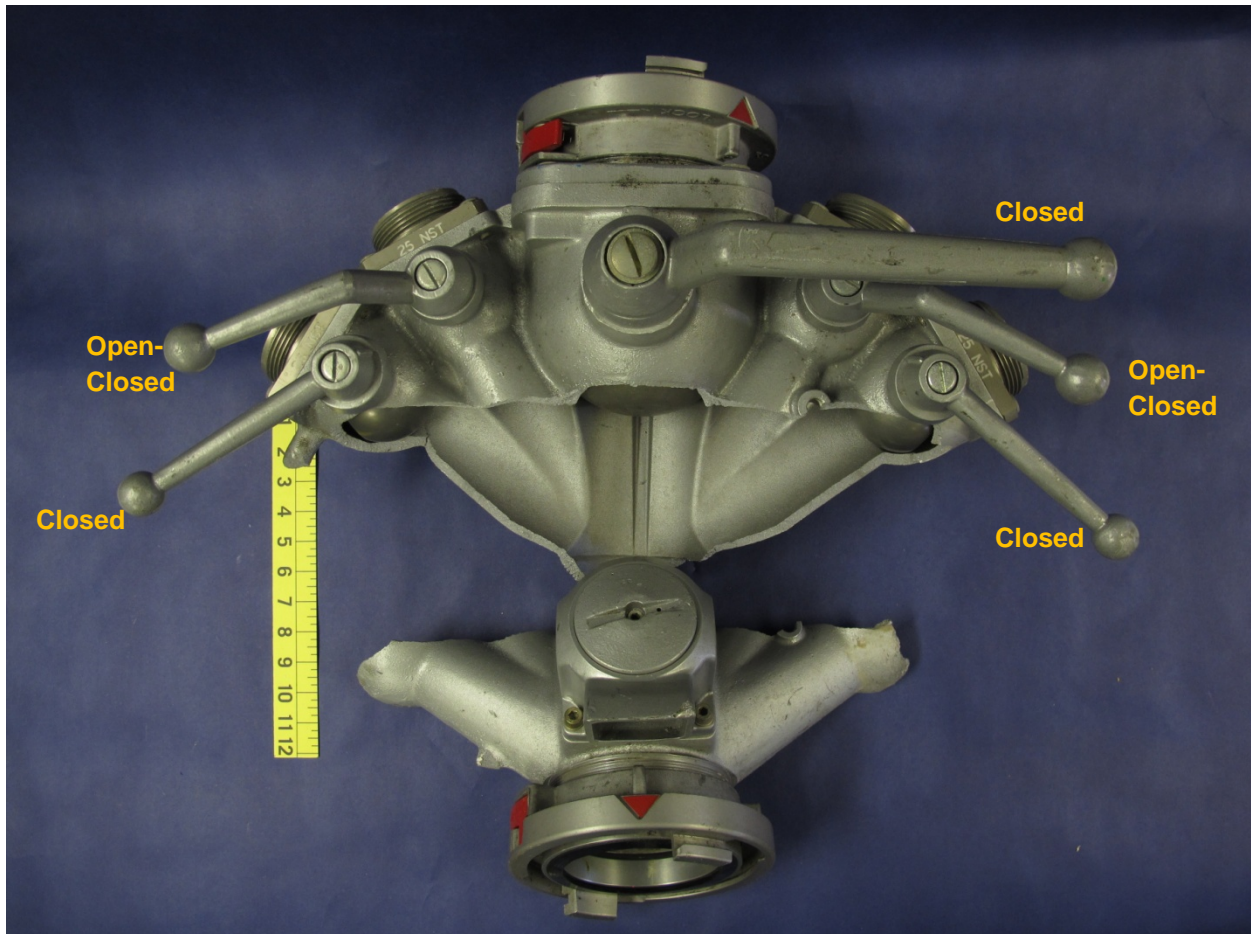
Figure 1. Ruptured manifold, as received. The two pieces that CTL received appear to represent the entire manifold, with the exception of the carrying handle, which was broken off and missing. All valves are shown in the closed position. According to NJ Division of Fire Safety, two of the valves were in the process of being closed when the rupture occurred. Position of valves at time of incident is indicated on the photograph above.

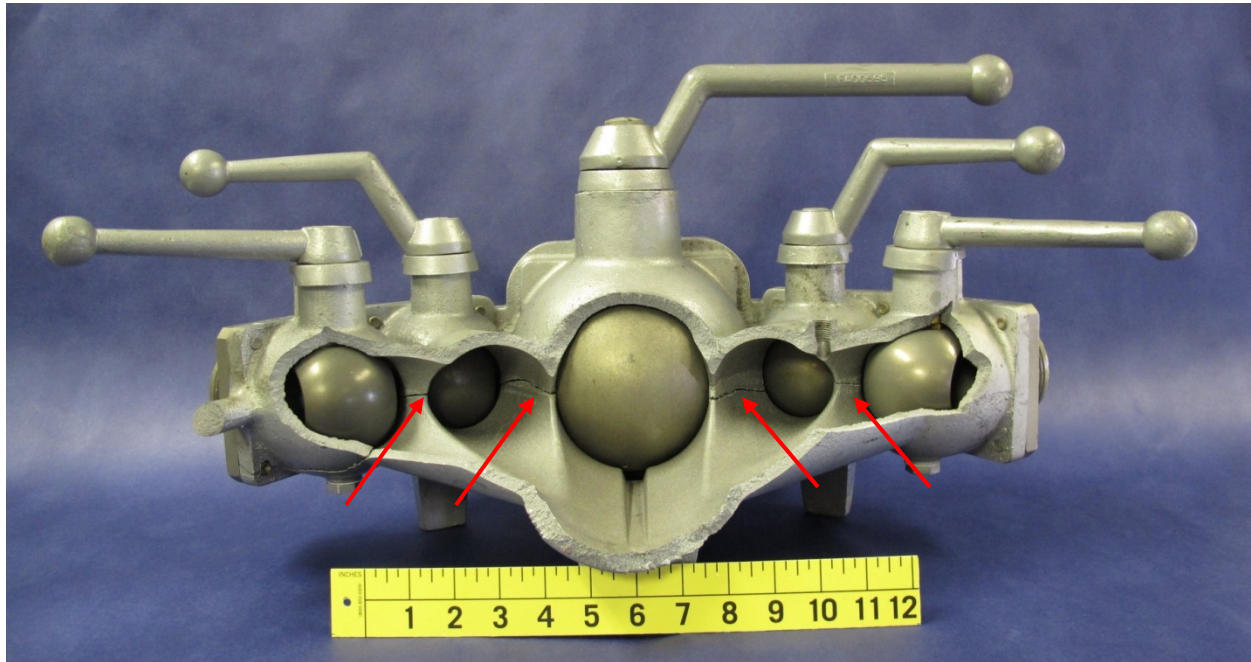
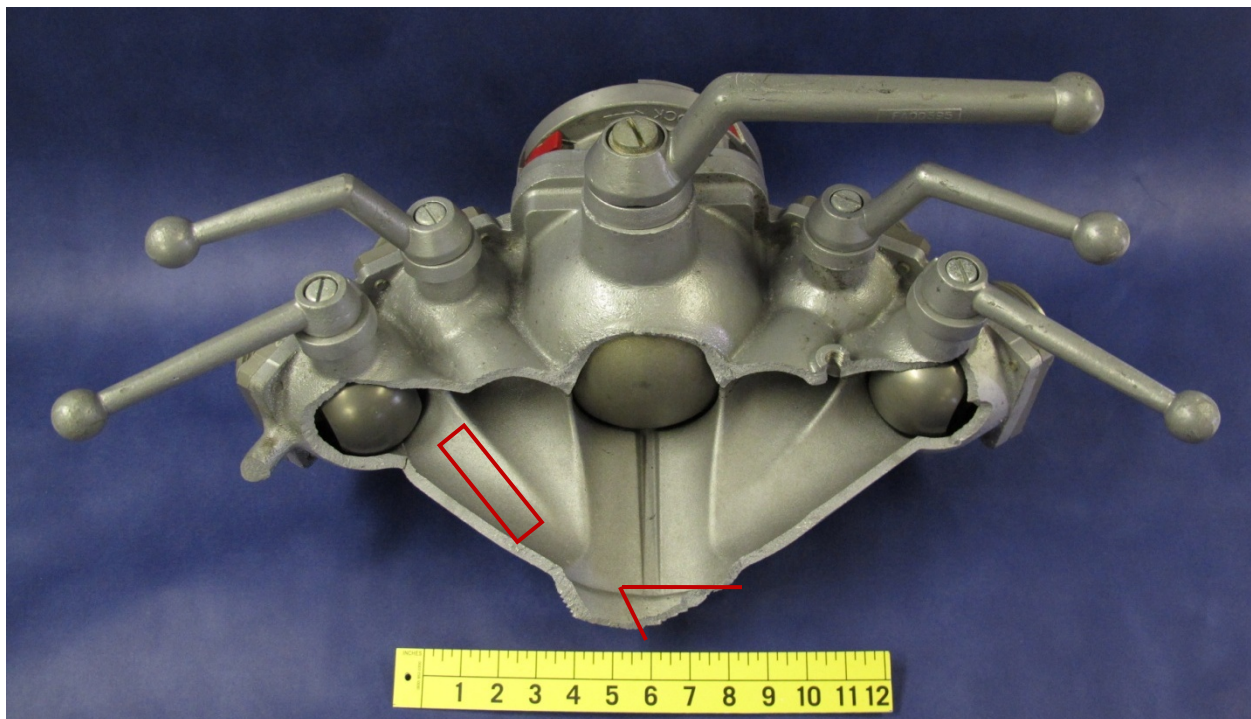
Figure 2. Two views of the larger piece. In addition to cracking that caused one piece to break away, cracking occurred all around the piece, especially through the approximate center-line of the cast manifold. The red lines on the bottom photograph show the approximate locations of cuts to remove the fracture surface for further examination, including a cross-sectional metallurgical mount. The red box shows the approximate location of samples removed for Charpy V-notch testing and AES.

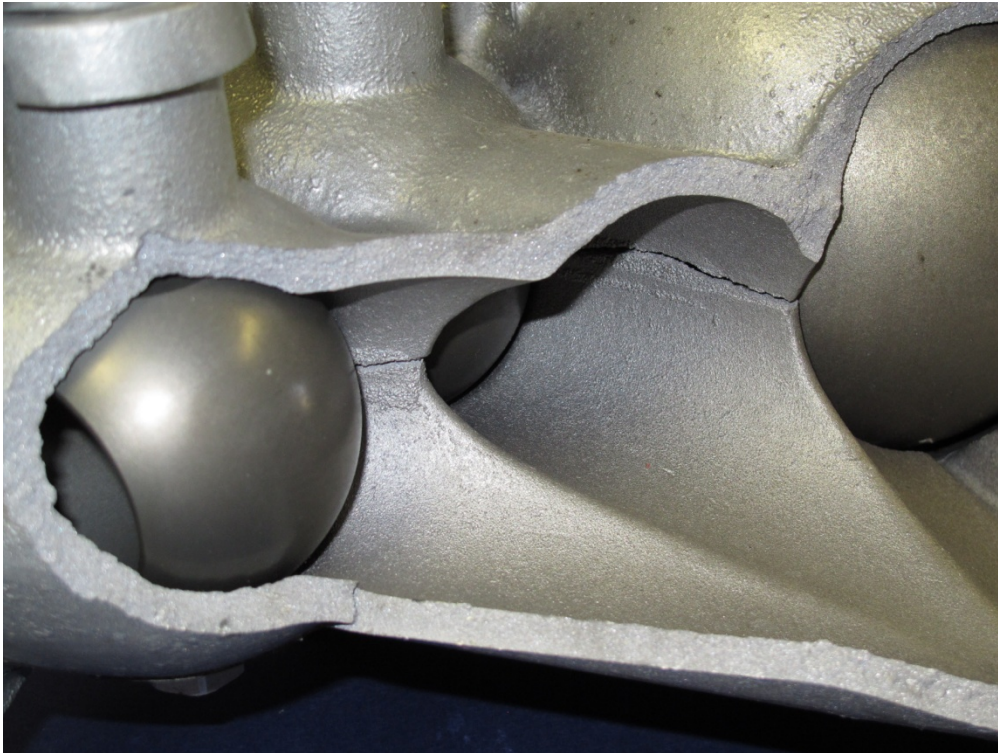
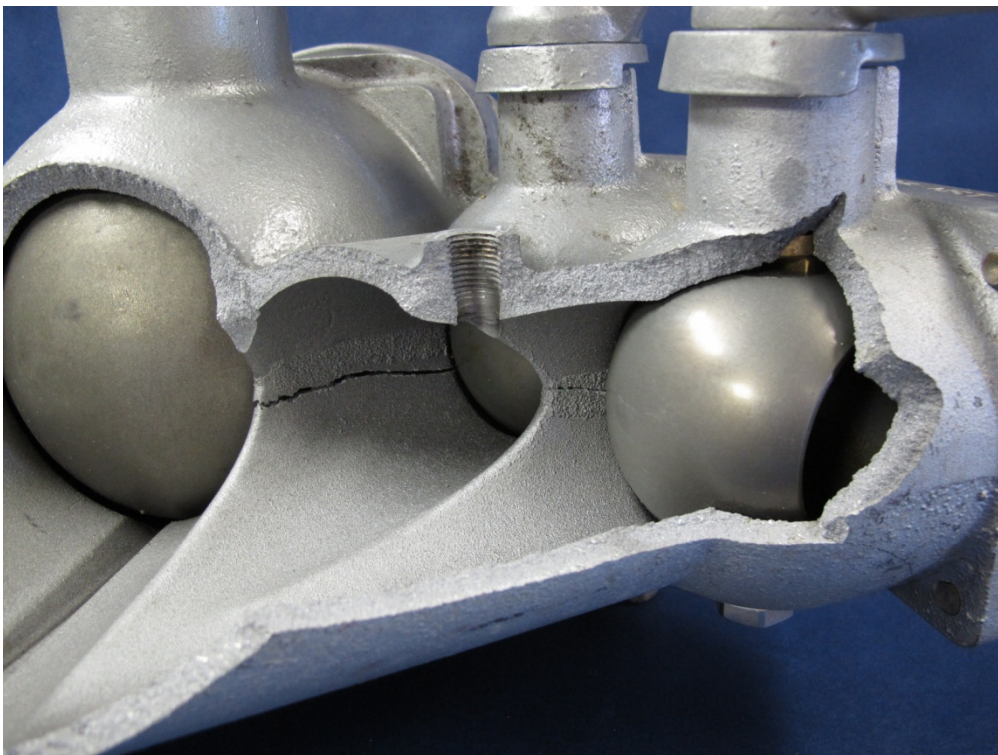
Figure 3. Closer views of the larger piece showing cracking.

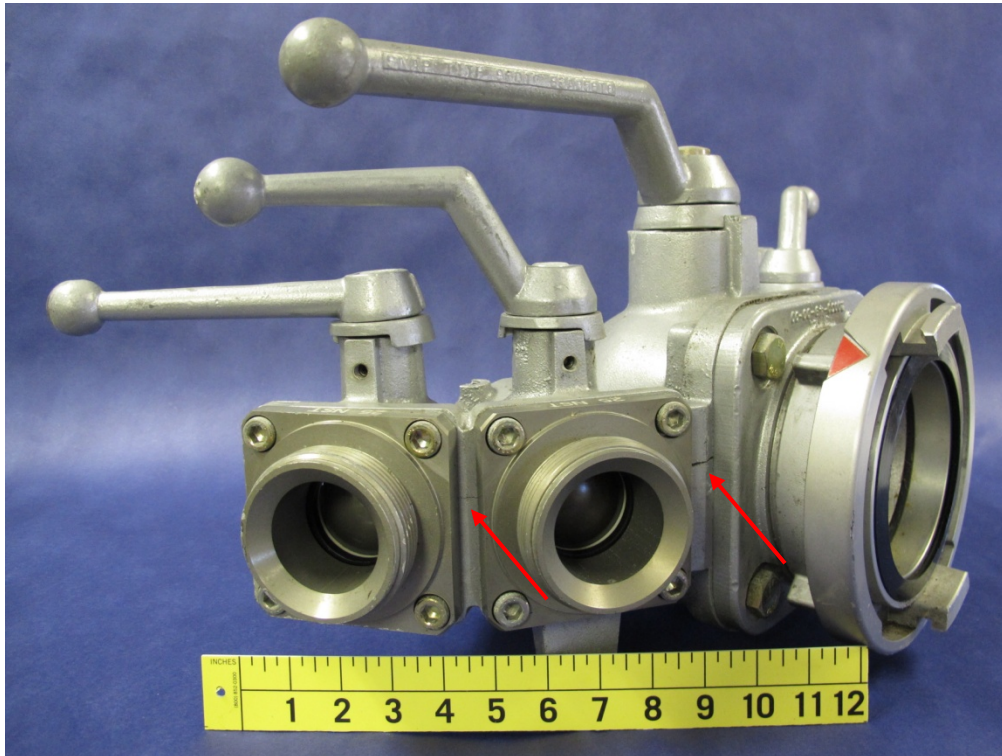
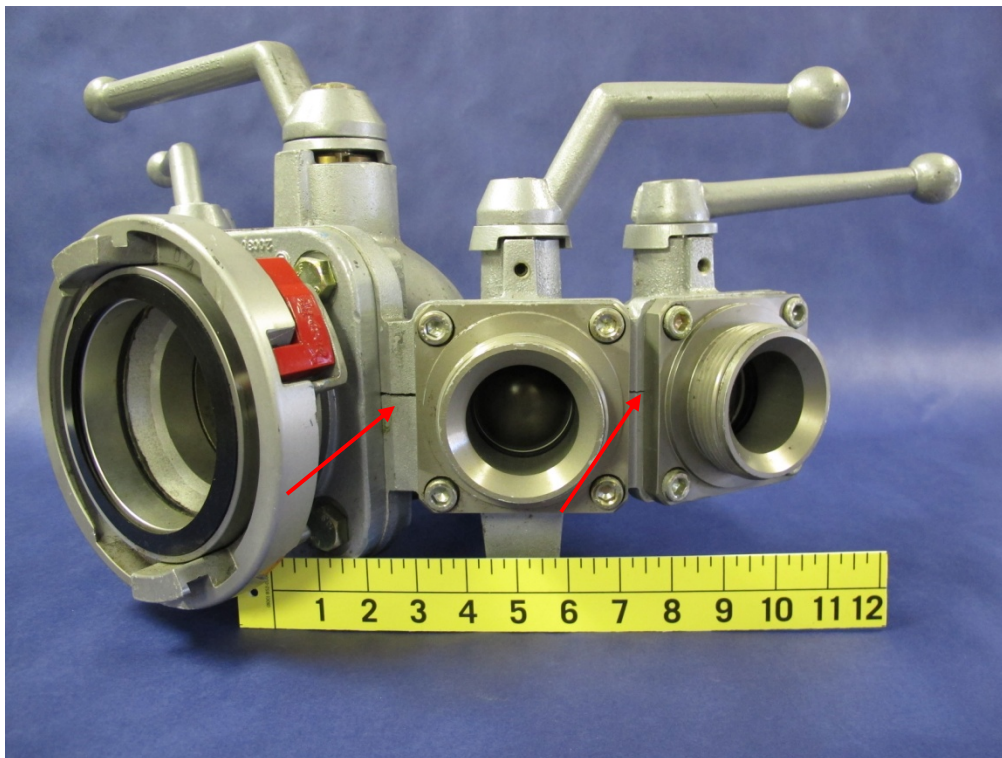
Figure 4. Additional views of the large manifold piece, showing cracking through the approximate center line (arrows).

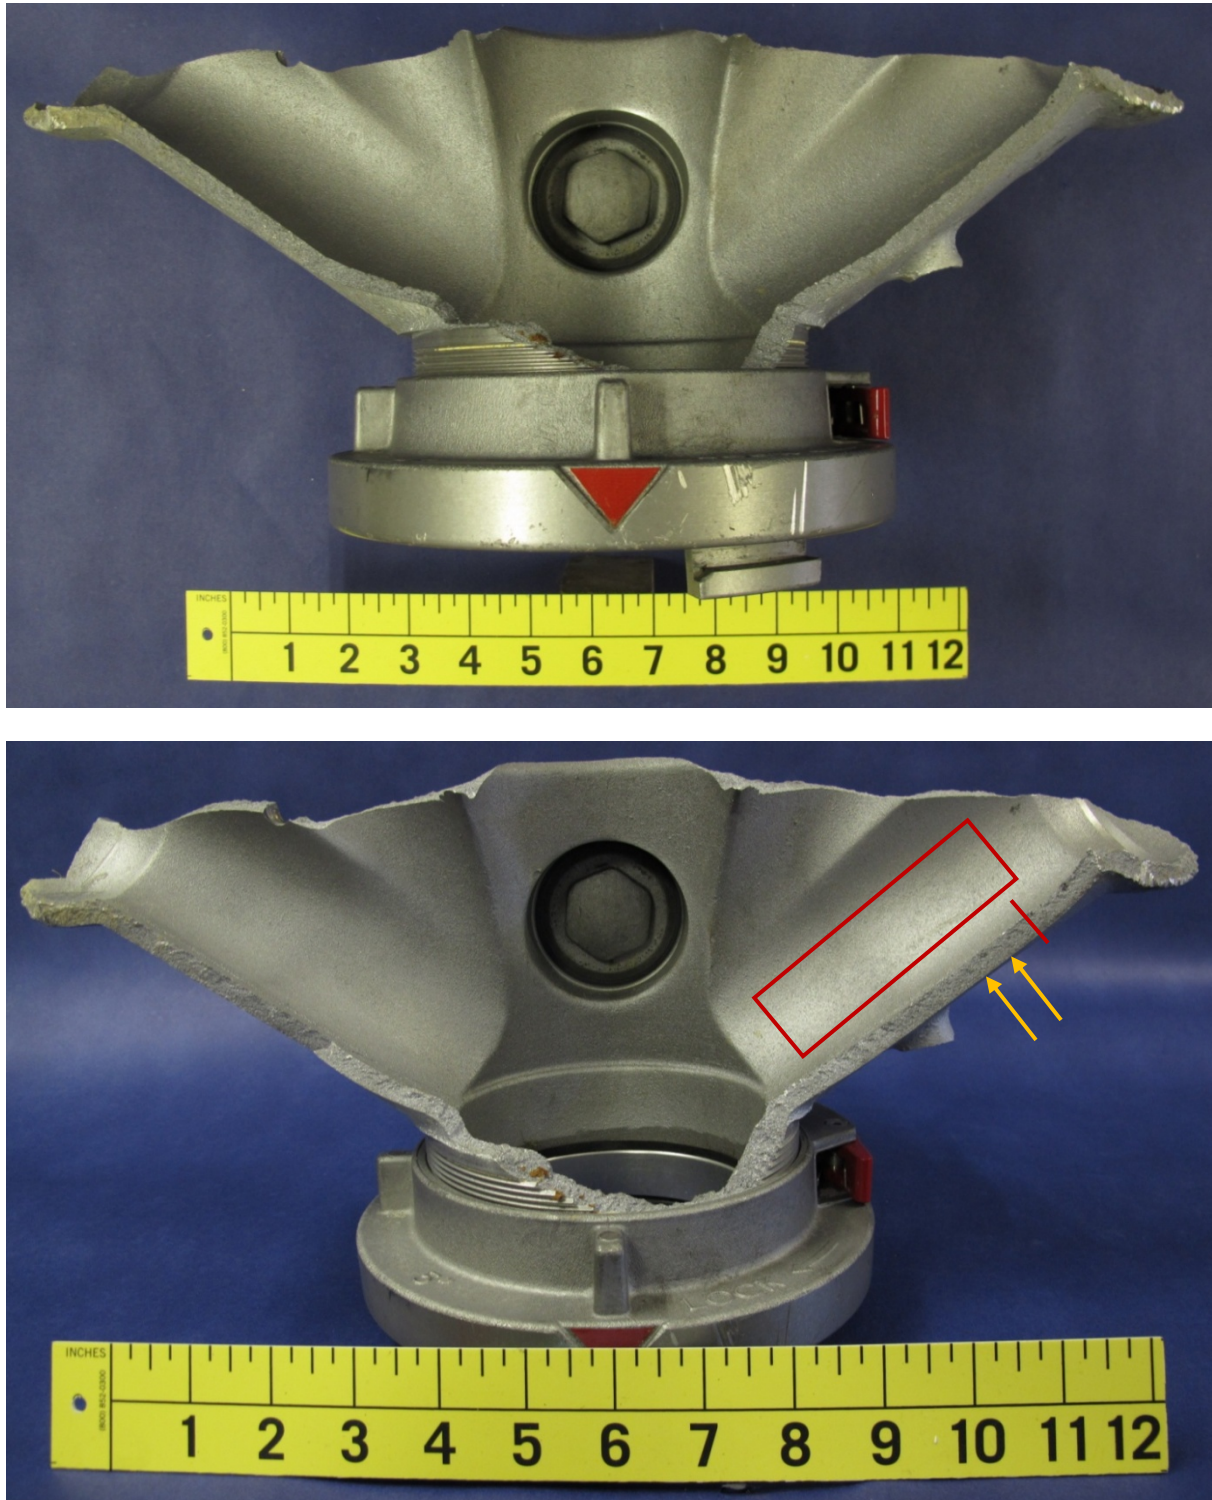
Figure 5. Several views of the smaller piece. The fracture surface is flush with the threads where the manifold is threaded into the inlet connection. Red box shows approximate location of samples removed for tensile testing. Red line shows approximate location of cross-sectional metallurgical mount. Yellow arrows show approximate location of SEM imaging of fracture surface.

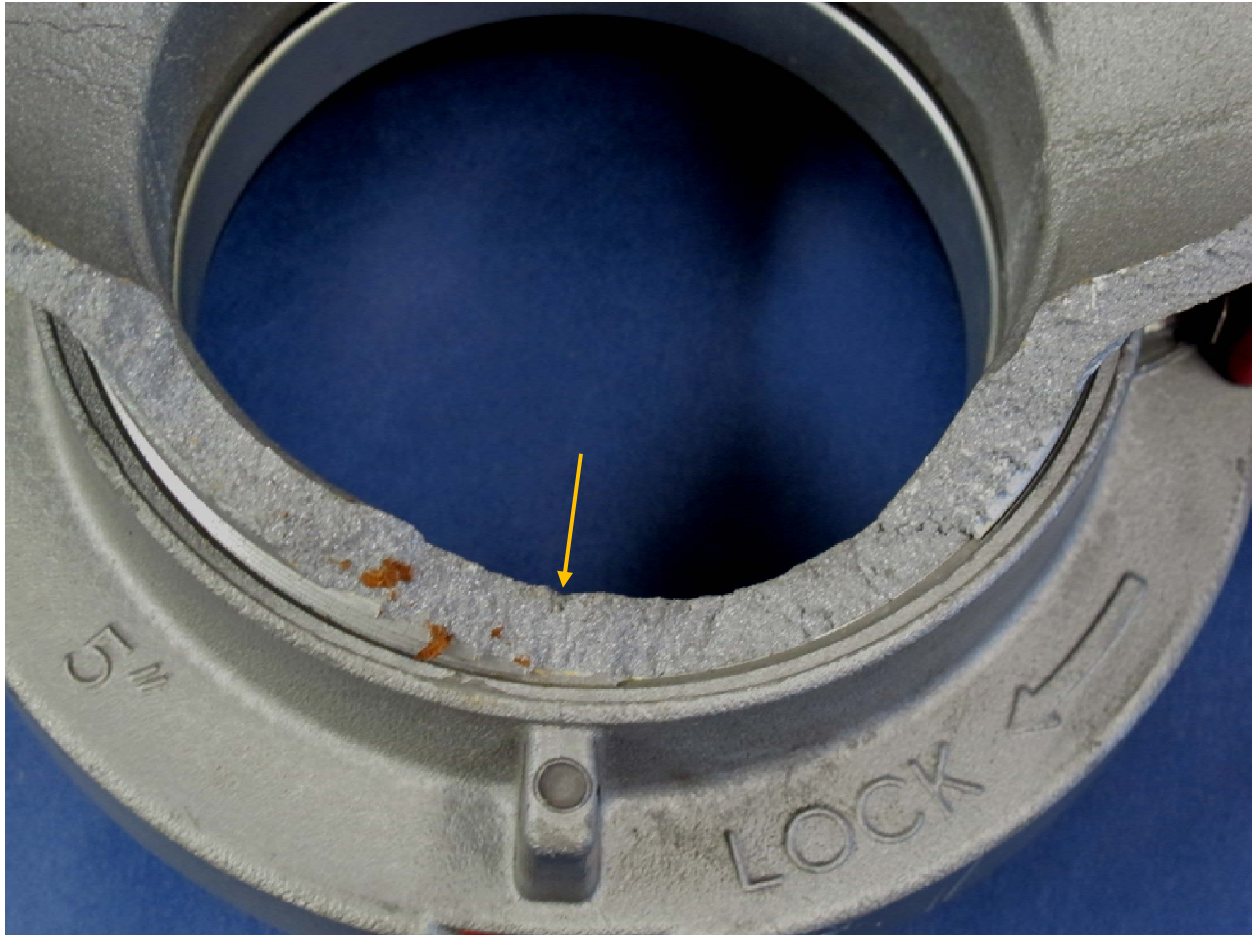
Figure 6. Closer view of fracture surface at inlet connection threads. Arrow shows location of Figures 7 and 8.

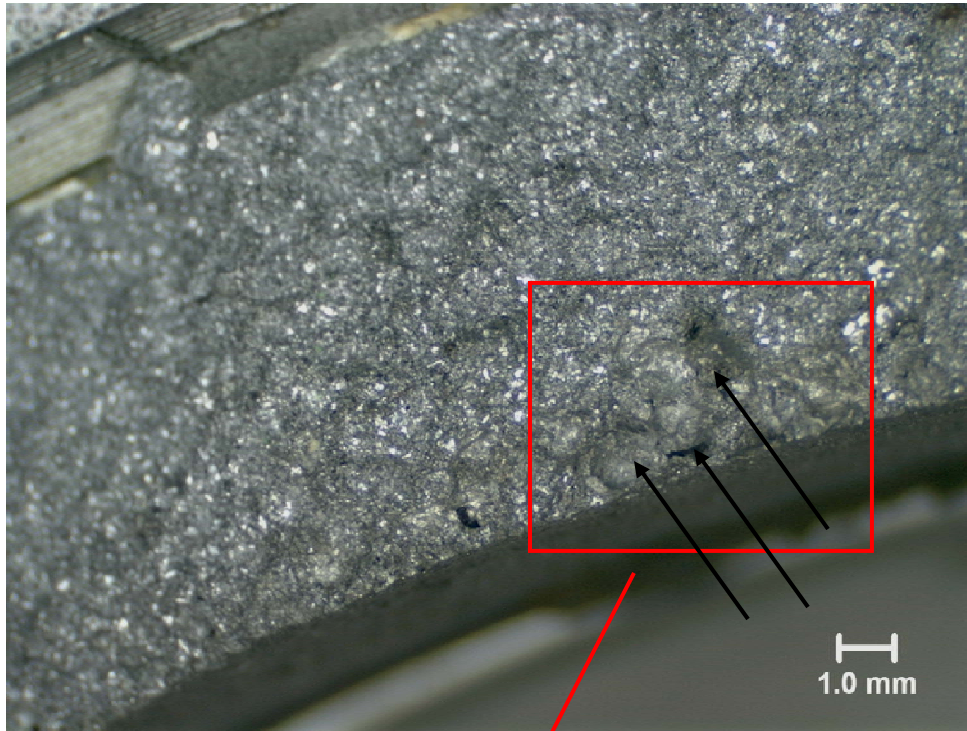
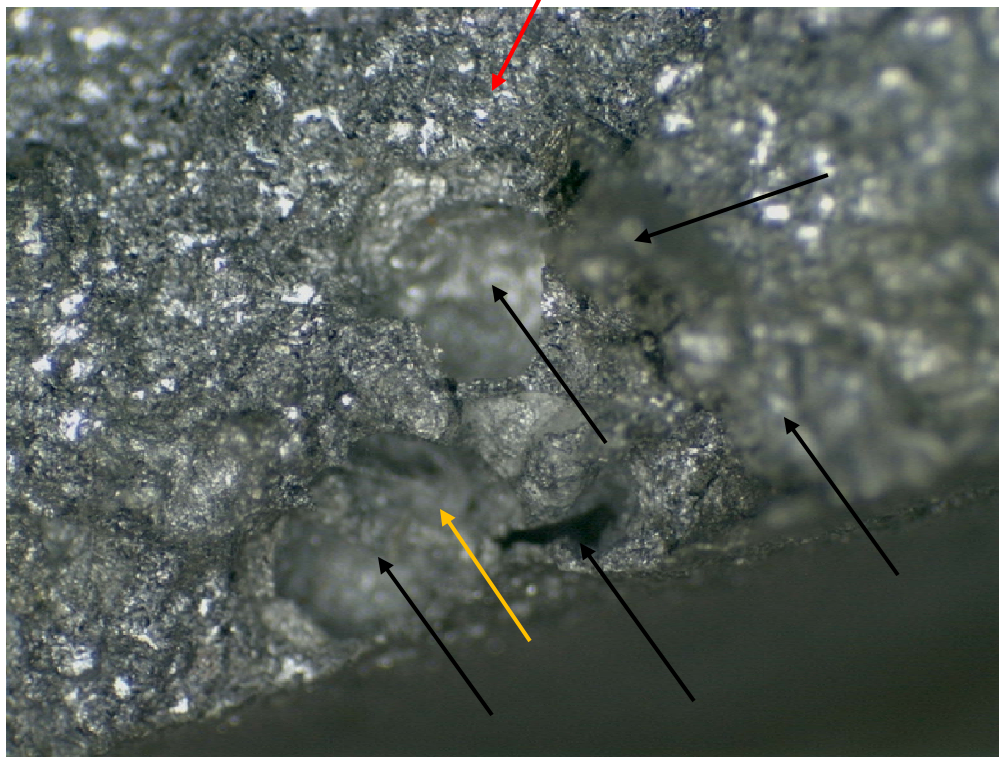
The fracture surface was examined using optical stereomicroscopy. Near the inlet threads there were large voids in the casting, **Figures 7 and 8**. The voids were seen as either smooth craters at the fracture surface or holes on the fracture surface that led to subsurface craters. In some places, there was a clear or white substance or second phase in the voids. The fracture surface at this location on the larger piece of the manifold was removed for further examination (see Figure 2 for location). The cut surface showed numerous large voids, **Figures 9 and 10**. There was a white or clear substance within some of the voids. A piece was removed and prepared as a metallurgical cross-sectional mount, **Figures 11 and 12**. Additional voids were present within the manifold casting wall – both large voids near the center of the cross-section and smaller voids near the ID and OD surfaces. The voids in the cross-section spanned a significant percentage of the entire wall thickness. The white substance was present within the voids in the polished cross-section, **Figure 13**.

Figure 7. Large voids in the casting near the threads at the manifold inlet. Some of the voids are seen as dark holes in the photograph. Others are seen as smooth craters. There appears to be a clear or white substance or second phase within some of the voids, yellow arrow. 7X and 20X original magnifications.

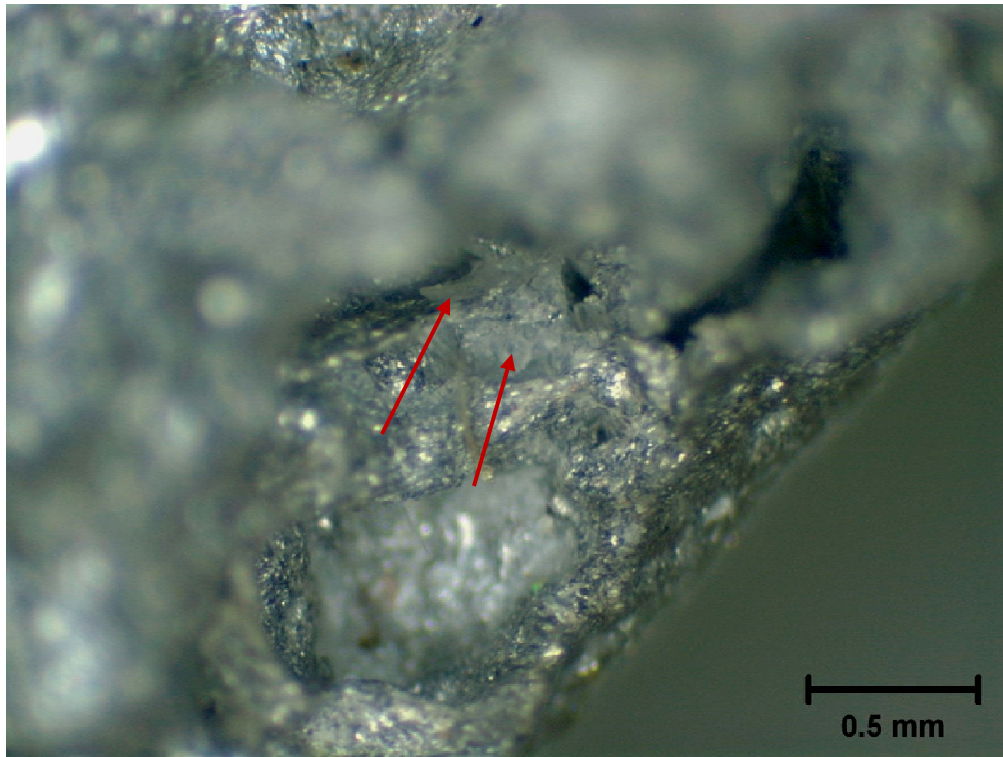
Figure 8. Clear or white substance or phase within some of the voids at 40X original magnification.

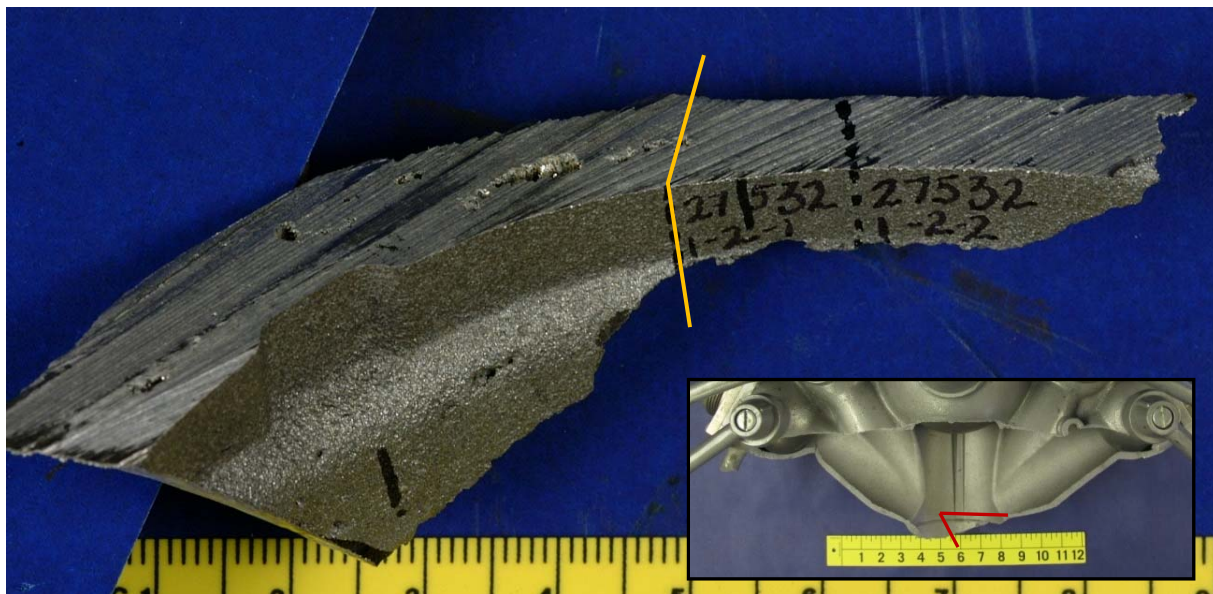
Figure 9. Cut piece from larger manifold piece showing large voids on the cut surface. Inset shows location of piece. Yellow lines show location of additional cut for cross-sectional metallurgical mount.

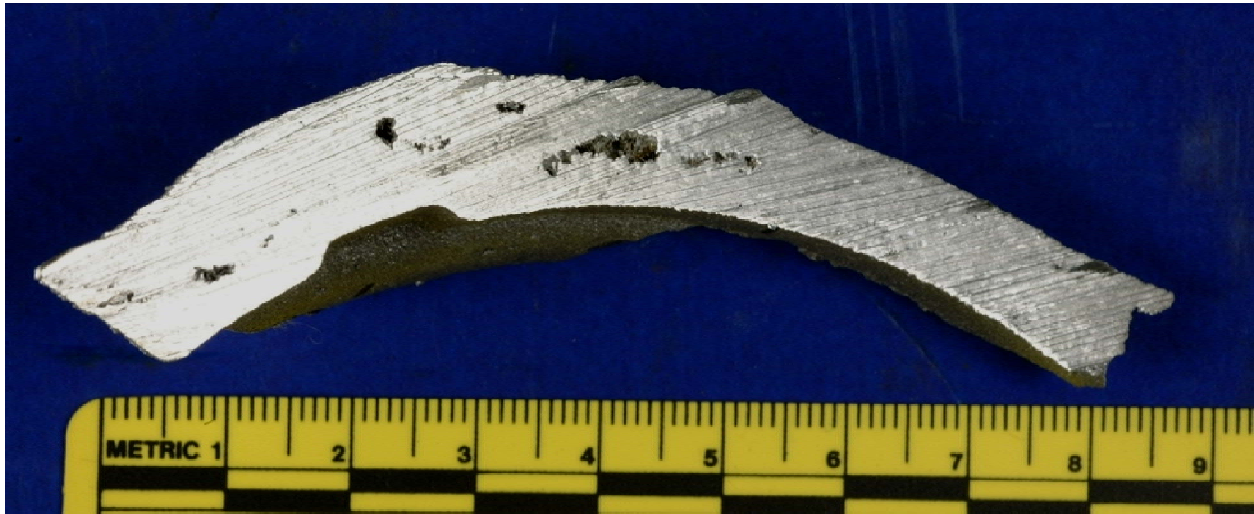
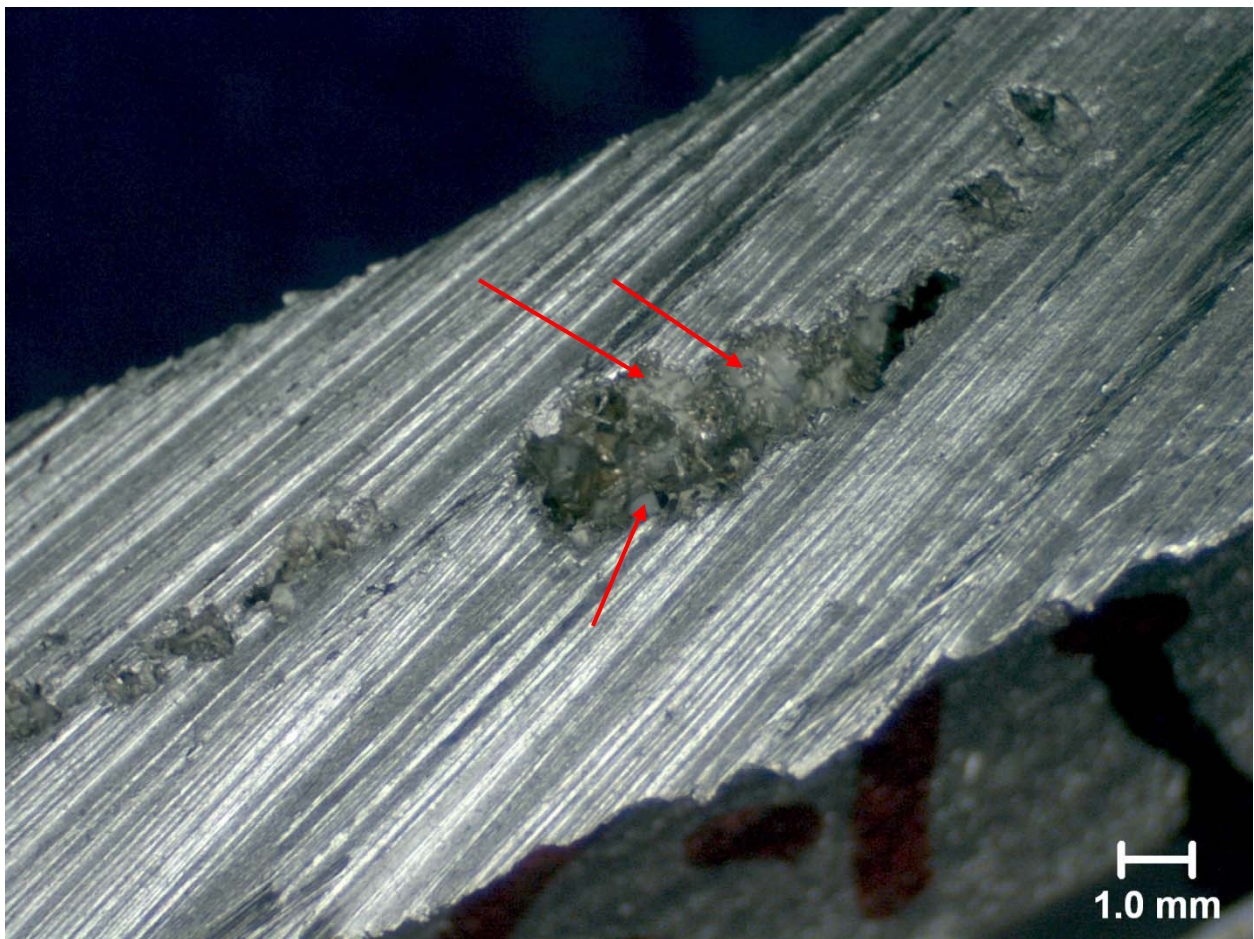
Figure 10. Cut surface showing large voids with white or clear substance within the voids (arrows).

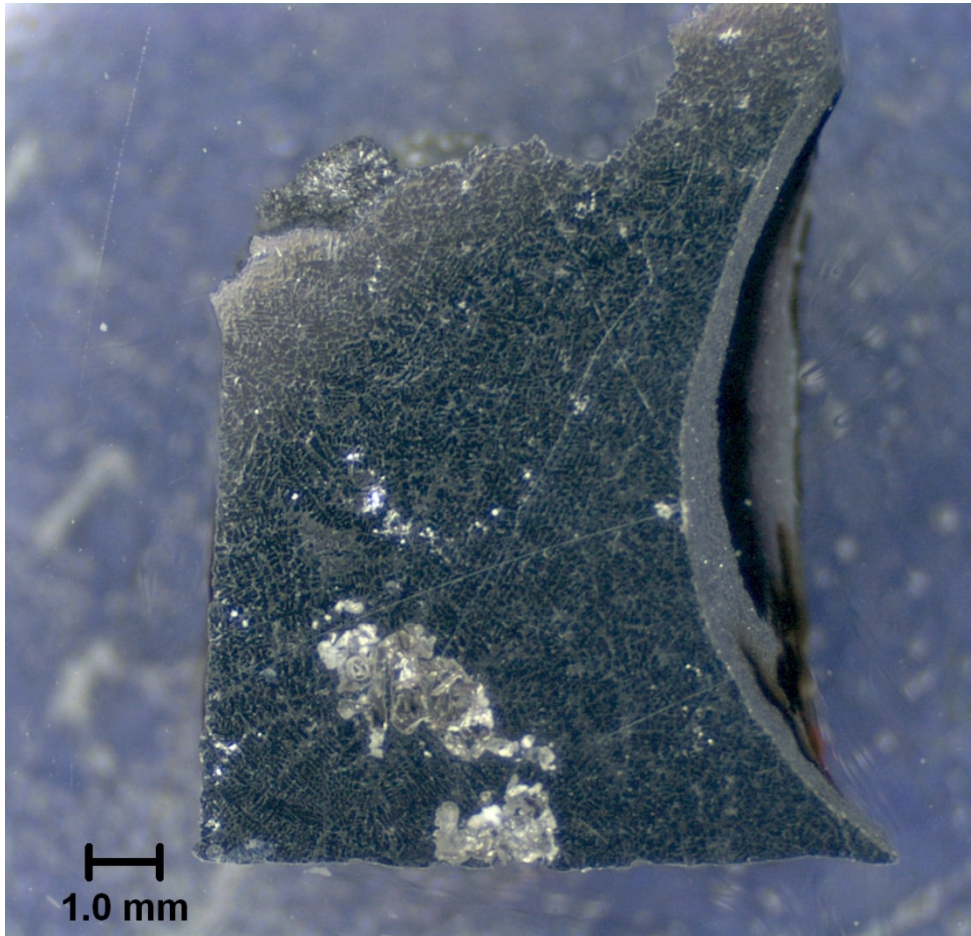
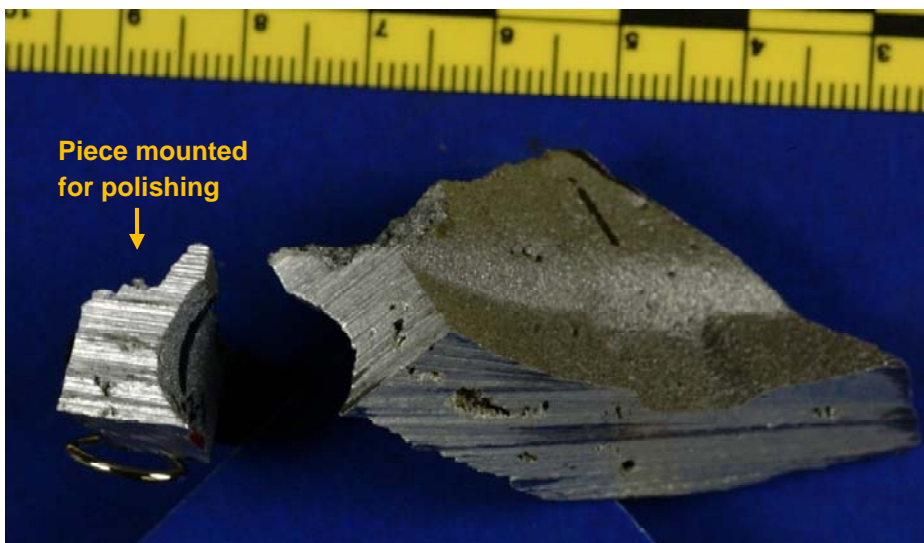
Figure 11. Cross-sectional metallurgical mount (polished, top; as cut, bottom) showing voids within the casting wall.

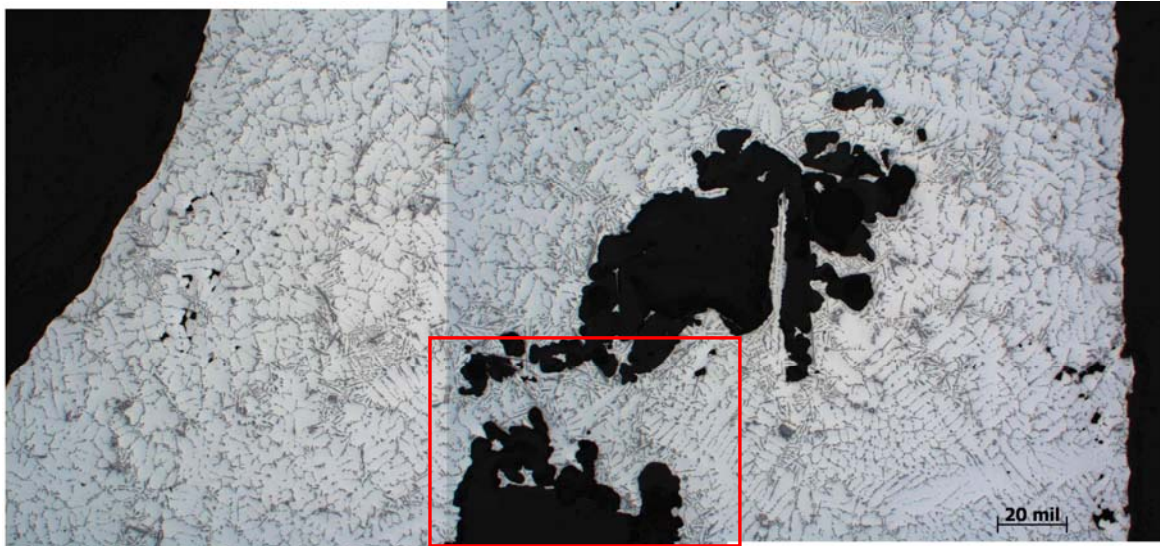
Figure 12. Extensive voids, large and small, were present within the casting wall, as seen in this polished cross-section. Red box shows approximate location of Figure 13. As polished. 25X original magnification photo montage.

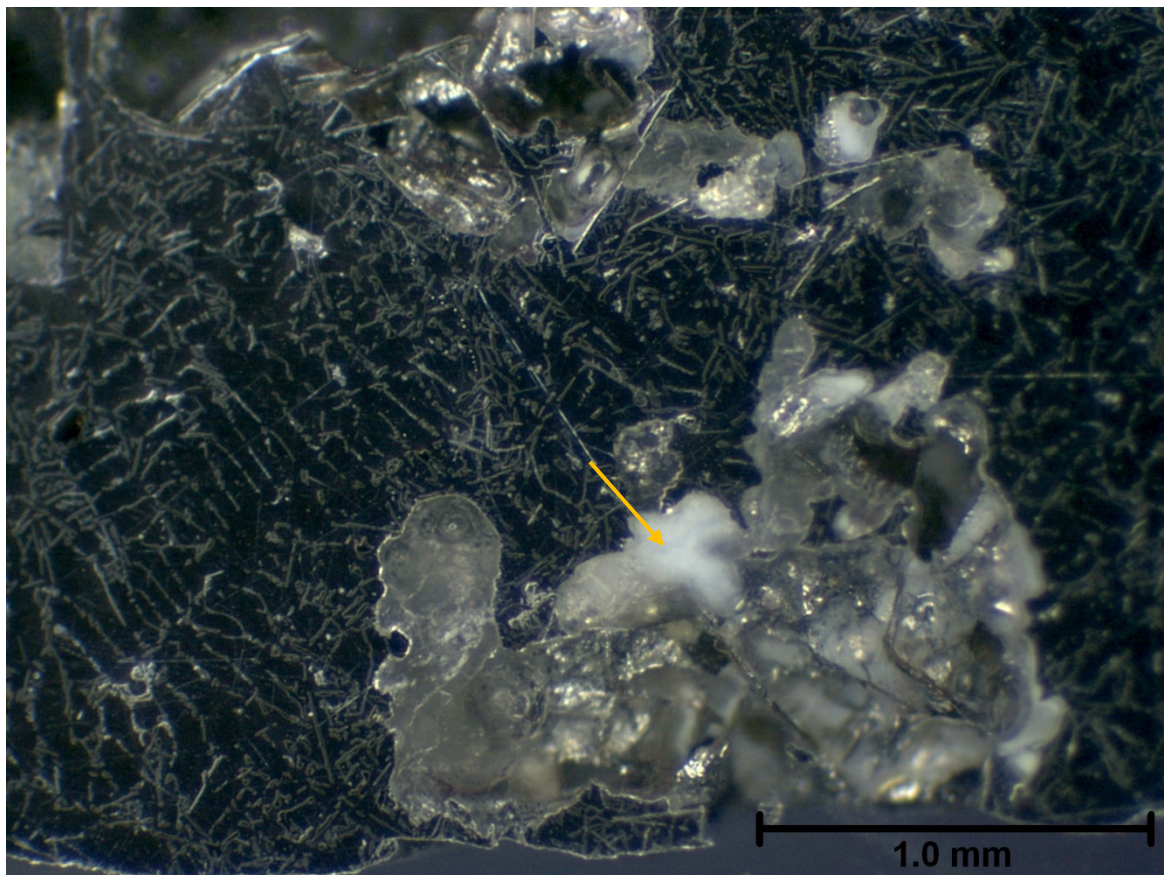
Figure 13. White substance within voids on polished cross-section. Note: due to the differences in optics in microscopes, this photograph is a mirror image of Figure 12. 40X original magnification.

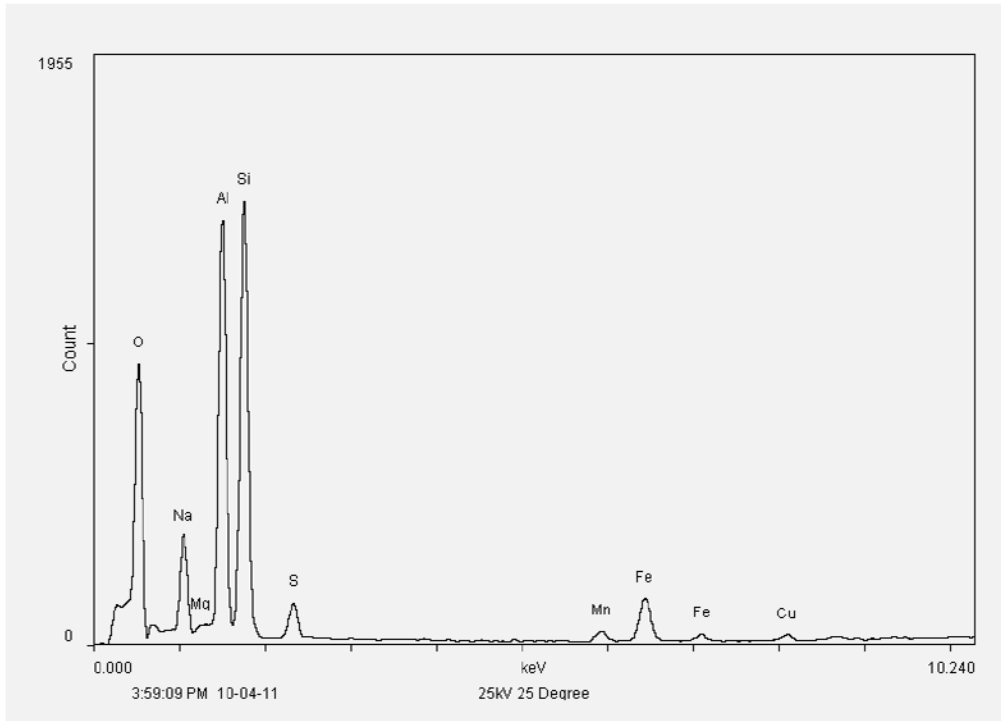
Figure 14. White substance on as-cut surface of cross-section contained high levels of silicon, sodium, and oxygen, plus lesser amounts of sulfur and iron and trace amounts of manganese, magnesium and, possibly, copper.

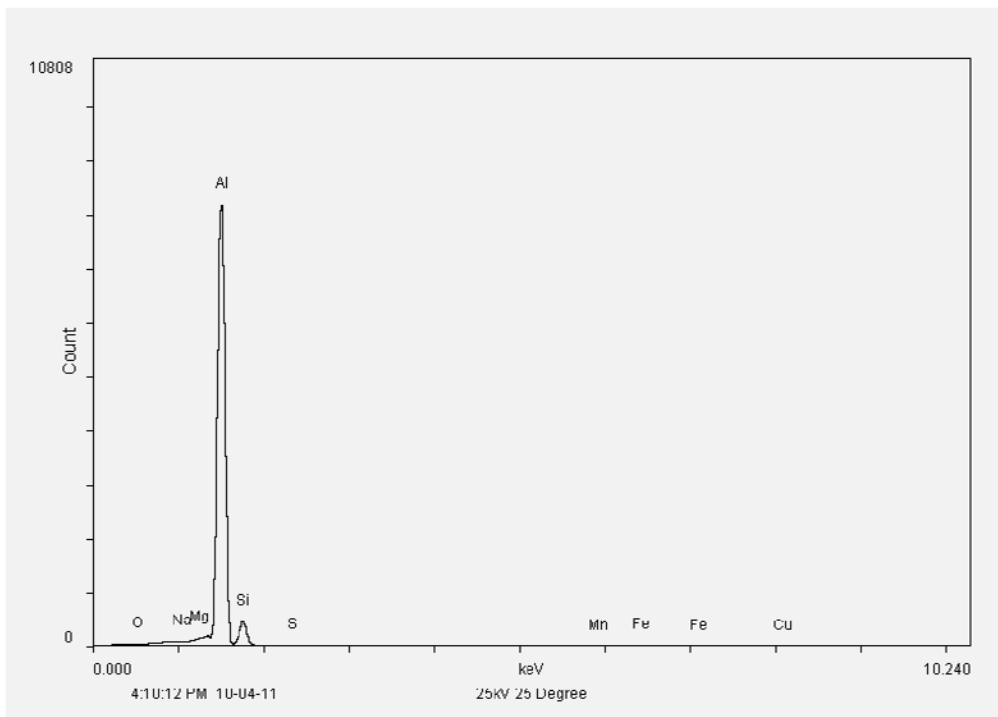
Figure 15. Freshly cut surface of cross-section, without voids or white substance, is aluminum and silicon.

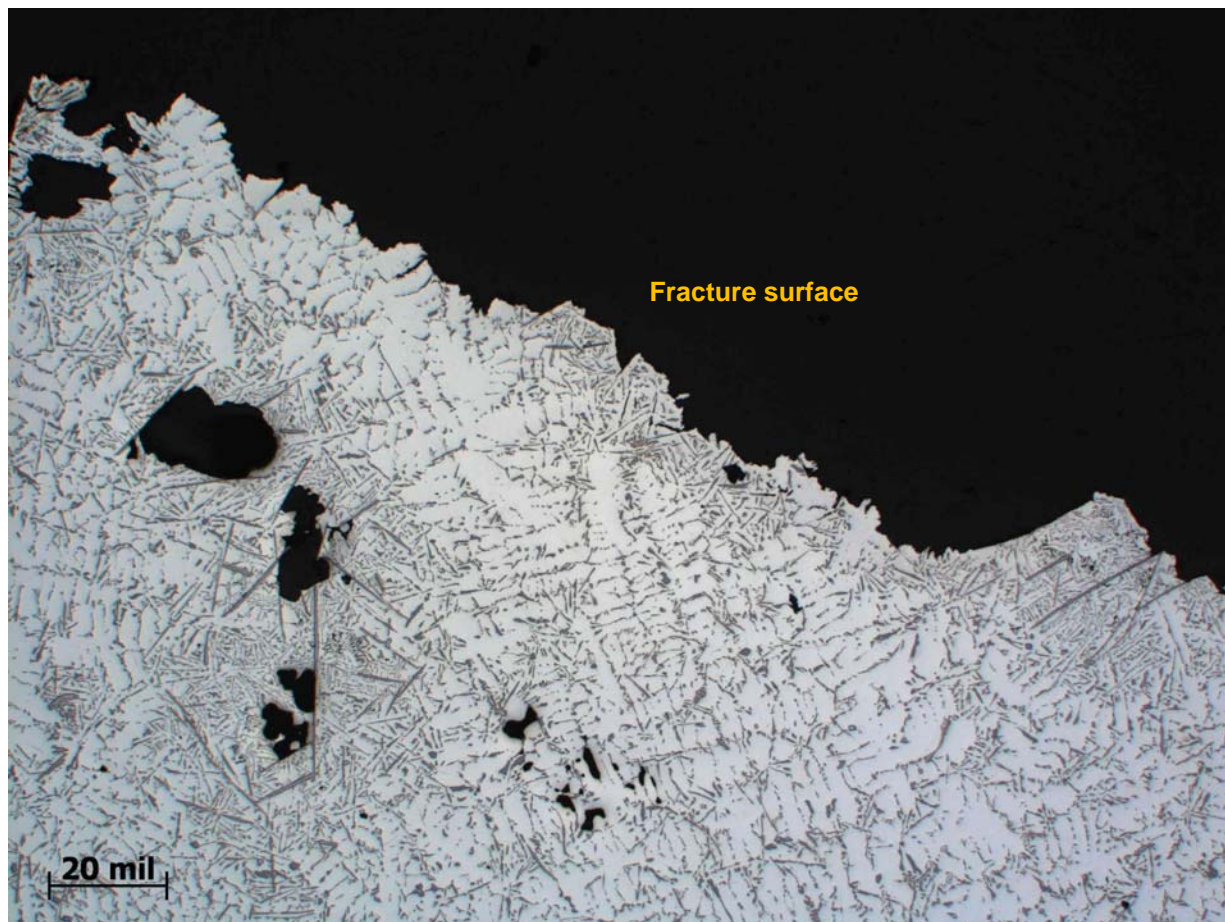
Additional voids were present in the cross-section near the fracture surface, **Figures 16 and 17**. The microstructure consisted of aluminum dendrites with angular second phases of silicon and intermetallic phases of iron and magnesium. These phases are brittle and the cross-section contains cracking through them, especially at the long needle-like particles. At the location of this cross-section, the fracture face itself occurs at the breakage of some of these needle-like particles. The microstructure appears to be consistent with an aluminum-silicon alloy casting that has not been modified. Modification is done in order to refine the microstructure to improve mechanical properties such as ductility.

Figure 16. Cross-section near fracture surface contains multiple large and small voids. As polished. 25X original magnification.
