NEW JERSEY DIVISION OF FIRE SAFETY

Firefighter Fatality and Serious Injury Report Series

Volunteer Firefighter Injured Upon Being Struck by Pieces of a Large Diameter Hose Appliance after it Failed Catastrophically

**Hampton, New Jersey
July 27, 2009**

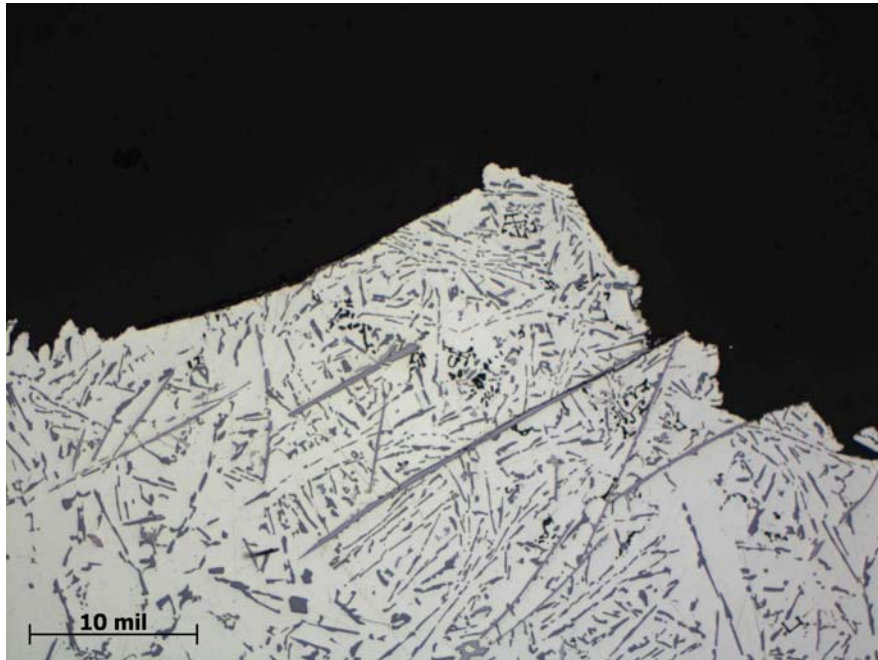
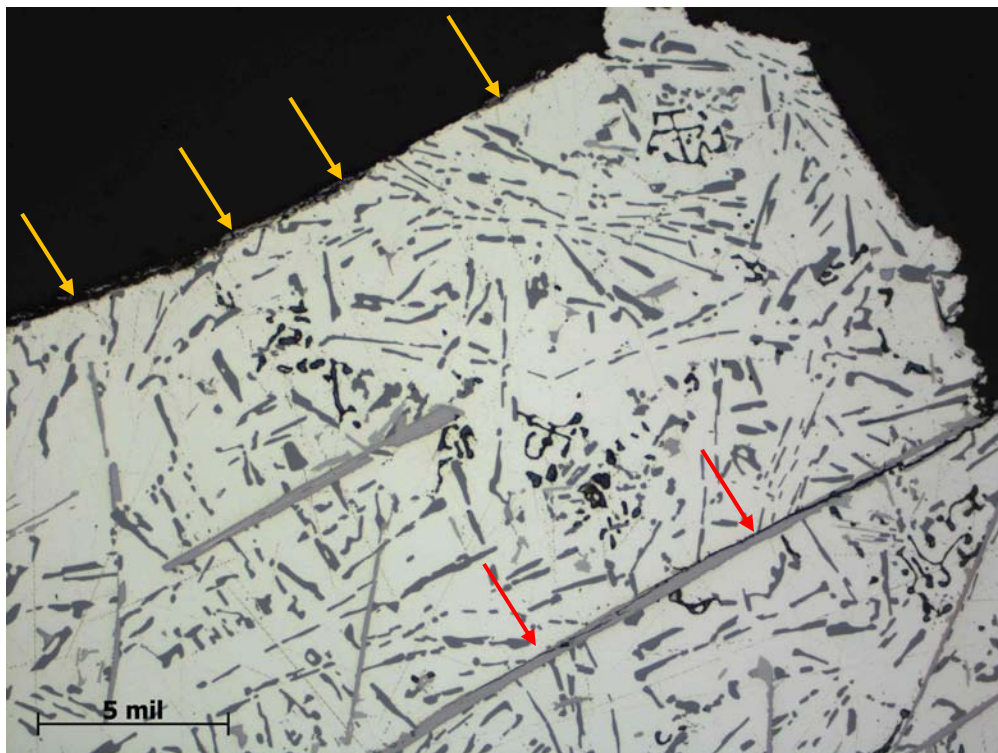
Figure 17. Higher magnification photomicrographs near the fracture surface (100X and 200X original magnifications, top and bottom, respectively). The microstructure consists of aluminum dendrites (white) with angular, brittle intermetallic phases containing silicon and, likely, iron and magnesium. Cracking has occurred through these brittle intermetallic phases (red arrows), especially the long needle-like phase. At this location, the fracture surface itself is due to the cleavage of one of these particles (yellow arrows).

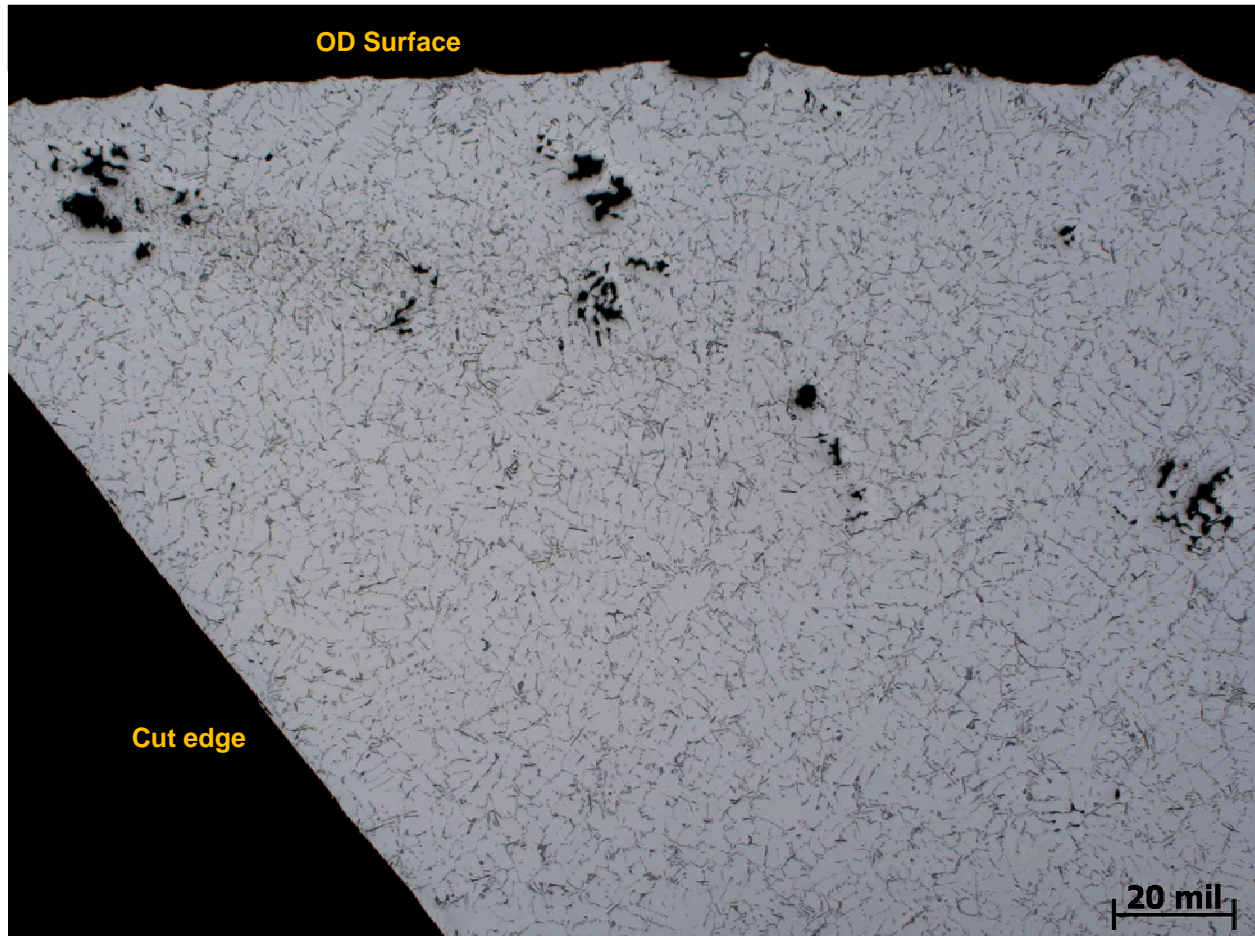
Several additional analyses on the manifold were performed. Another metallurgical cross-sectional mount was prepared, **Figure 18**. This sample was taken from the smaller manifold piece, away from the location of the large voids (see Figure 5). This sample was prepared to document a typical cross-section of the casting that was not associated with known voids. Numerous small voids were present throughout the section. The needle-like brittle phase associated with the fracture surface was not as pronounced at this location. The fracture surface near this location was imaged in the SEM, **Figure 19**. The fracture was typical of brittle cleavage fracture. The fracture surface was examined at various magnifications and no evidence of fatigue was present.

Figure 18. Cross-section taken from smaller manifold piece. There were no obvious voids or other defects associated with this location. Numerous voids are present throughout the cross-section. This photograph shows voids near the outside (OD) surface. The long needle-like phase that was abundant near the fracture surface is much less pronounced here. See Figure 5 for location of this mount. 25X original magnification. Unetched.

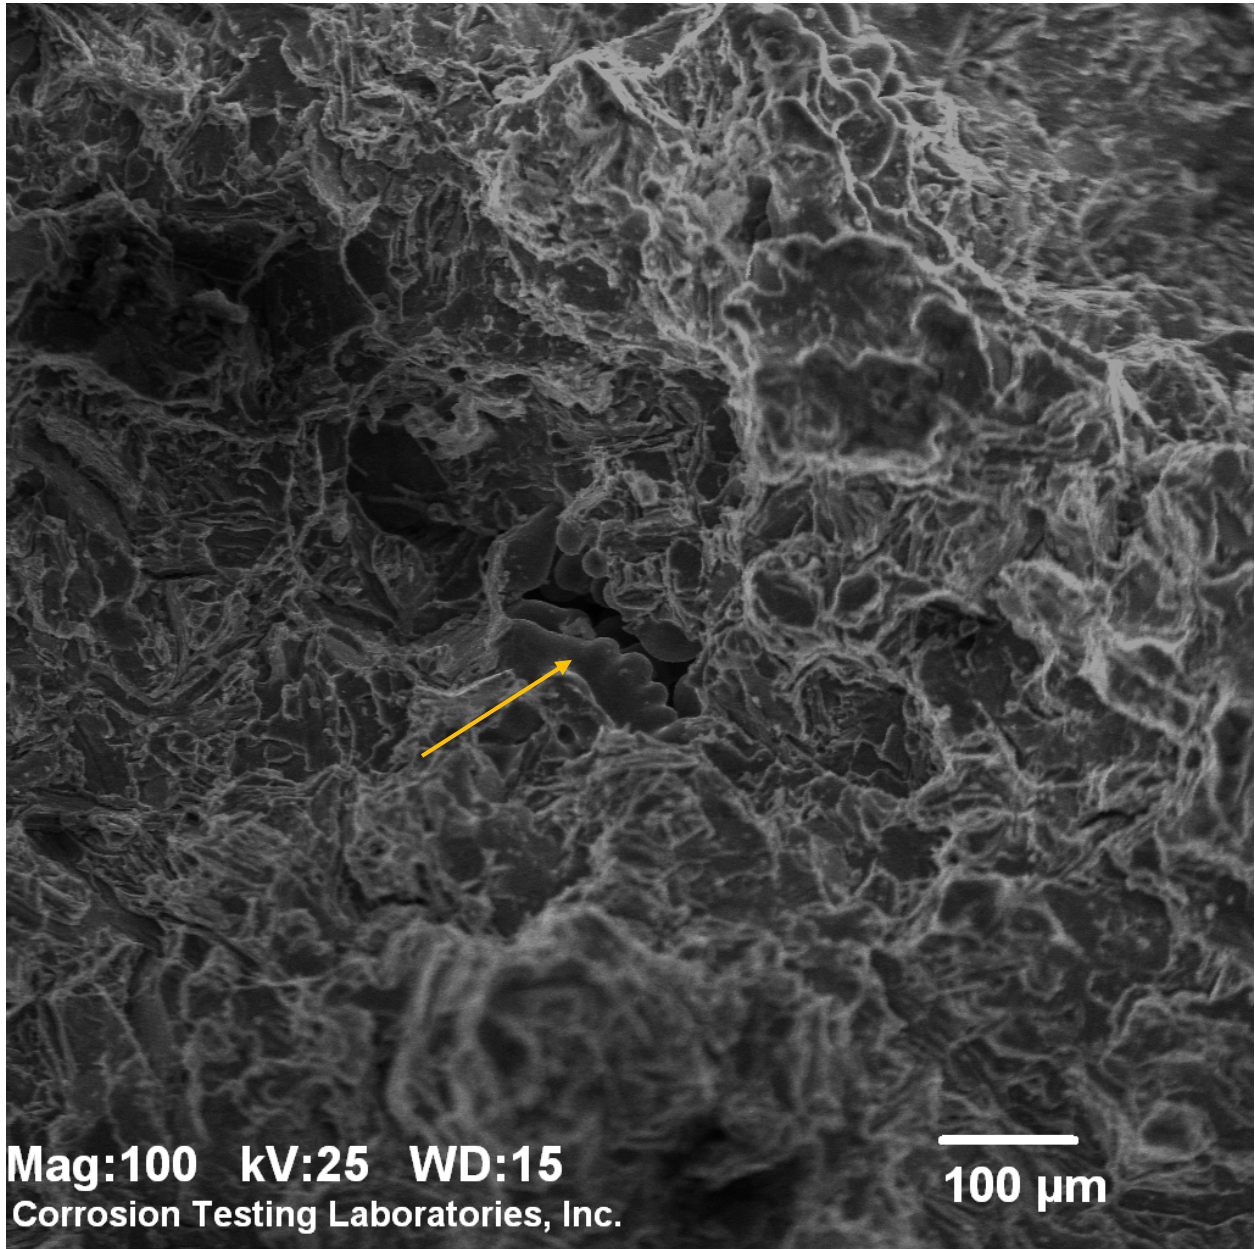
Figure 19. Fracture surface near the location of the mount shown in Figure 18 (also see Figure 5 for location). Fracture is typical of brittle cleavage. A casting void (arrow) is present in the center of the photograph. No evidence of ductility or fatigue fracture is present. 100X original magnification.
