# Polk County Fire Rescue

## Post Incident Analysis

Residential Structure Fire

13802 Rock Ridge Road, Lakeland, FL

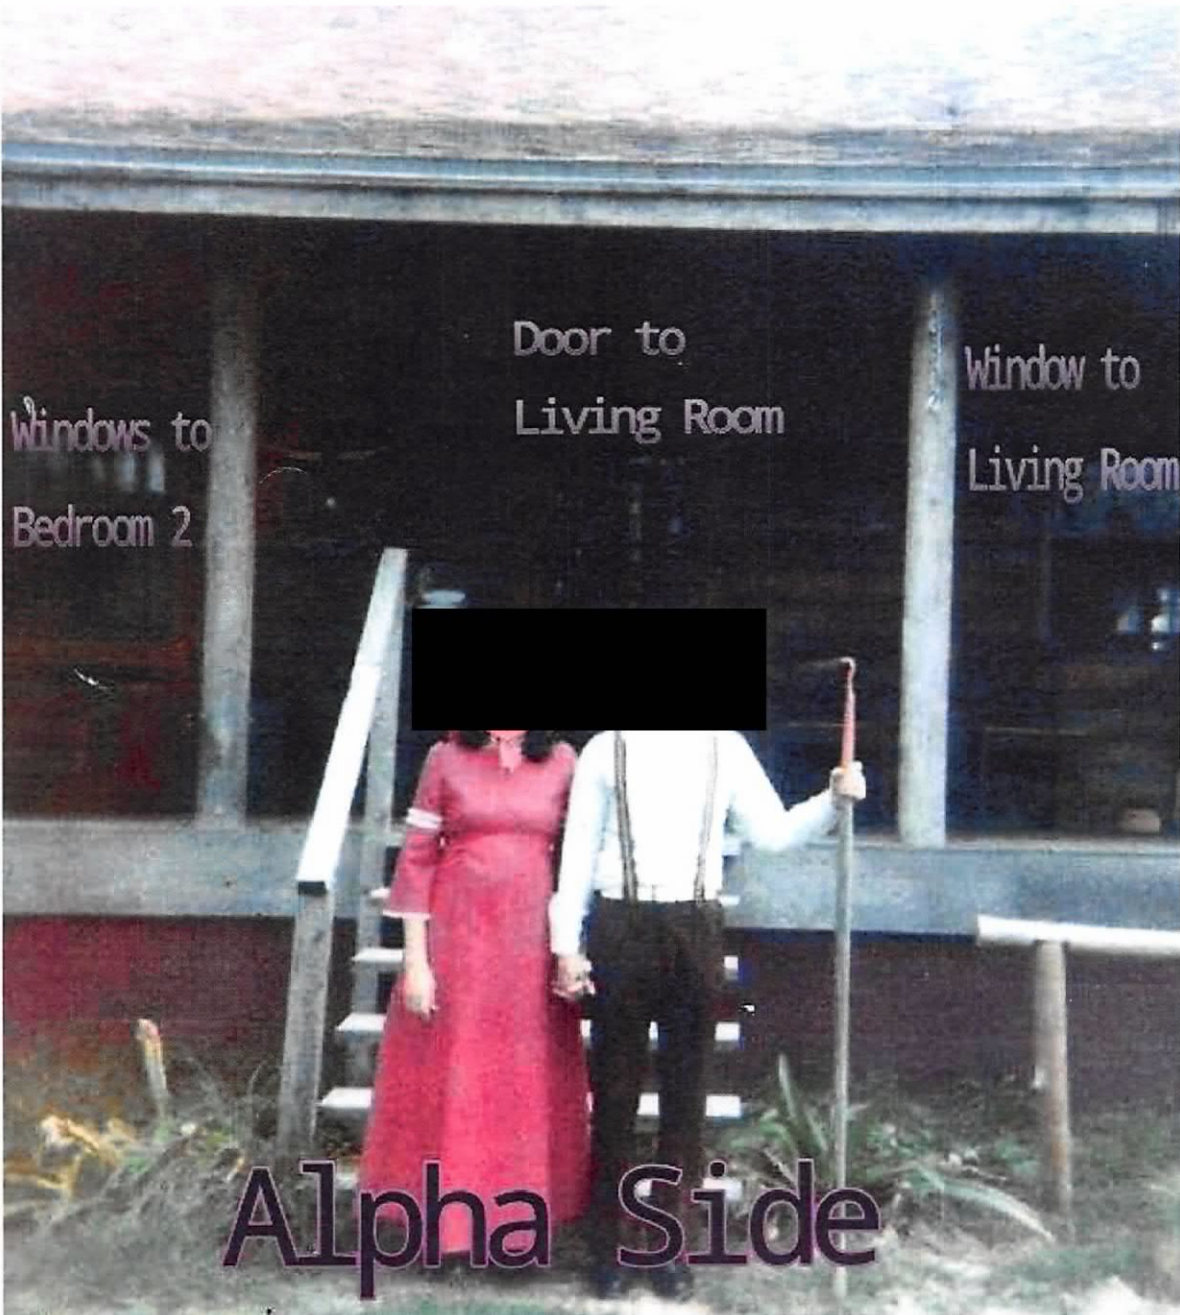
Alpha Side

Windows to  
Bedroom 2

Door to  
Living Room

Window to  
Living Room

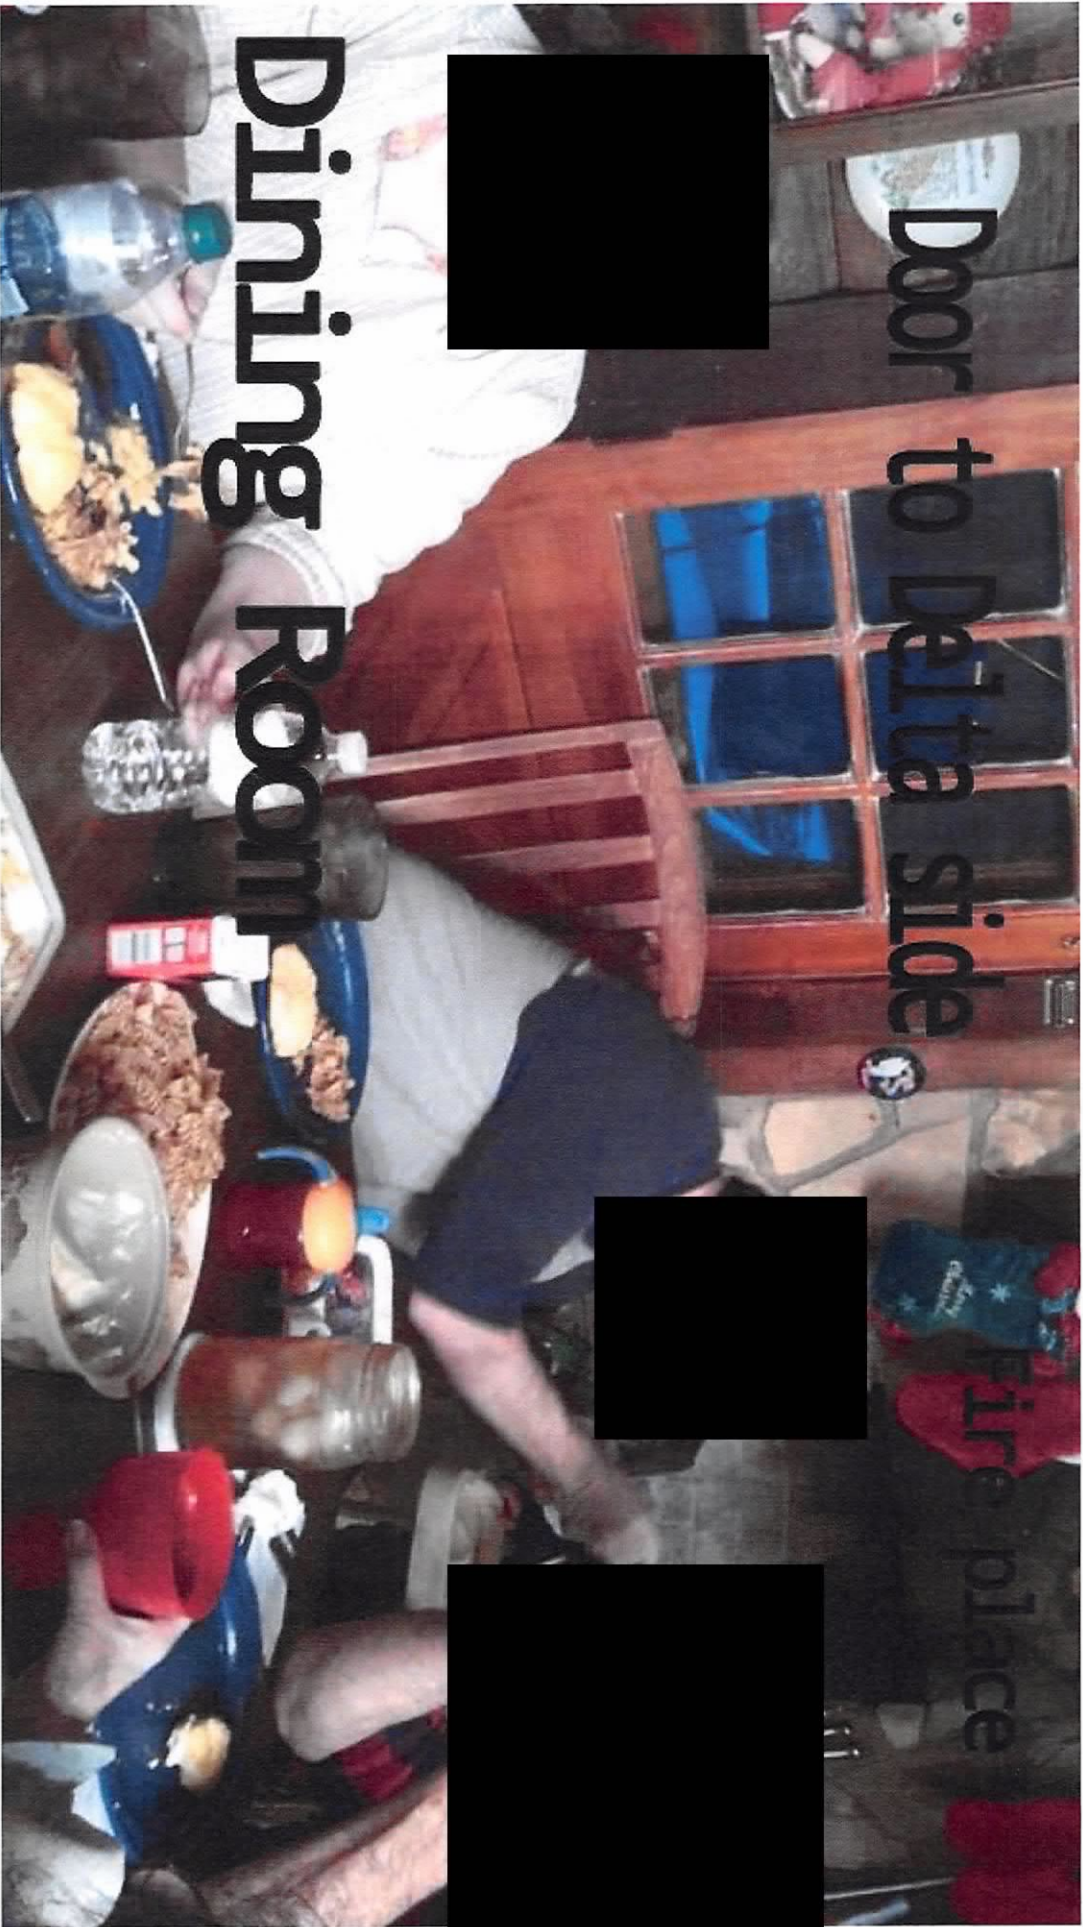
Door to Delta side

Dining Room

Fire place

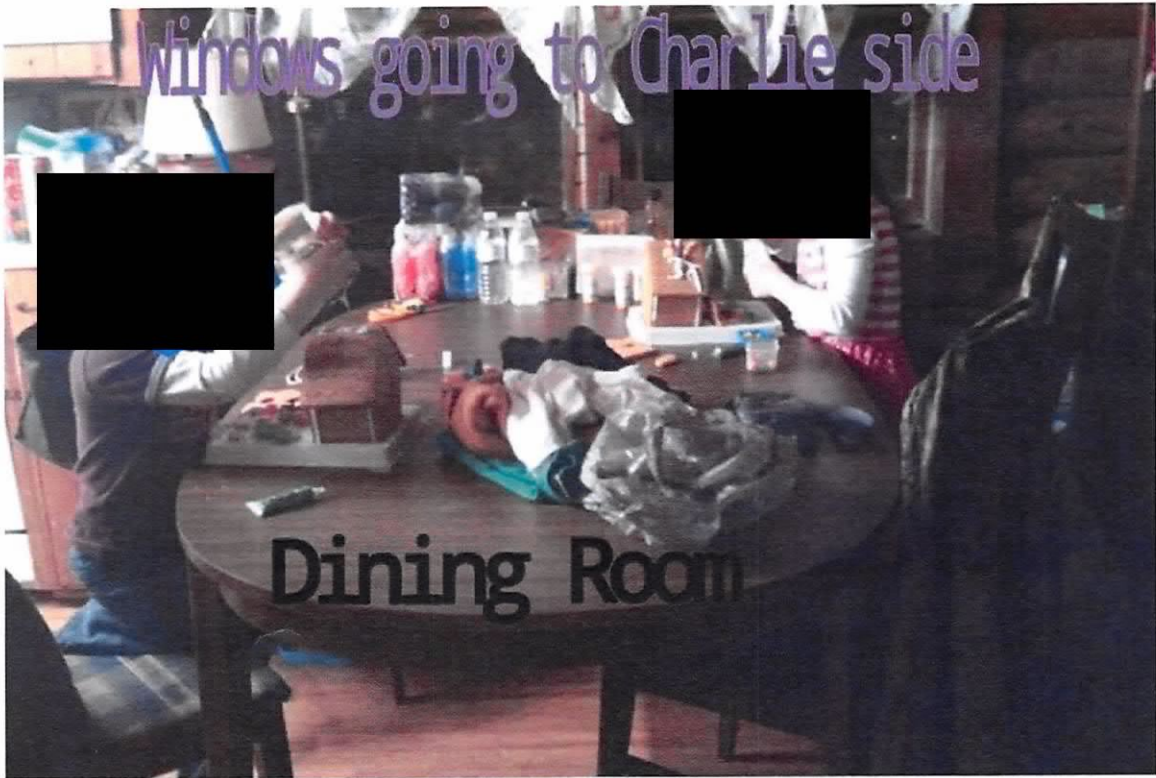
Windows going to Charlie side

Dining Room

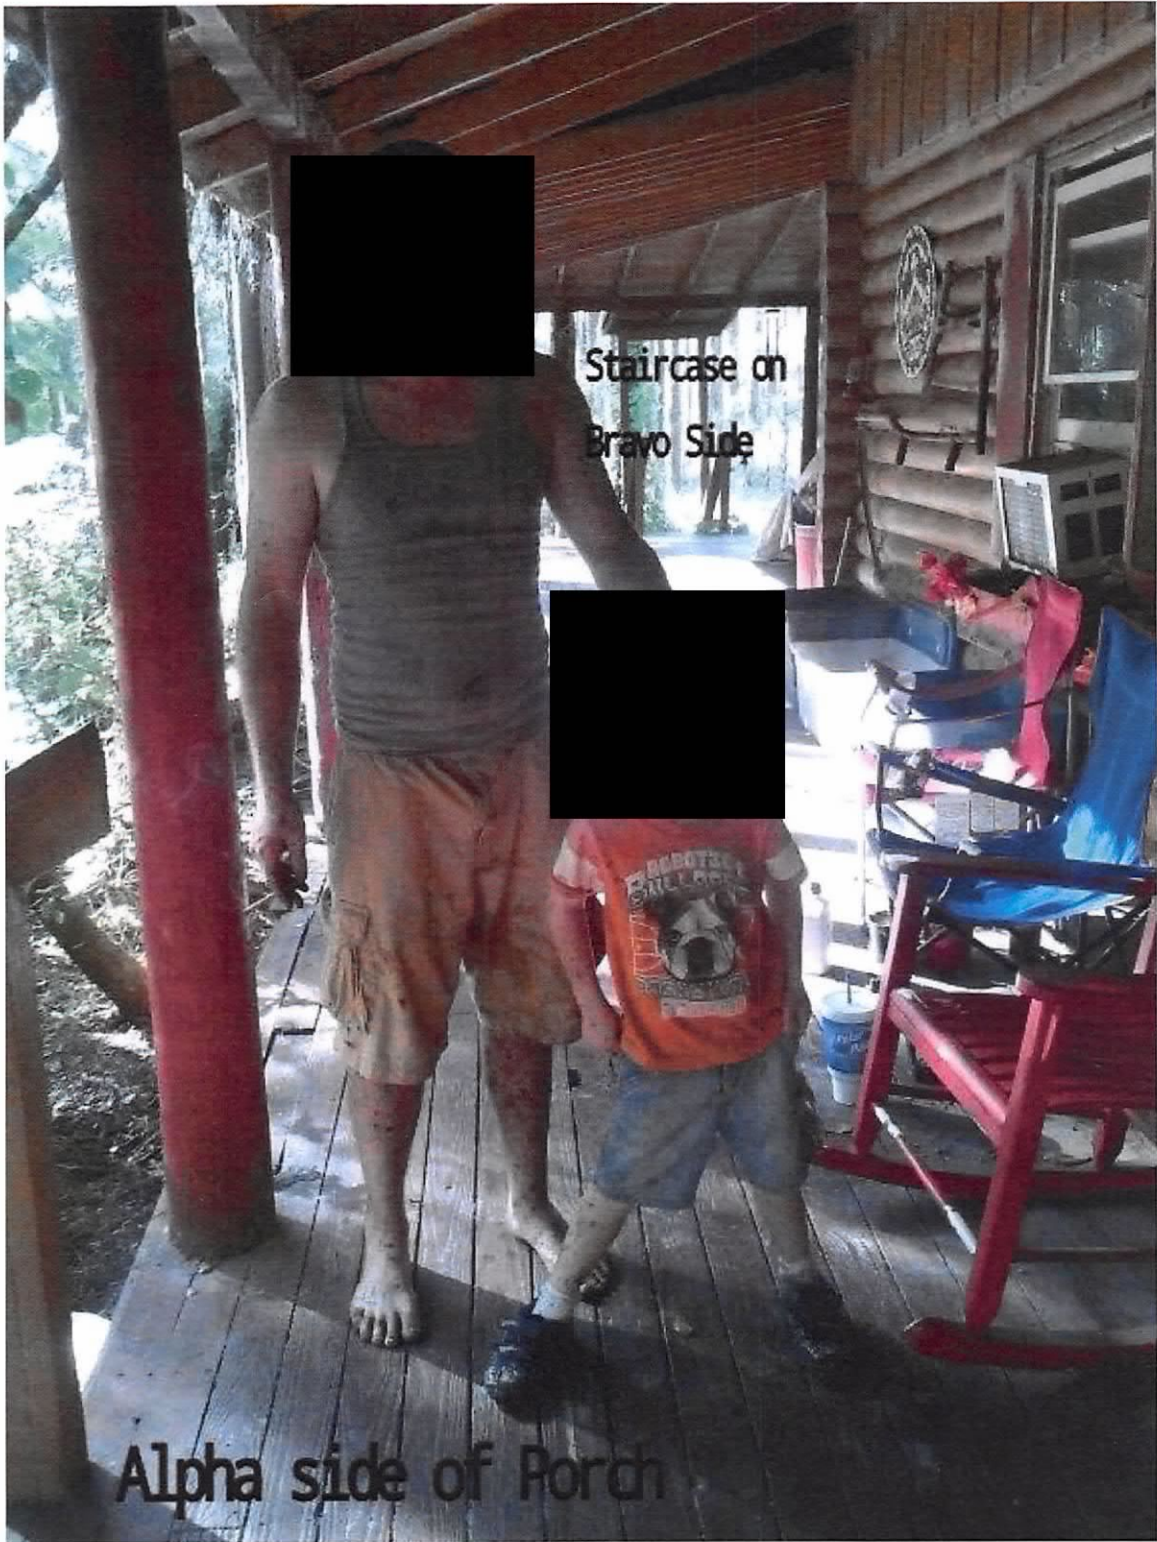
Staircase on  
Bravo Side

Alpha side of Porch
