NIOSH
Fire Fighter Fatality Investigation
and Prevention Program

February 11, 2009

Nine Career Fire Fighters Die in Rapid Fire Progression at Commercial Furniture Showroom – South Carolina

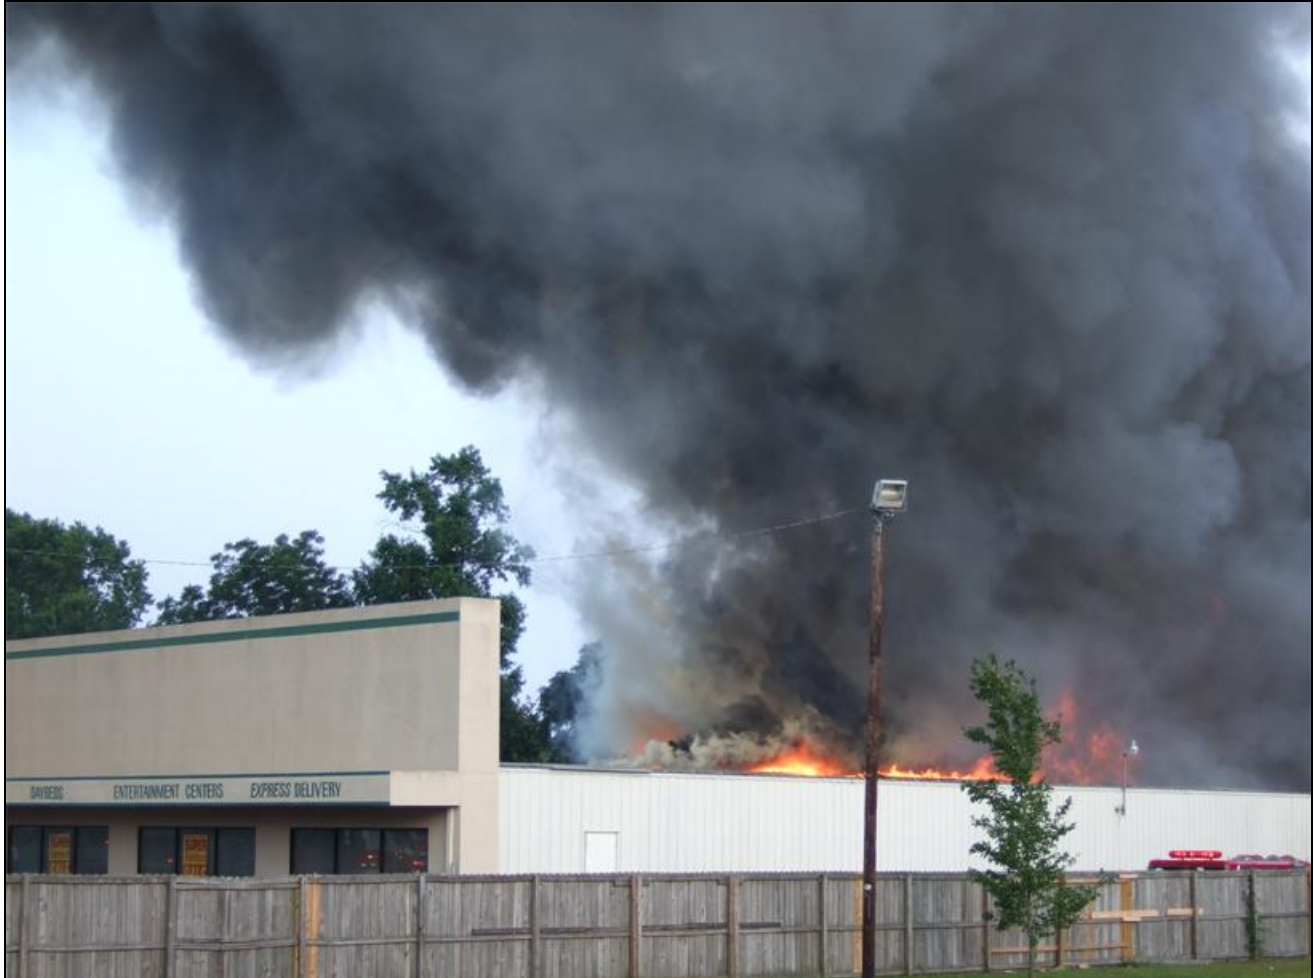
Photo 1. Time approximately 1924 hours. Fire is visible over showroom roof. Smoke is dark gray in color and becoming turbulent. The flames may not have been visible from front parking lot or close to the building on the D-side. (Photo courtesy of Dan Folk.)

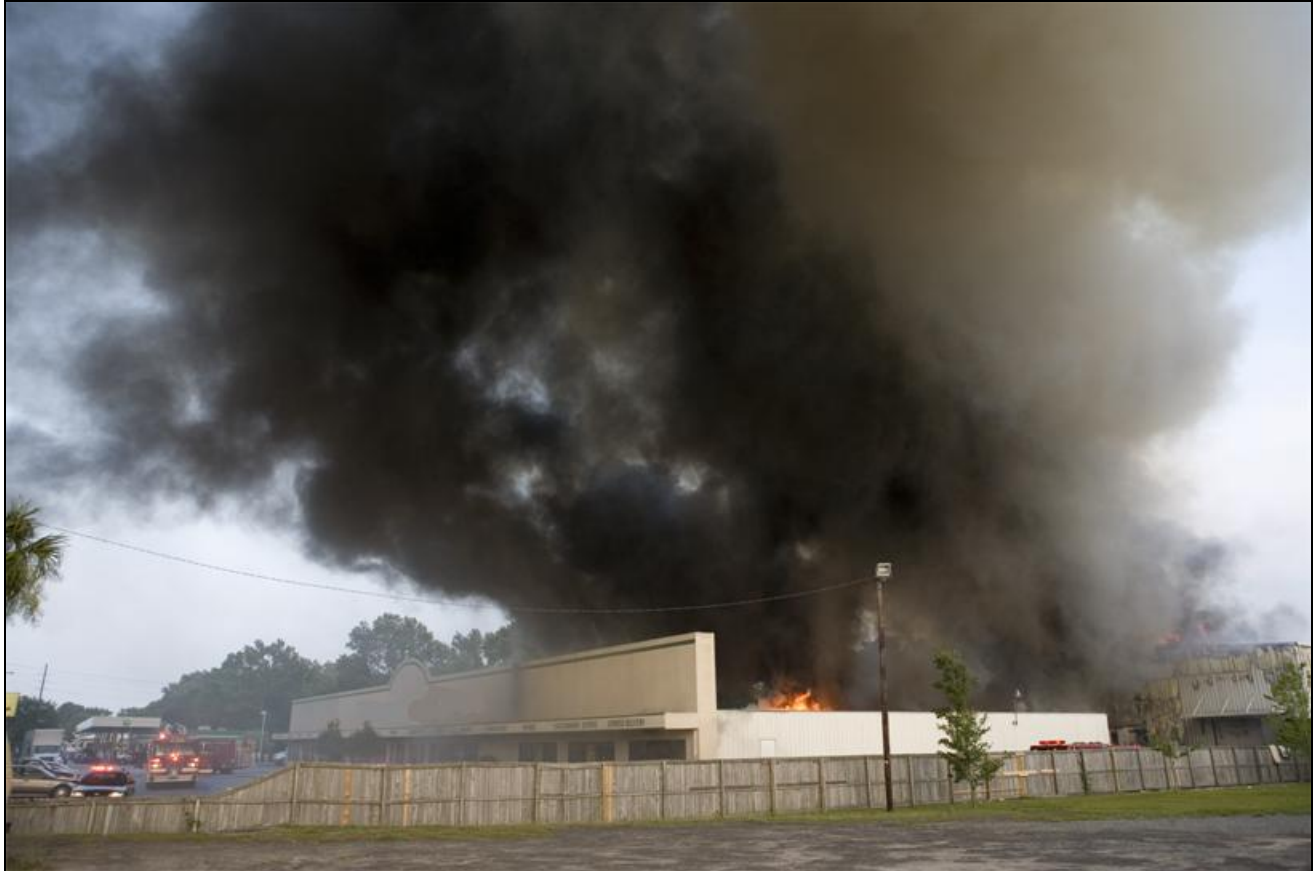
- **1929 hours**
Broken radio traffic of fire fighter in distress asking “which way out” then “everyone out”
- **1930 hours** (see Photo #2)
E-11 radios that 2 ½” hose line is charged
Several different fire fighters in distress radio “need some help out,” “need help getting out,” also “lost connection with the hose”
AC radios Fire Chief that they are attempting to free civilian trapped in warehouse

Photo 2. Time approximately 1930 hours. Note how smoke has changed to dark black color indicating it is rich with products of incomplete combustion. Note Ladder 5 and Engine 11 in front of structure as well as fire department vehicle in lower left corner. The top of Engine 10 is just visible over the fence at the lower right. (Photo courtesy of Associated Press, Alexander Fox photographer.)

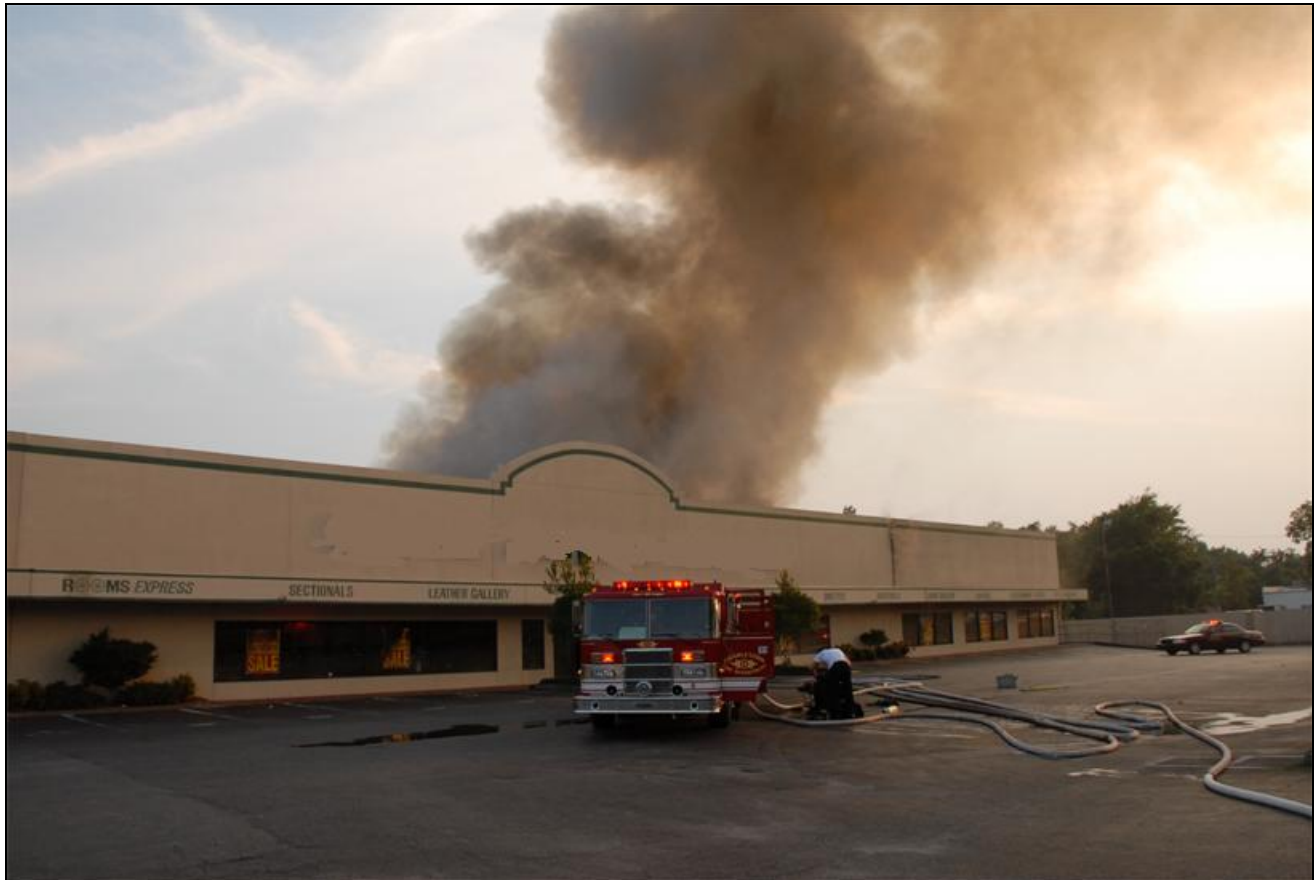
- **1931 hours – 1934 hours** (see Photo #3)
More broken radio traffic from fire fighters in distress
L-5 repositioned to D-side by off-duty fire fighters
Fire Chief asks for E-3 to come to scene and lay supply line to L-5
BC-5 reports civilian is out of building
E-16 engineer radios dispatch that police department is needed to prevent traffic from running over supply line.
FF calls Mayday
Fire Chief asks AC “is everyone out?” AC responds the civilian is out
Fire Chief radios AC to make sure his people are accounted for.
E-15 FF exits building (out of air) – reports he didn’t call the Mayday
Fire Chief radios “who called Mayday”
Fire Chief radios “...we need to vacate the building”
Dispatch tells Fire Chief that the L-5 engineer emergency button (on radio) has been activated
Fire Chief radios for E-15 captain with no response
E-15 FF changes air cylinder and goes back inside

Photo 3. Time approximately 1934 hours. Note lack of any fire personnel in front of structure. At this point, the E-11, L-5, E-16, E-15, E-19, and E-6 crews are inside the showroom. Also note how the color of smoke column appears different from previous photo which may be due to the angle of the photograph and position of the sun. *(Photo courtesy of Police Department, Bill Murton, photographer.)*

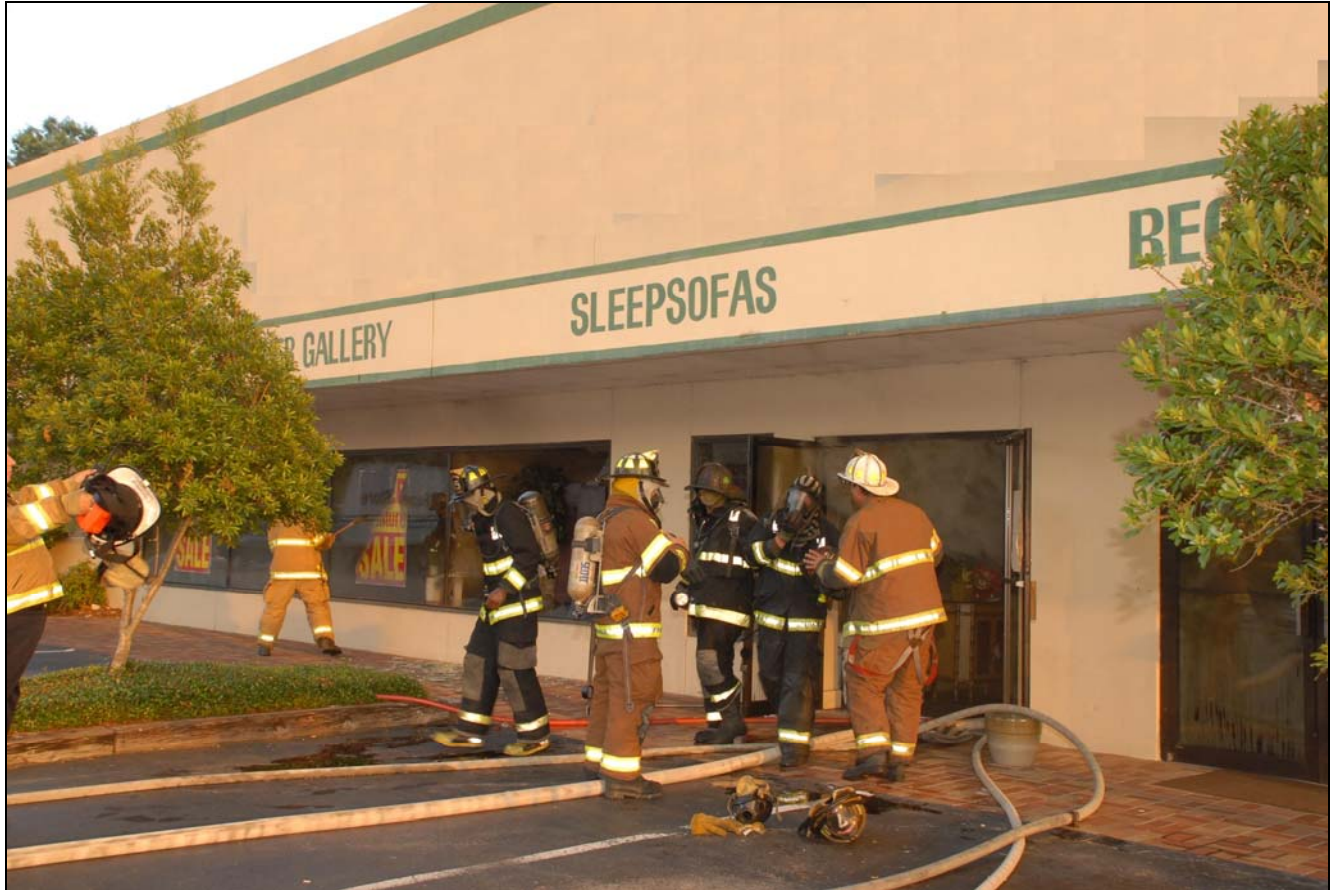
Photo 4. Last surviving members of the initial attack crews exit showroom at approximately 1935 hours.
(Photo courtesy of Police Department, Bill Murton, photographer.)

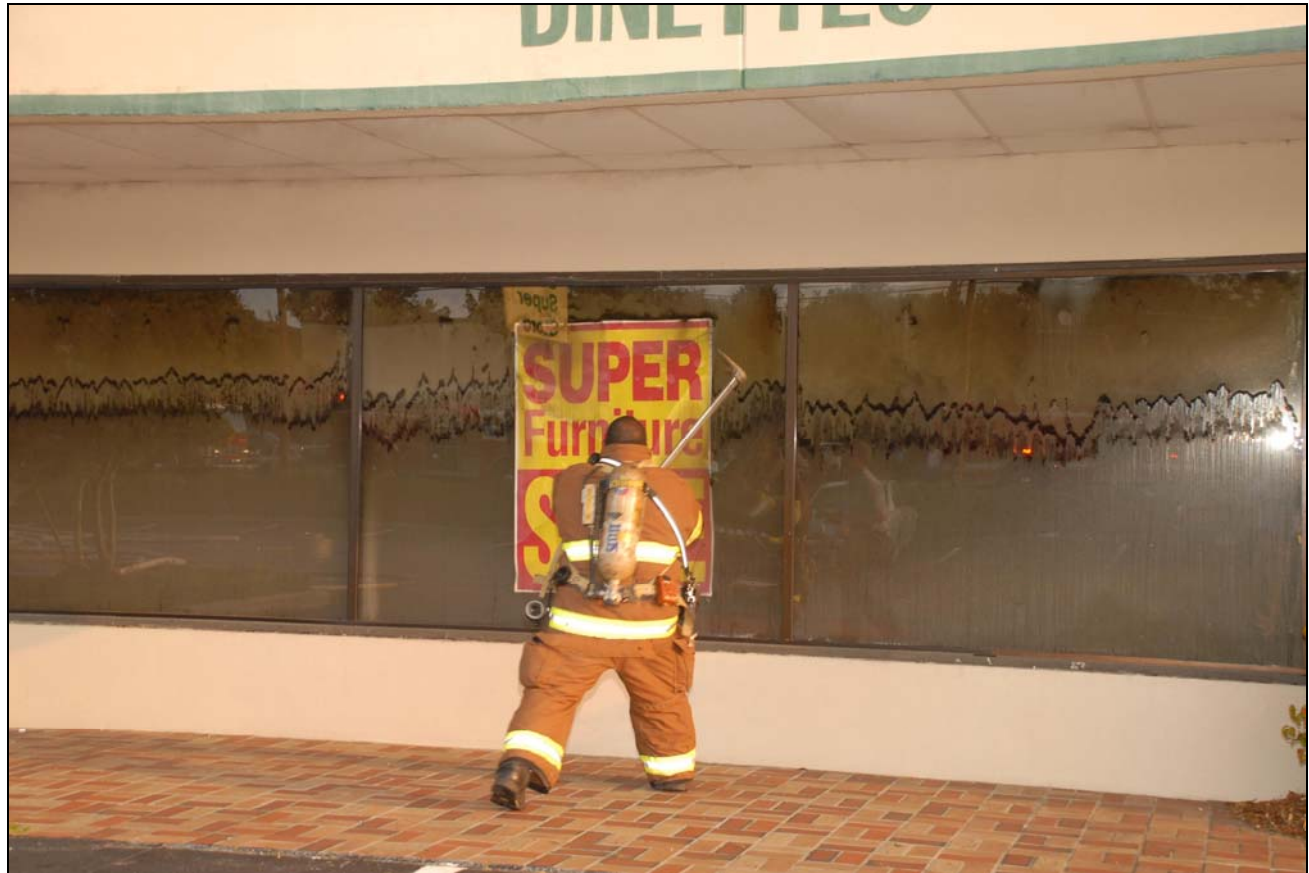
Photo 5. Time approximately 1935 hours. Mutual aid fire fighter breaking showroom front window. Photo taken just prior to mutual aid department making rescue attempt in front showroom. Note the heavy tar stains on the windows indicating the smoke inside the showroom is rich with flammable products of incomplete combustion. (Photo courtesy of Police Department, Bill Murton, photographer.)

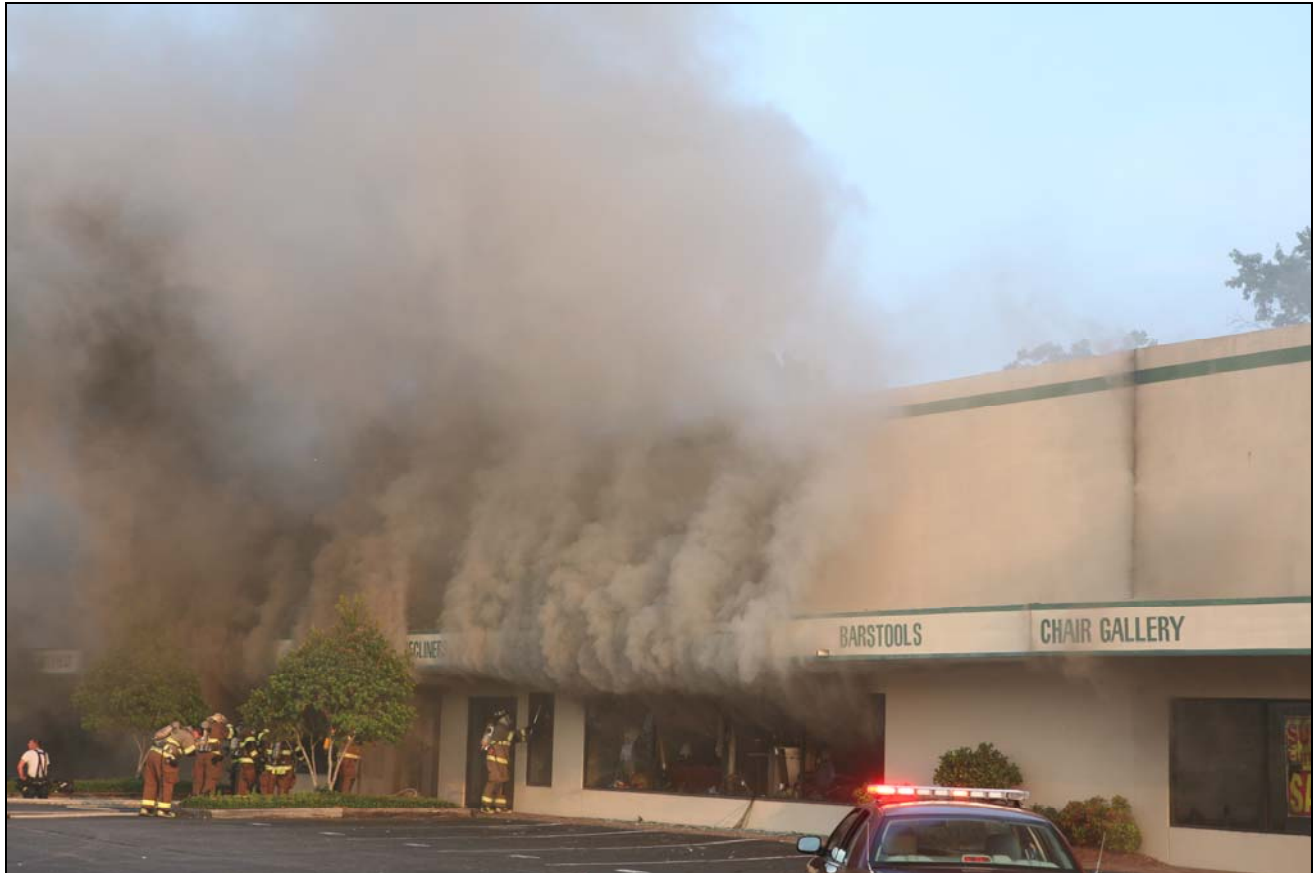
Photo 6. Time approximately 1936 hours. Note turbulent dark gray smoke rolling out of the showroom as the front windows are being knocked out. Mutual aid crew is assembling for search and rescue attempt.
(Photo courtesy of Associated Press, Alexander Fox, photographer.)

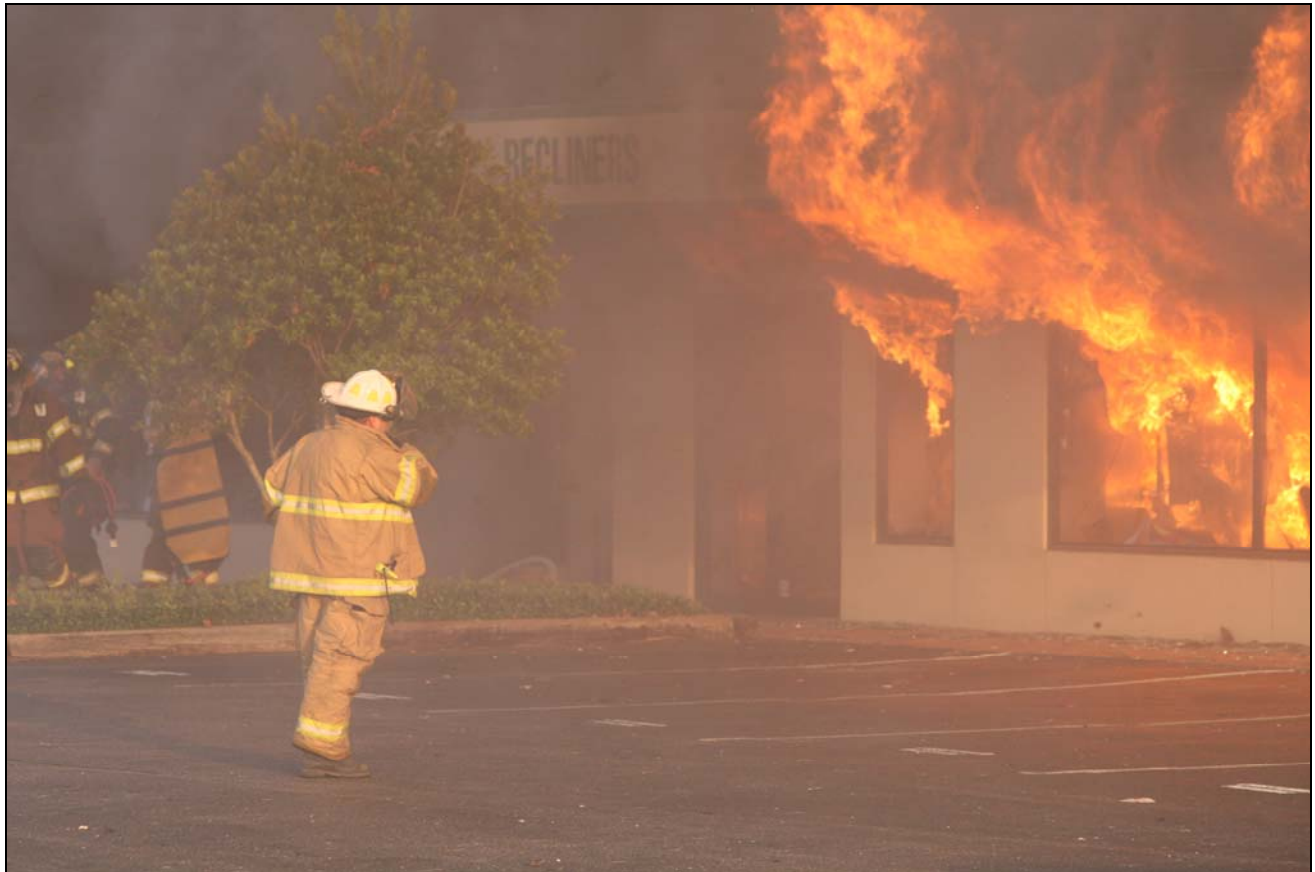
and combustion by-products in the showroom ignited, filling the showroom with flames. The two mutual aid fire fighters lost contact with the two disoriented fire fighters and were driven outside by the intense heat and flames (see Photo 7). One of the rescuers received second degree burns on his face, neck, hands, and arms. An off-duty Battalion Chief and the Engine 6 engineer also entered the structure for a rescue attempt. They also were driven out by the rapid fire spread.

Photo 7. Time approximately 1938 hours. Photo shows conditions at front of showroom just before the interior search and rescue attempts were halted due to the interior conditions.

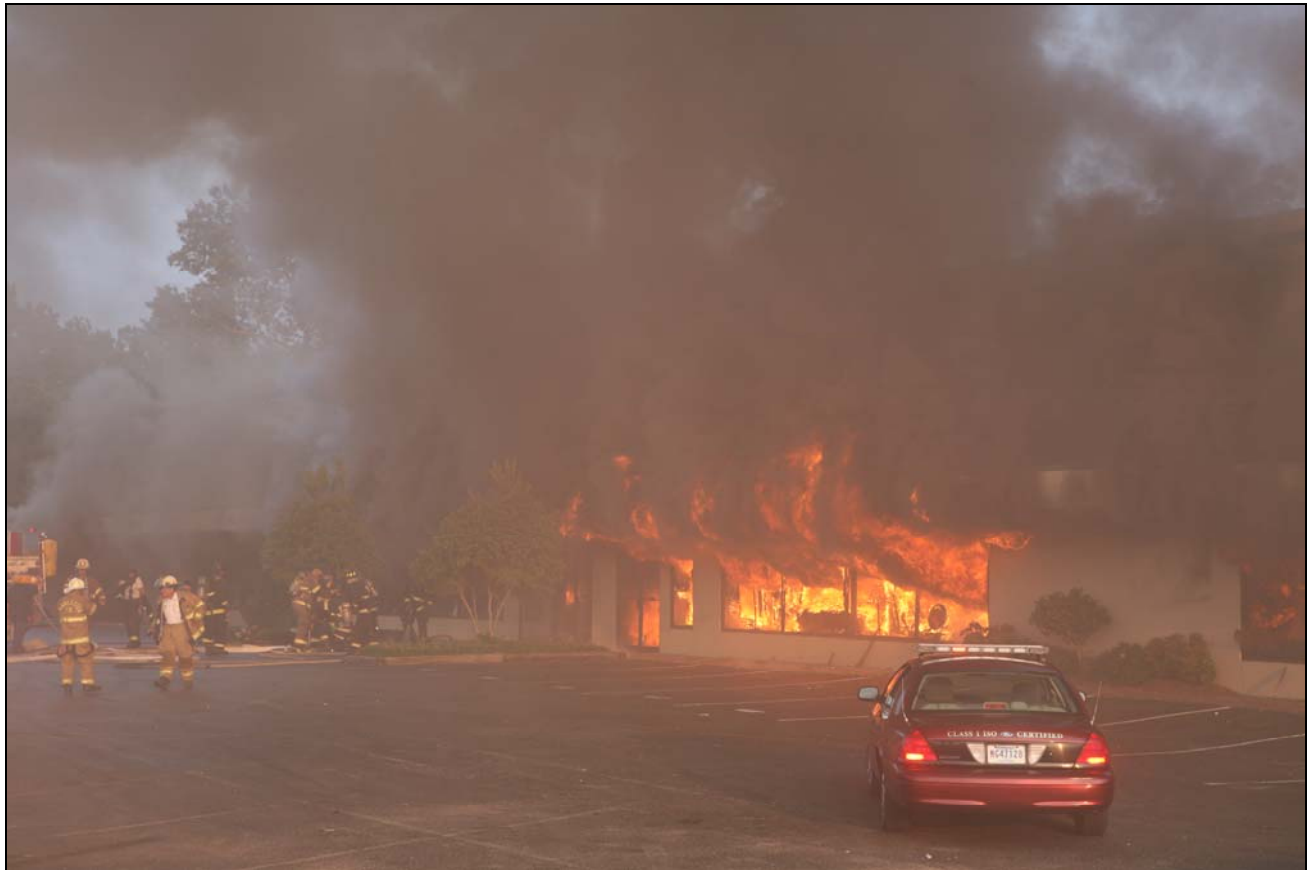
Photo 8. Time approximately 1938 hours. Photo taken less than a minute after rescue crews are forced out of the showroom by the interior conditions. Note fire rolling out the showroom windows.
(Photo courtesy of the Charleston Post and Courier.)

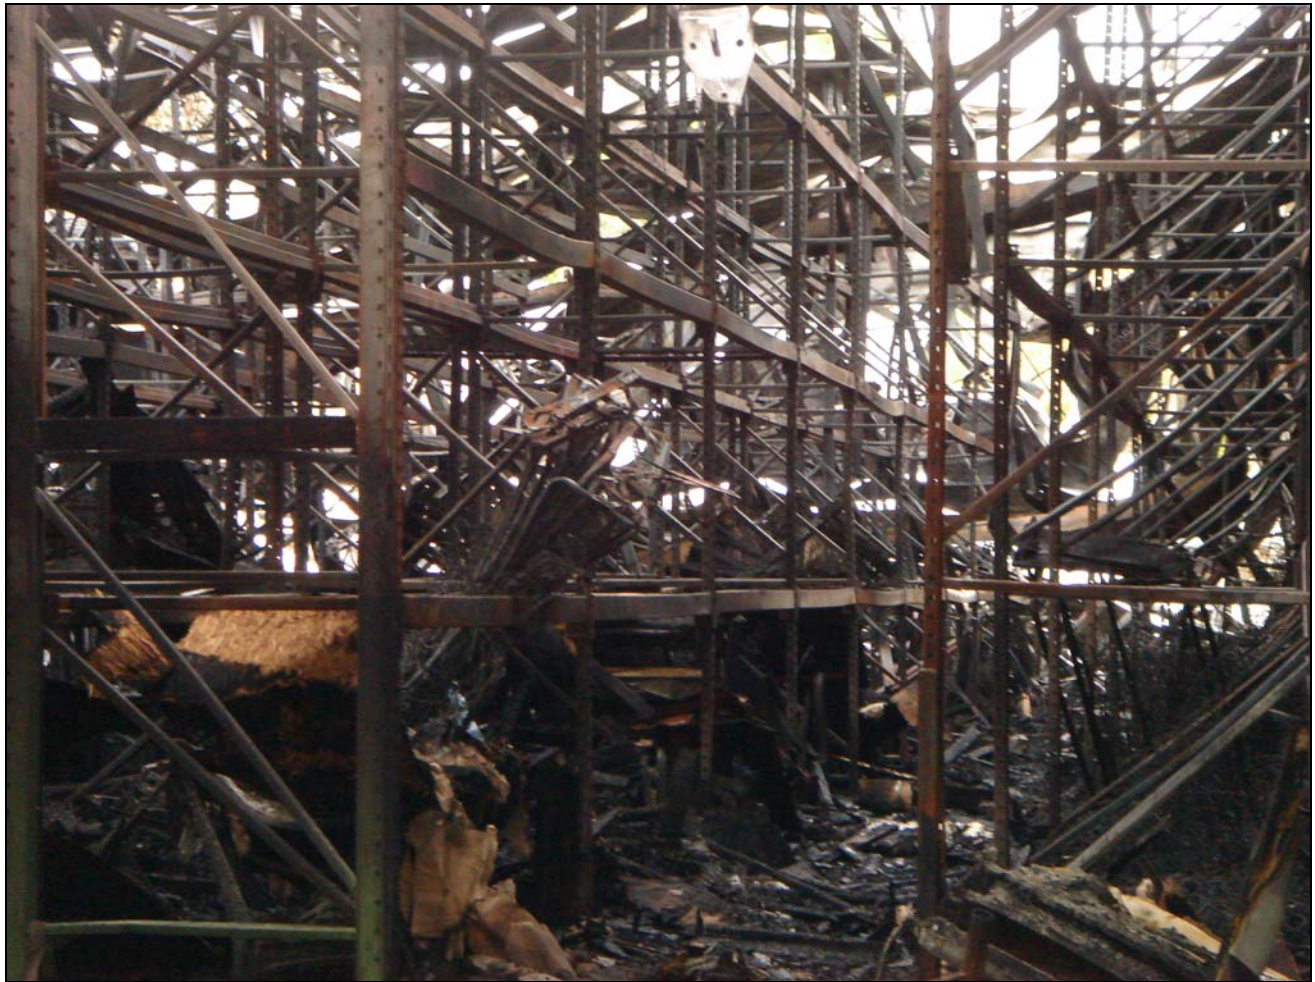
Photo 9. Storage racks in warehouse post fire. Storage racks were filled with various furniture and mattress items. Note the extent to which the storage racks filled the warehouse which gives an indication of the volume of merchandise and the fuel load inside the 15,600 square foot warehouse. The warehouse measured approximately 130 ft. by 120 ft. and was 29 ft from floor to roof. (Photo – NIOSH.)

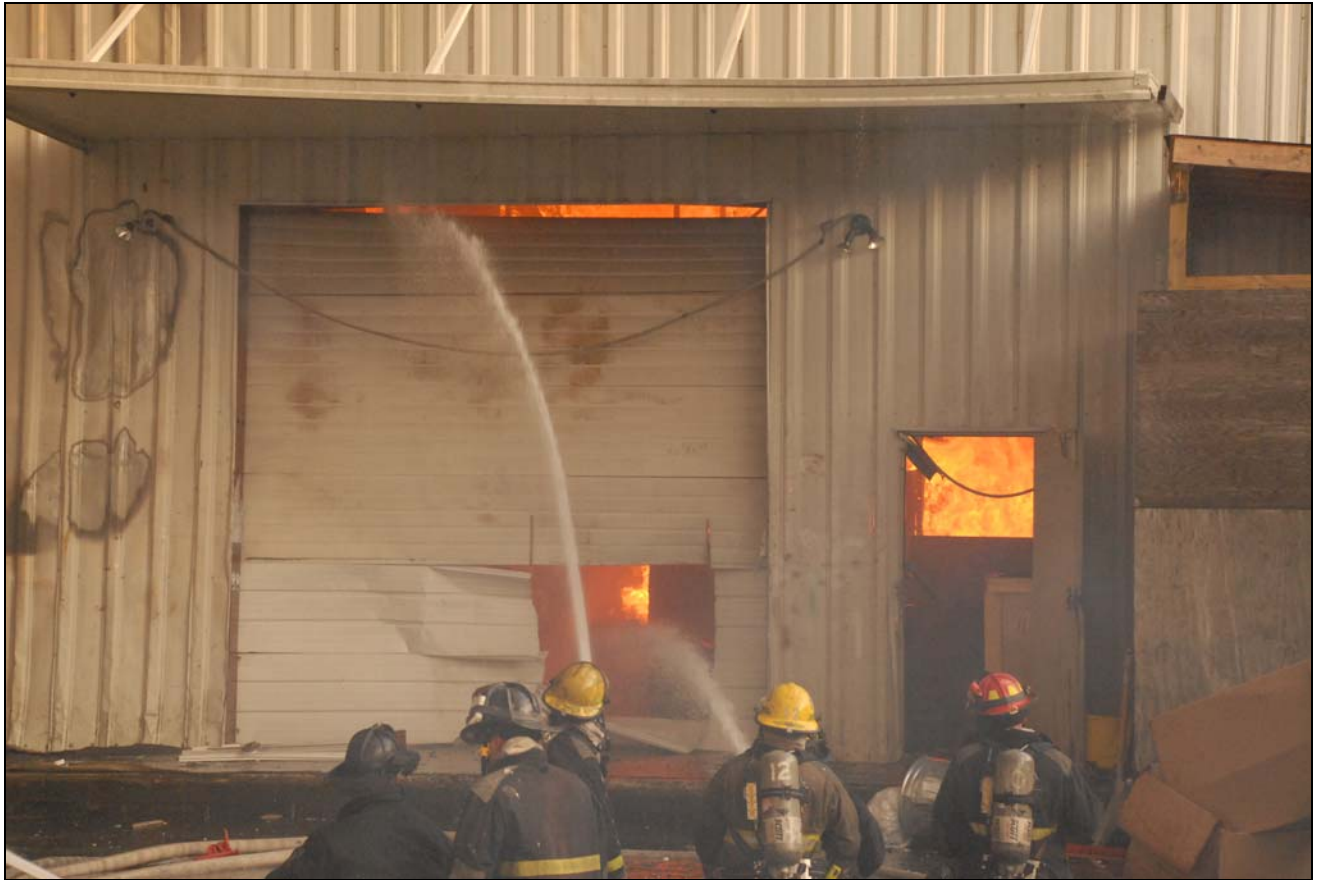
Photo 10. Time approximately 1942 hours. Engine 10 and Engine 12 crews battle fire in warehouse from outside. *(Photo courtesy of police department, Bill Murton, photographer.)*

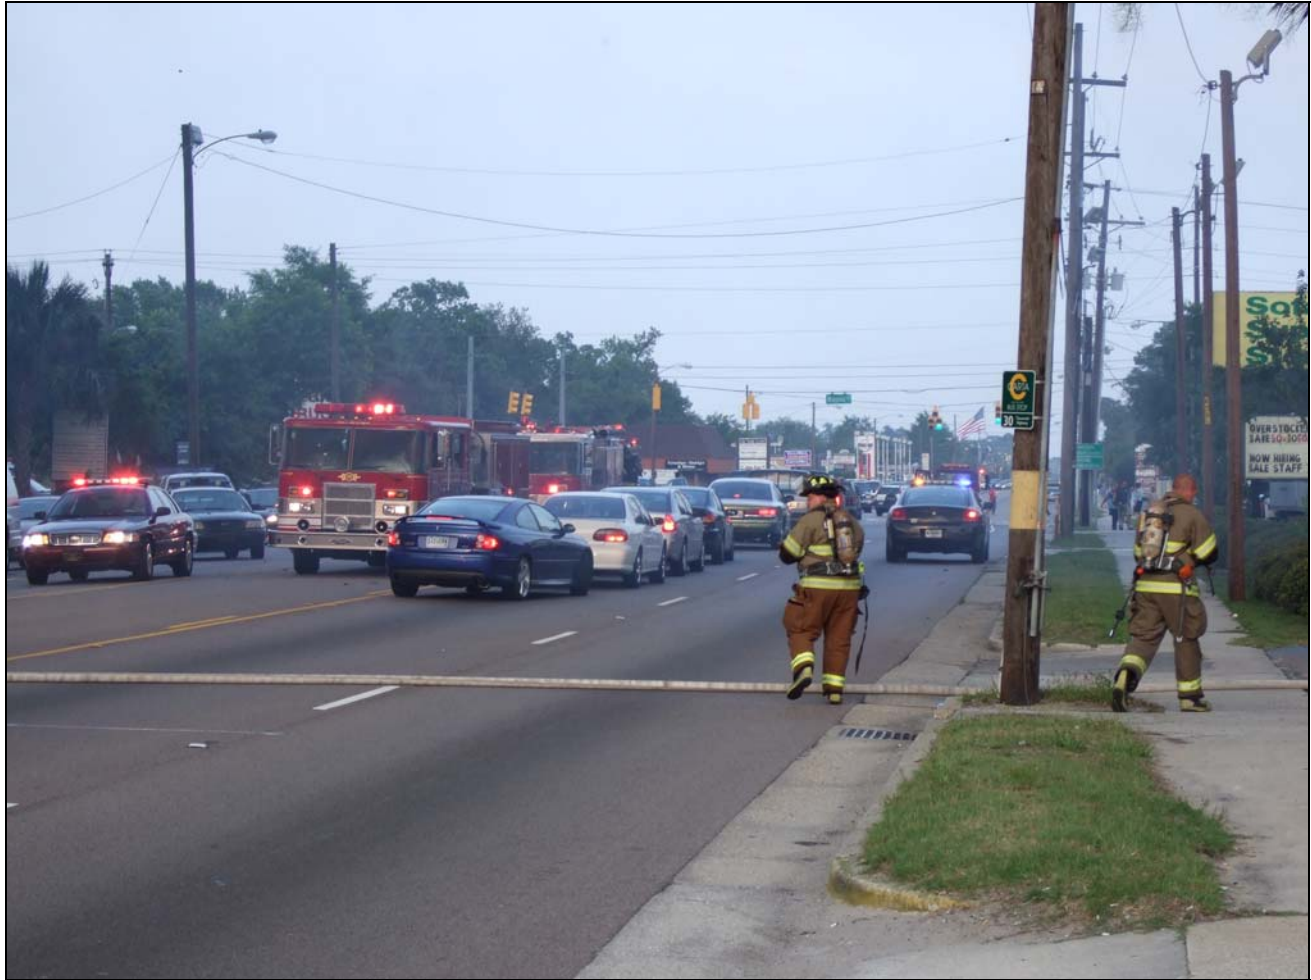
Photo 11. Time approximately 1925 hours. Note traffic on major highway in front of incident site driving over 2 ½ inch supply line. The hose line runs from Engine 12 (to left of photo) to Engine 10 (to right of photo). Photo shows mutual aid crew members arriving on scene. *(Photo courtesy of Dan Folk.)*

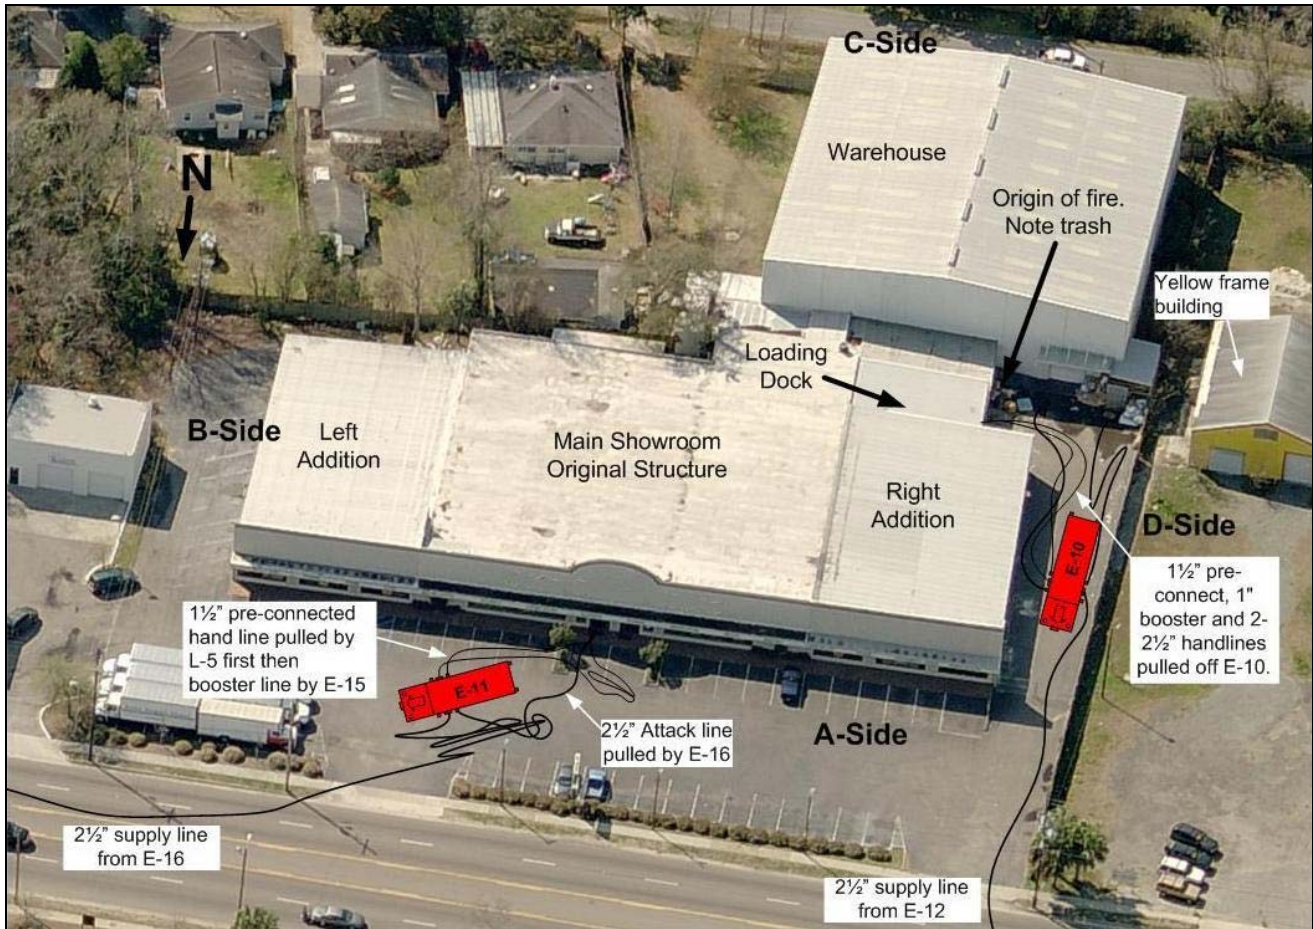
The structure had been inspected by the fire department on a number of occasions. In 1987, fire inspection duties were transferred from the fire department to the city with the last documented fire code inspection by the city in 1998. The fire department continued to perform periodic pre-plan inspections. A building pre-plan form obtained from the fire department dated April 26, 2006 noted that store contents were “household furniture and office equipment” and that the rear warehouse contained racks approximately 30 feet high (see Appendix III). The pre-plan form did not mention the large volume of furniture and flammable materials (fuel load) contained in the structure. It was reported to NIOSH investigators by fire fighters during interviews that trash from the furniture business, including packing materials, cardboard, broken furniture and other flammable materials, were routinely stored against the building near the loading dock on the west (D) side of the structure (see Diagram 2).

The E-16 engineer was instructed to lay a supply line for E-11 so he drove east on the highway toward where a hydrant had been previously located. This hydrant had been removed in 2004 because it had received damage from heavy truck traffic in the immediate area. He continued east to the next hydrant located approximately 1,200 feet away. *Note: 1,850 feet of a single 2 ½” supply line was stretched from E-11 to the hydrant.* The E-16 engineer reported hearing the radio traffic about the civilian worker being trapped in the rear of the building just as he was pulling up to the hydrant. (see Diagram # 2)

Diagram 2. Location of Engine 10 and Engine 11, supply lines and hose lines pulled at different times during the incident. Note accumulation of trash at loading dock on the day photo was taken, 3 months prior to the incident. Note the absence of ventilation ductworks or other roof penetrations over the showroom, thus no path for smoke and hot gases to escape.

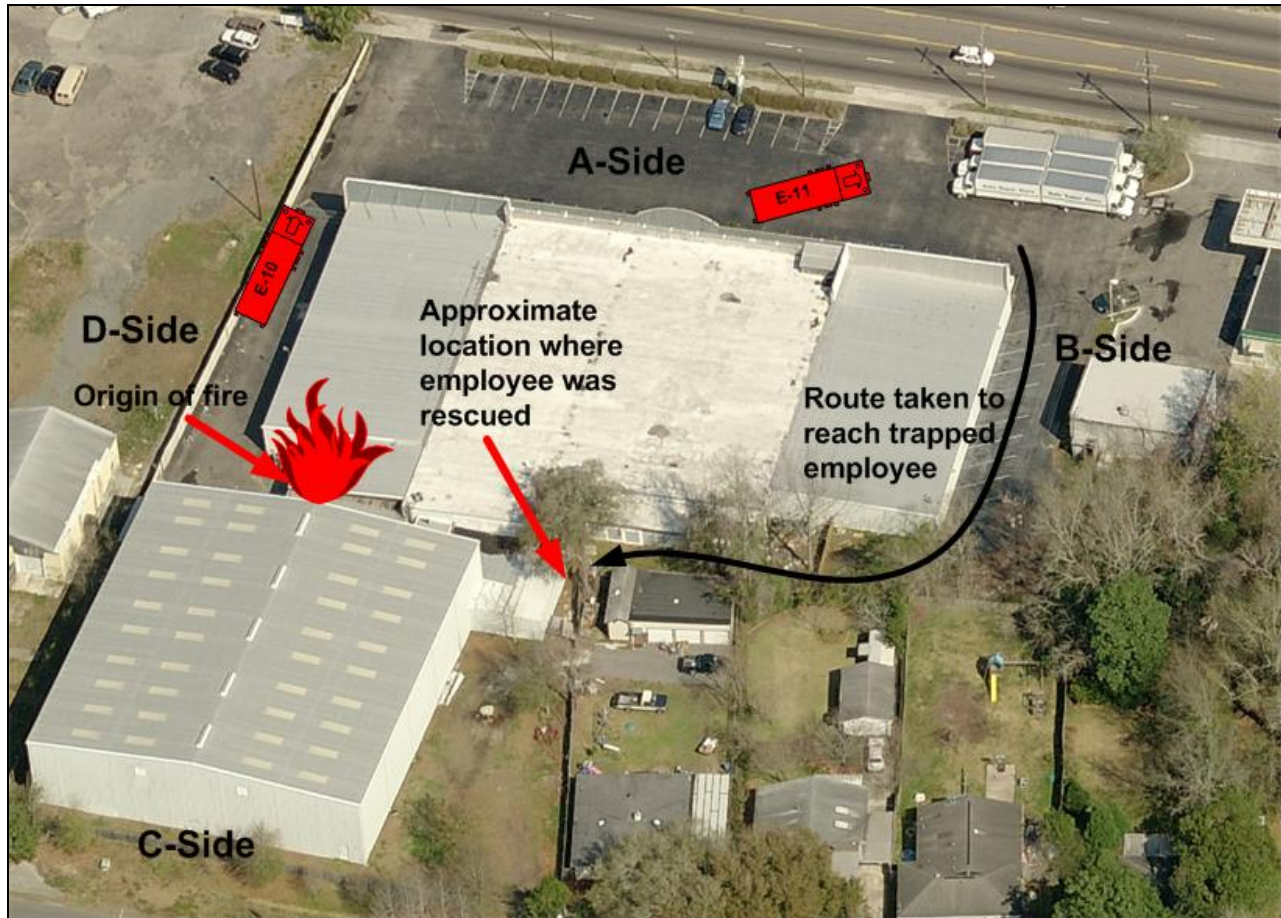
Diagram 3: Note location where mutual aid crew cut through exterior wall to extricate male employee trapped inside the warehouse. From aerial photo taken in 2007.
(copyright Pictometry International – used with permission of Pictometry).

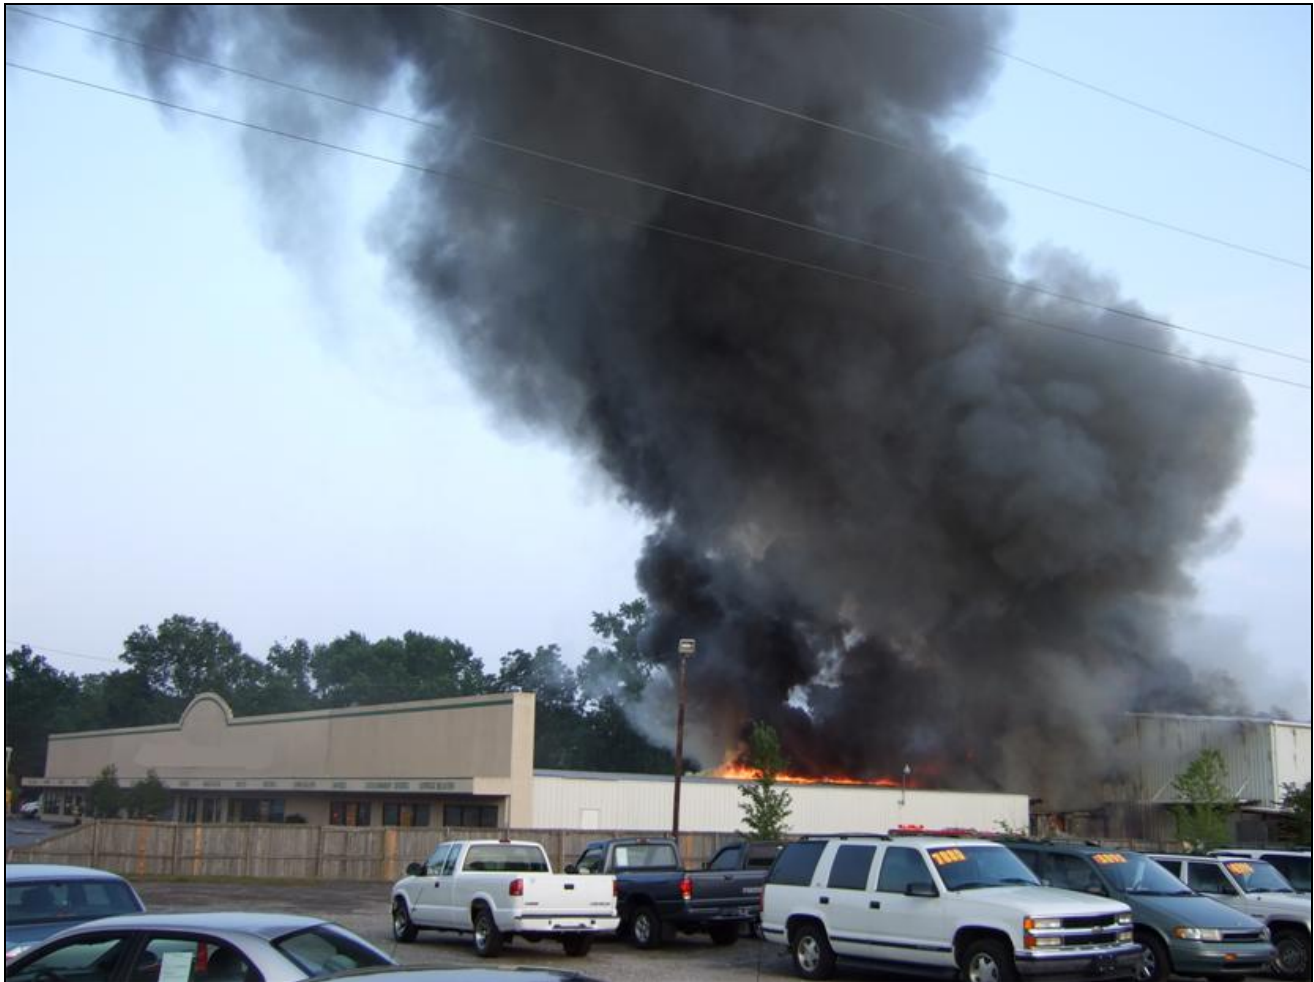
Photo A-1. Time is approximately 1923 hours. Fire is visible over showroom roof. Smoke is dark gray in color and becoming turbulent. The flames may not have been visible from front parking lot or close to the building on the D-side. (Photo courtesy of Dan Folk.)

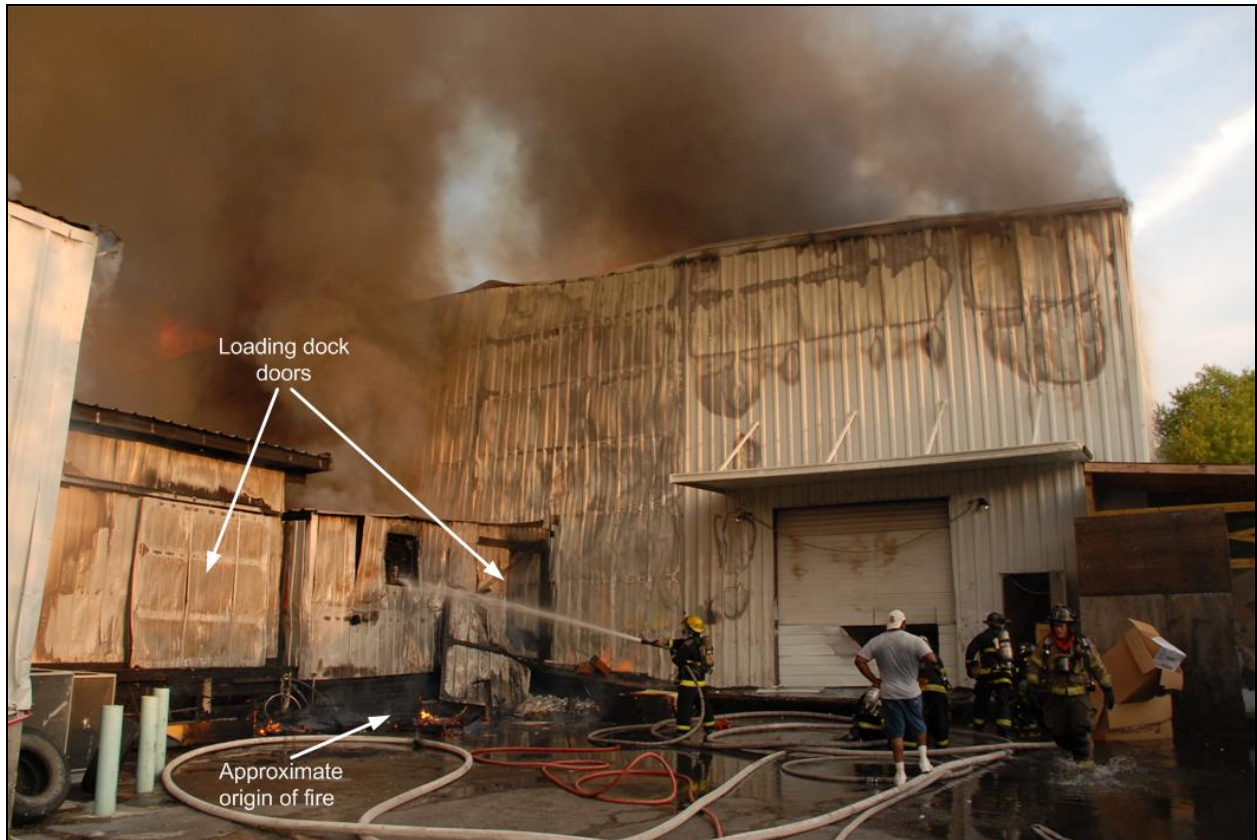
Photo A-2. Time is approximately 1936 hours. Loading dock area approximately 20 minutes after first crews arrived on scene. Note heat damage to metal siding on loading dock and warehouse.
(Photo courtesy of Police Department, Bill Murton, photographer.)

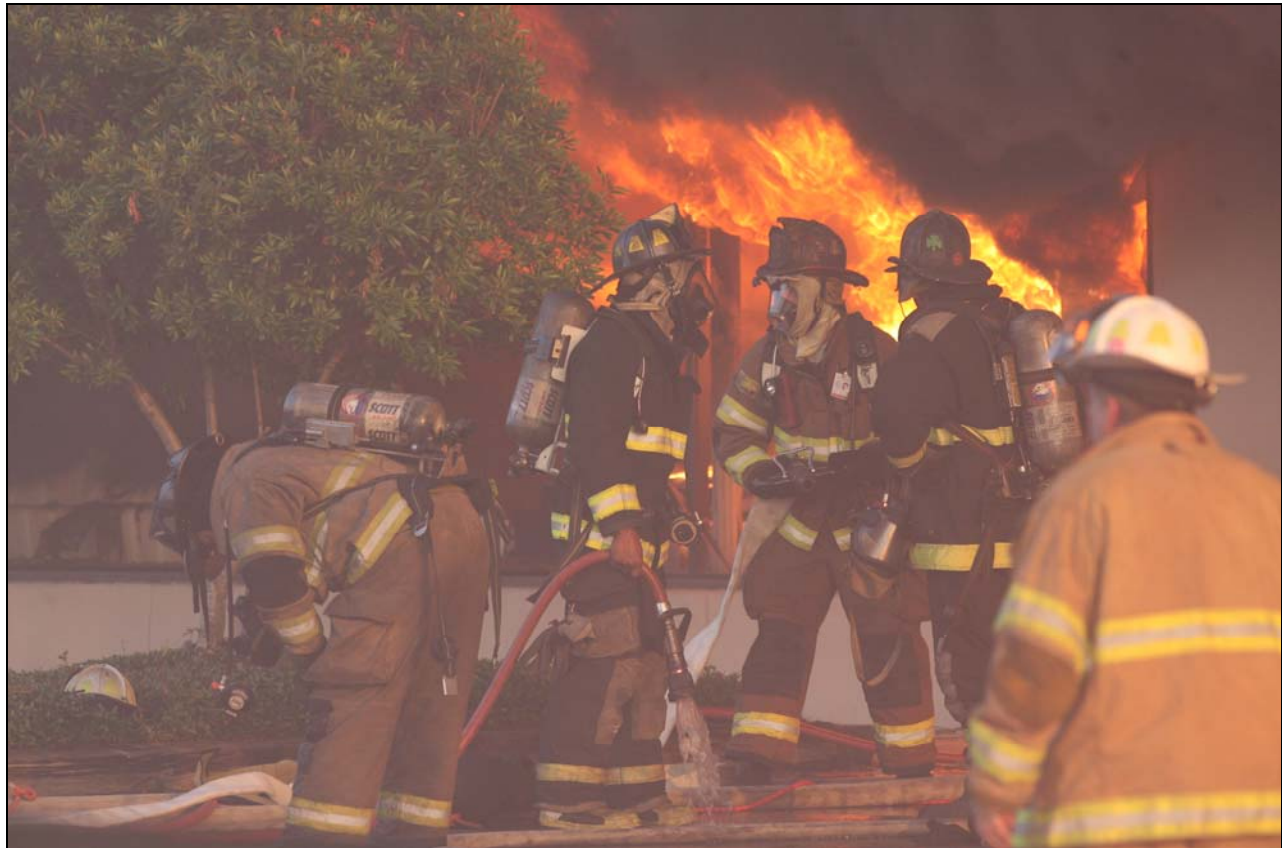
Photo A-3. Time approximately 1939 hours. Fire fighters near front entrance to showroom. Note lack of water pressure on the red booster line and the 2 ½” hand line. Also note lack of gloves and hood.
(Photo courtesy of the Charleston Post and Courier.)

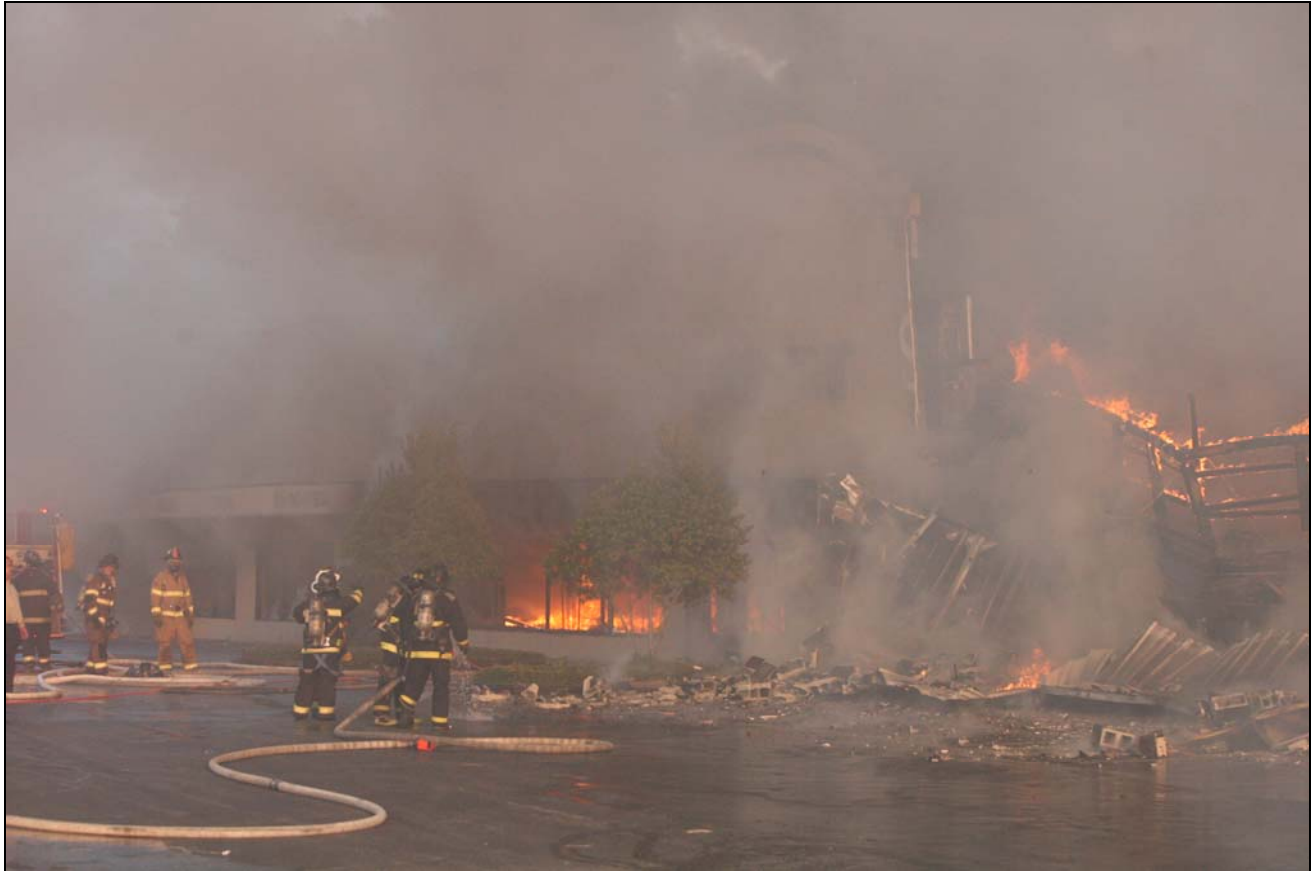
Photo A-4: Time approximately 1951 hours. Front façade beginning to collapse.
(Photo courtesy of the Charleston Post and Courier.)
