U.S. Fire Administration/Technical Report Series

Twelve-Fatality Hotel Arson

Reno, Nevada

USFA-TR-164/May 2008

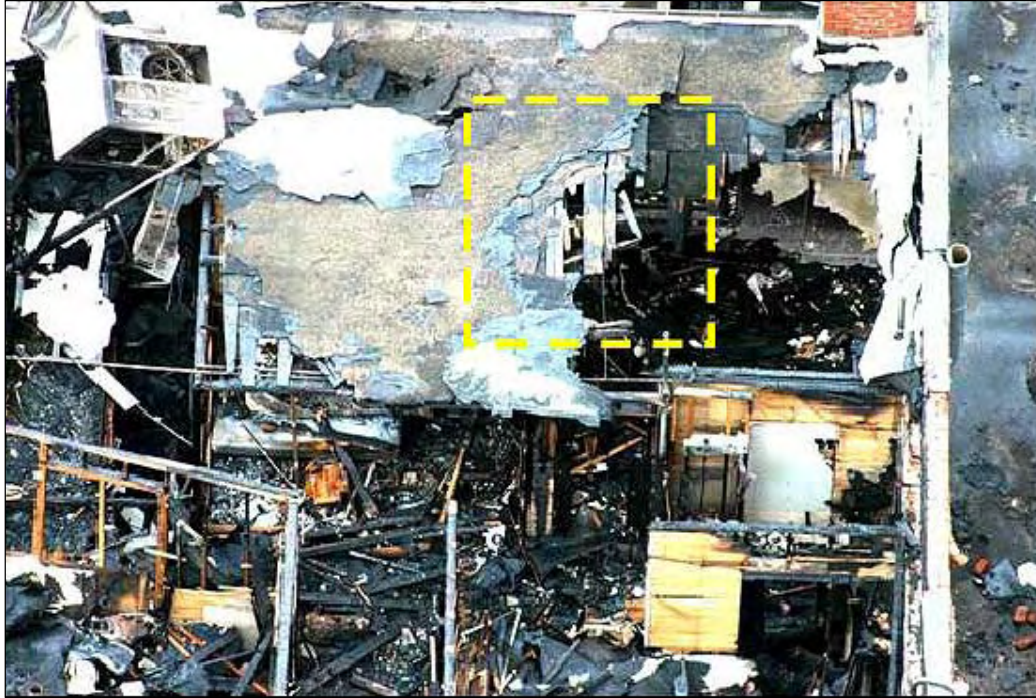
Figure 3. Overhead Photo Showing the Various Layers of Roofing Material.

The hotel's roof was flat, and comprised of layers of tarpaper and roll roofing over wood decking supported by wood joists. The inverted flat roof design consisted of decking raised several feet above the main roof supported by light wooden supports forming a cockloft, which is a void space between the underside of the roof decking and the ceiling below. Flat roofs have a life span of between 20 and 30 years. It is not uncommon to find numerous layers of tarpaper and other roll roofing 3 or more inches thick in older buildings, where the roof has been built up over many years. The yellow box inside Figure 3 (an aerial photograph) shows the various layers of roofing, including roll roofing, roof planking, and roof joists.

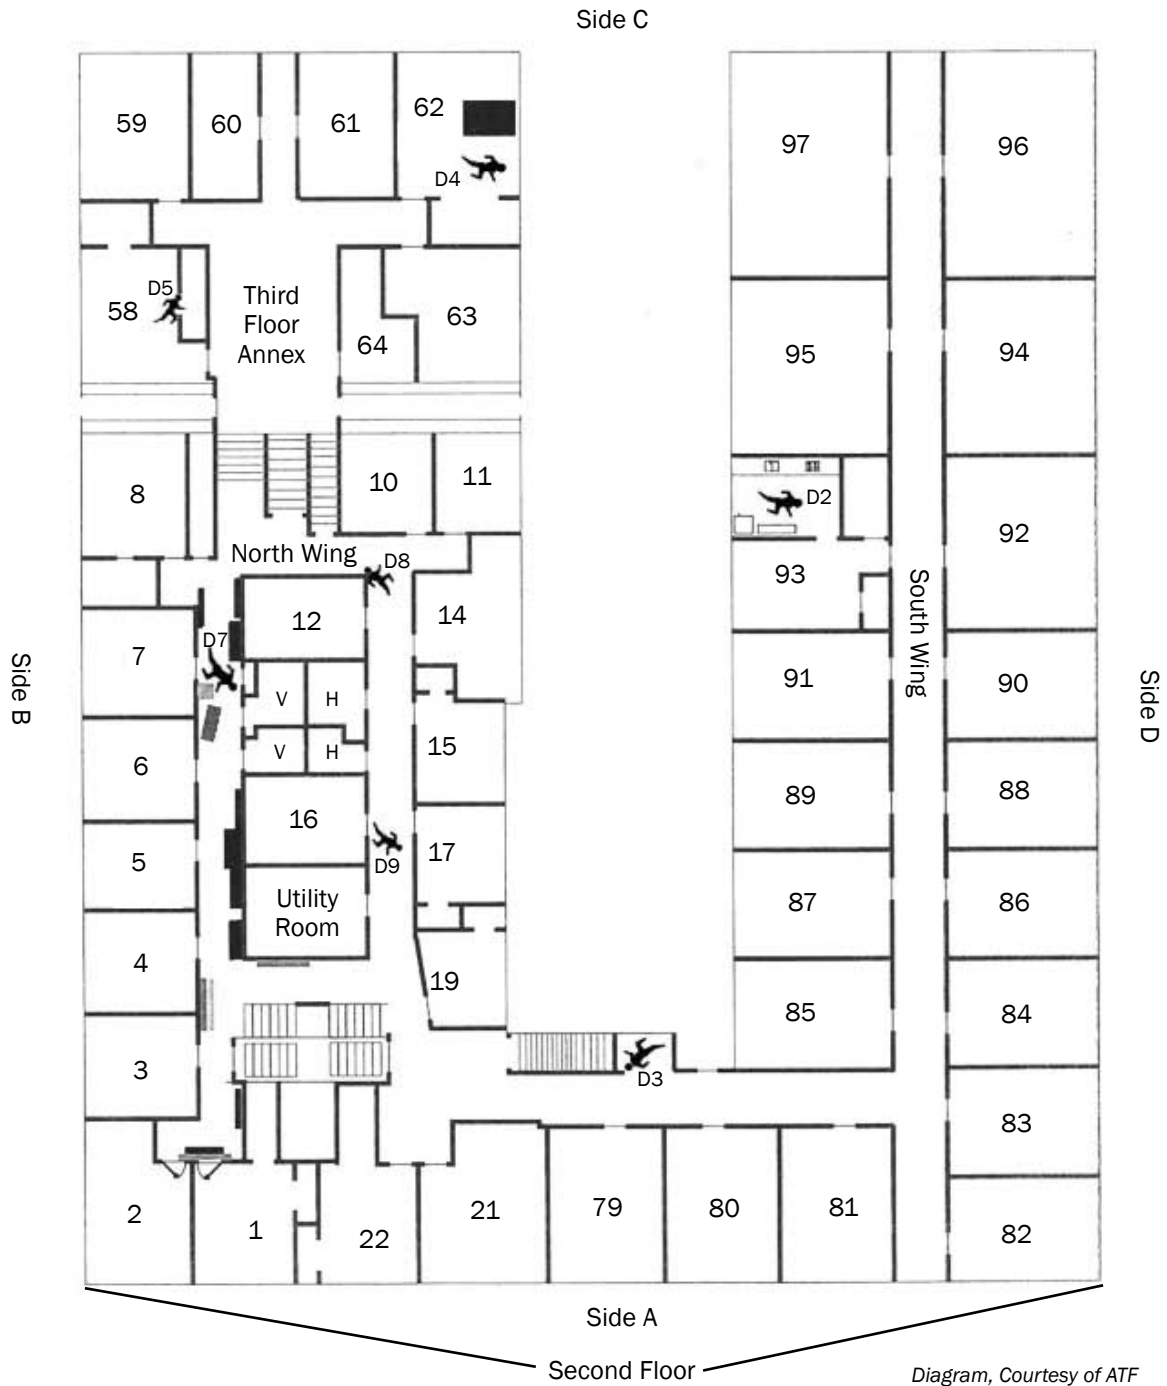
Figure 15. Fire Victim Locations: Second Floor and Third Floor Annex.

According to the IC, many of the building occupants who attempted to exit the building through the interior corridor perished in the fire. Seven of the 12 fire fatalities were found in the hallways during the postfire investigation. Figure 15 and Figure 16 show the locations where the fire victims were found.

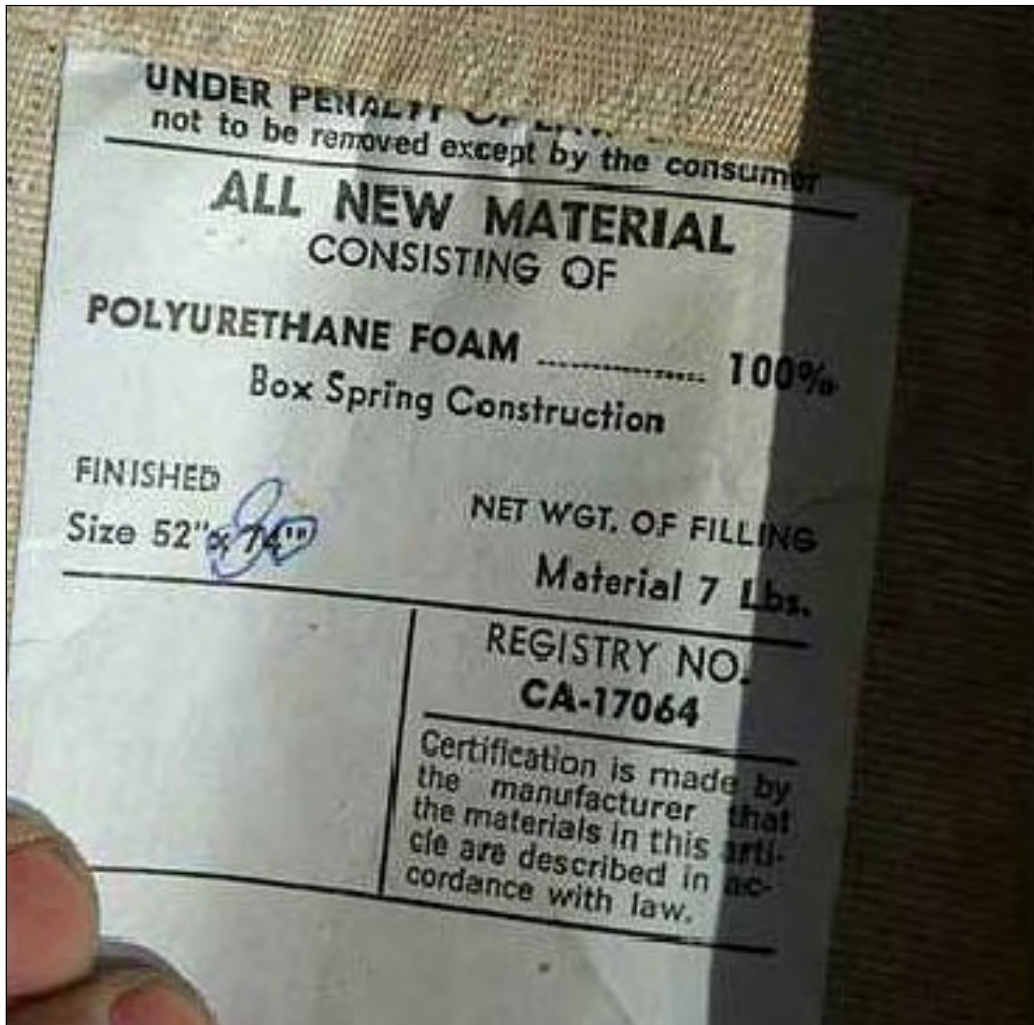
Figure 17. Remnants of Mattresses in the Hallway of the Second Floor.

Fuel Load—Several factors influenced the rapid spread of the fire. The first was fuel load. There were mattresses in the north hallway the day of the fire; the bulk of those old mattresses were ready for removal from the hotel. These were all twin institutional-grade mattresses and box springs, which measured 52 inches wide and 74 inches tall. The mattress tags read that the mattresses were 100-percent polyurethane foam, having a net weight of seven pounds of filling. Figure 18 is a photo of a mattress tag taken by ATF agents; it lists the type and quantity of padding contained in the mattresses that were stacked along the hallway walls.
