# Los Angeles City Fire Department Preliminary Summary Report

### Injuries/Commercial Structure Fire

**May 16, 2020  
Boyd Incident  
CA-LFD-001073**

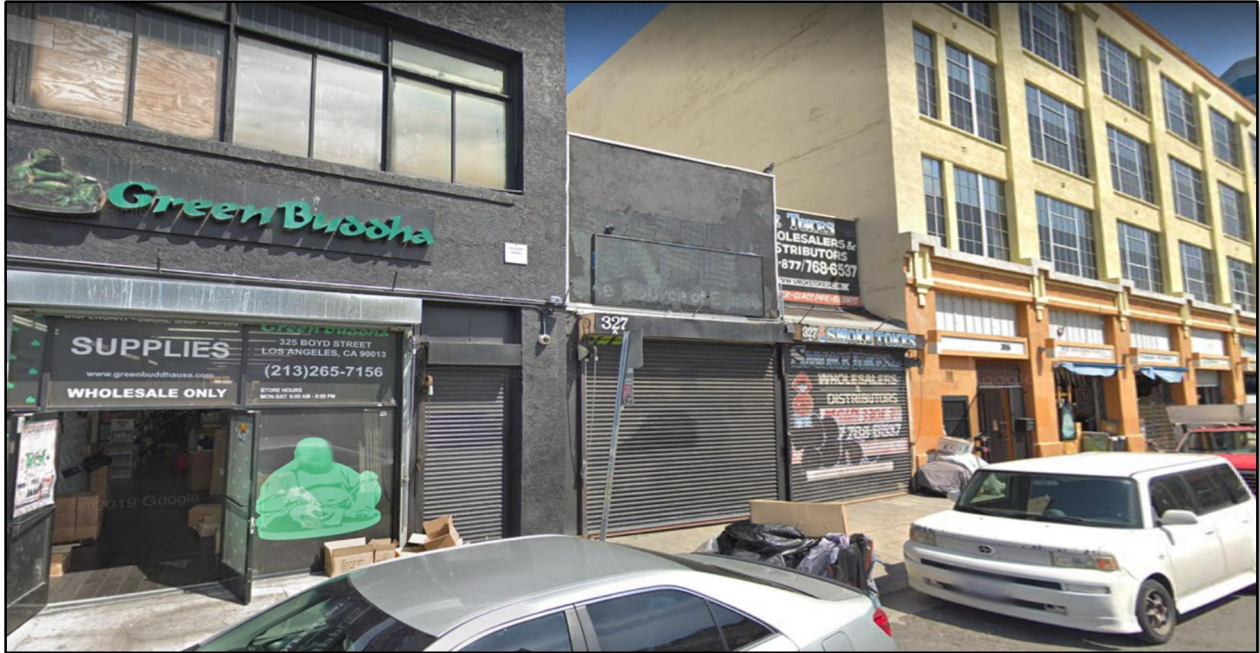
Street view from Google Maps
