NIOSH
Fire Fighter Fatality Investigation
and Prevention Program

February 11, 2009

Nine Career Fire Fighters Die in Rapid Fire Progression at Commercial Furniture Showroom – South Carolina

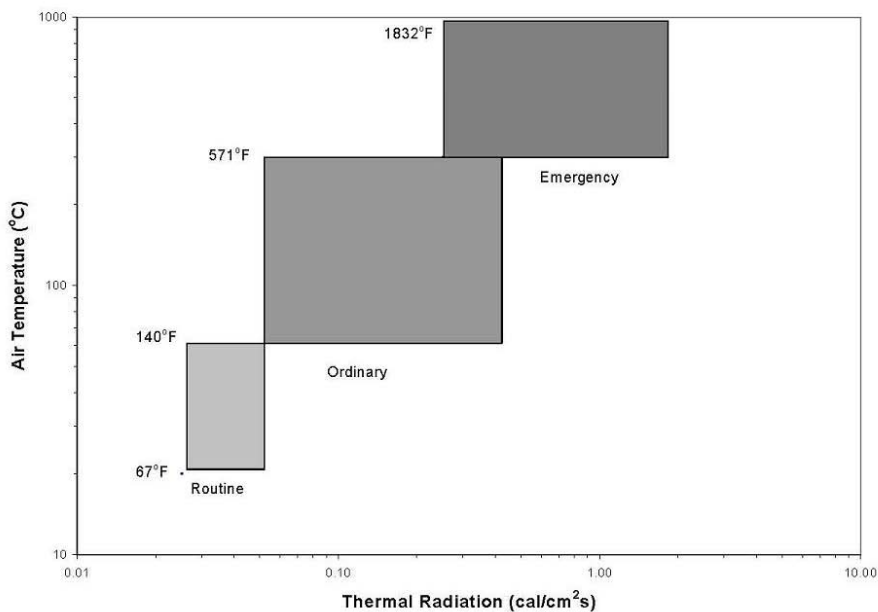
Figure 1– Classification of Fireground Conditions

The relationship between increasing thermal radiation (expressed in $\text{cal}/\text{cm}^2\text{s}$) and the resulting rise in air temperature (expressed in degrees Celsius and degrees Fahrenheit) is presented in Figure 1. Possible structural fire fighting situations are illustrated in this figure:^{1,2}
