U.S. Fire Administration/Technical Report Series

Twelve-Fatality Hotel Arson

Reno, Nevada

USFA-TR-164/May 2008

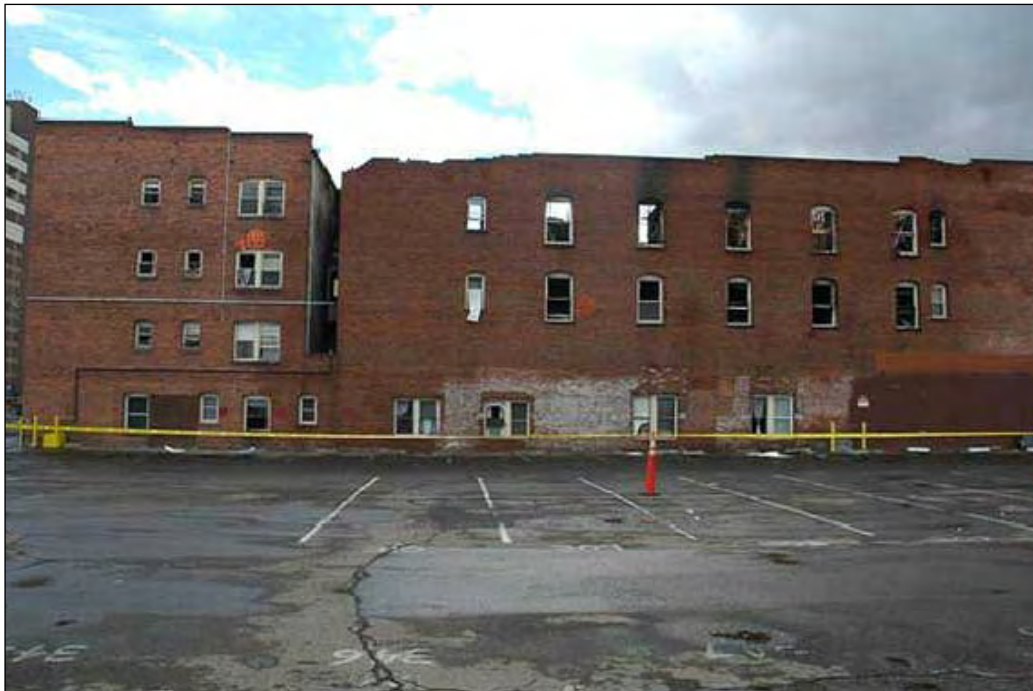
Figure 2. Offset Between the Annex and North Wing.

The north and south wings of the hotel were three stories in height, and the Annex was four stories. The Annex was attached to the east end of the north wing at ground level, and above the first floor only by narrow enclosed staircases, which can be seen in the following photo between the Annex and north wing. The height difference between the north wing and Annex created a slight offset of approximately 3 to 4 feet between floors of the Annex and north wing. Figure 2 shows the offset in height between the Annex and north wing.

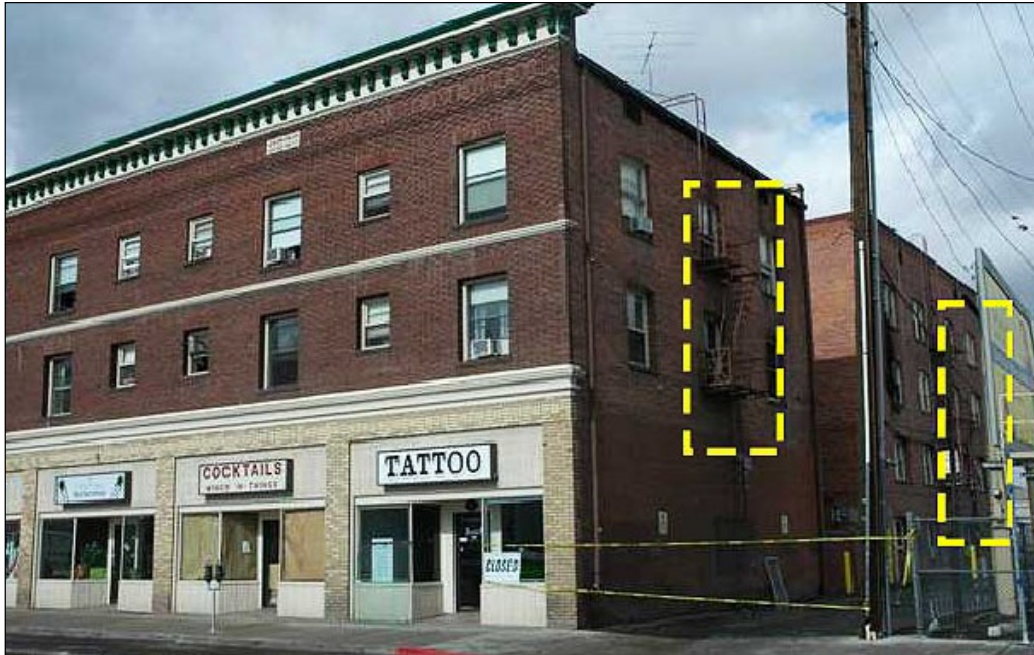
Figure 6. Rear Fire Escapes.

The hotel had four exterior fire escapes. Two were located on the front (Side A) of the hotel at the west end of the north and south wings, and two at the rear of the building that serviced the south wing and Annex. The north and south wing fire escapes serviced the second and third floors of the hotel. The fire escape at the rear of the Annex serviced the second through the fourth floors of the Annex. **The only access to the fire escapes was through the interior hallways.** During the fire, the interior conditions deteriorated so rapidly that the interior hallways and stairwells quickly became untenable and residents who failed to exit the building immediately could not get to the fire escapes

and to safety. Figure 5 and Figure 6 show the location of the exterior fire escape on the front and rear of the hotel.

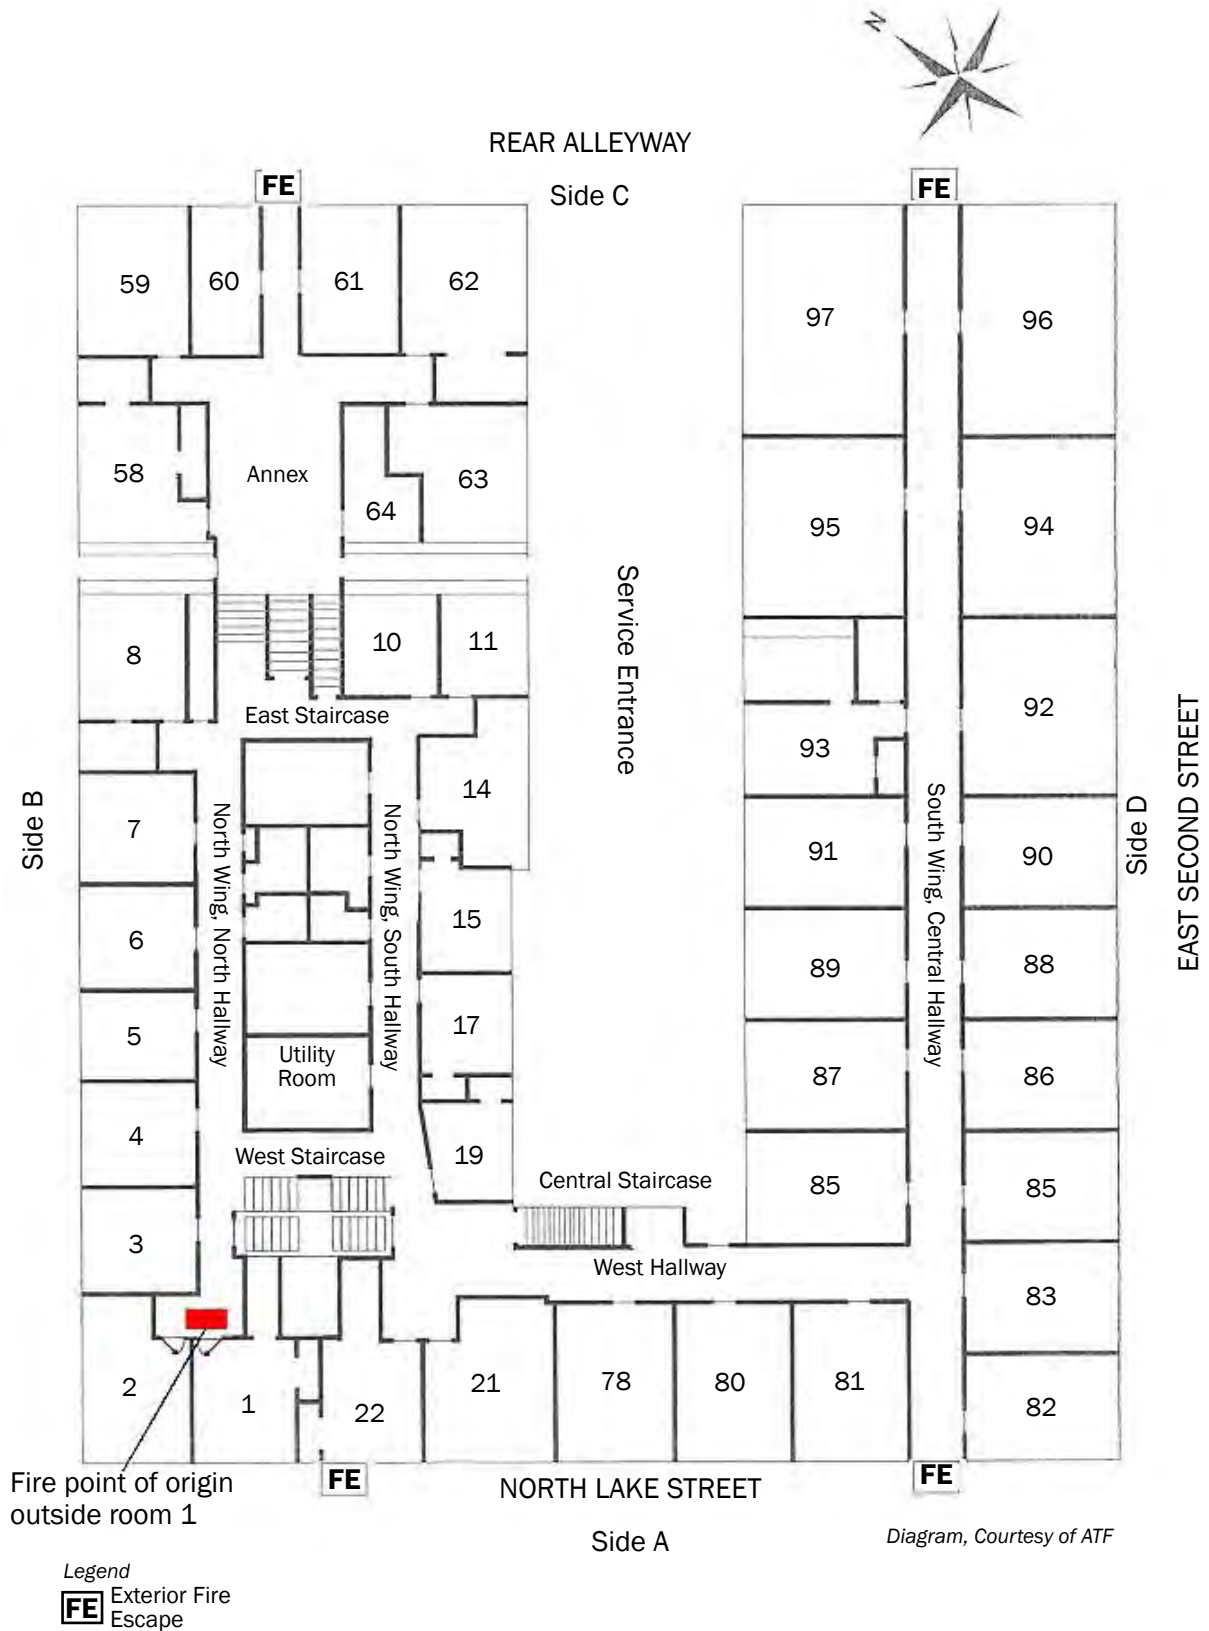
Figure 7. Fire Zone 8.

The system first alerted to the fire at 9:59 p.m. when a smoke detector in Zone 8 activated. This zone covered the entire second floor of both the north and south wings. Fire investigators determined the fire started on the second floor of the north wing. In less than 2 minutes detectors in Zones 3, 4, and 5 activated as well, which is a good indication of how fast the smoke and heat were spreading. Figure 7 shows the second floor area encompassing Zone 8 in which the first smoke detector alerted. Table 2, which follows, shows the time sequence of smoke detector and alarm activations the evening of the fire.
