# **A Technical Analysis:** The Performance of Composite Wood Joists Under Realistic Fire Conditions

*Melissa Avila,*  
*Project Engineer,*  
*New Technology Group*  
**Tyco Fire Suppression &  
Building Products**

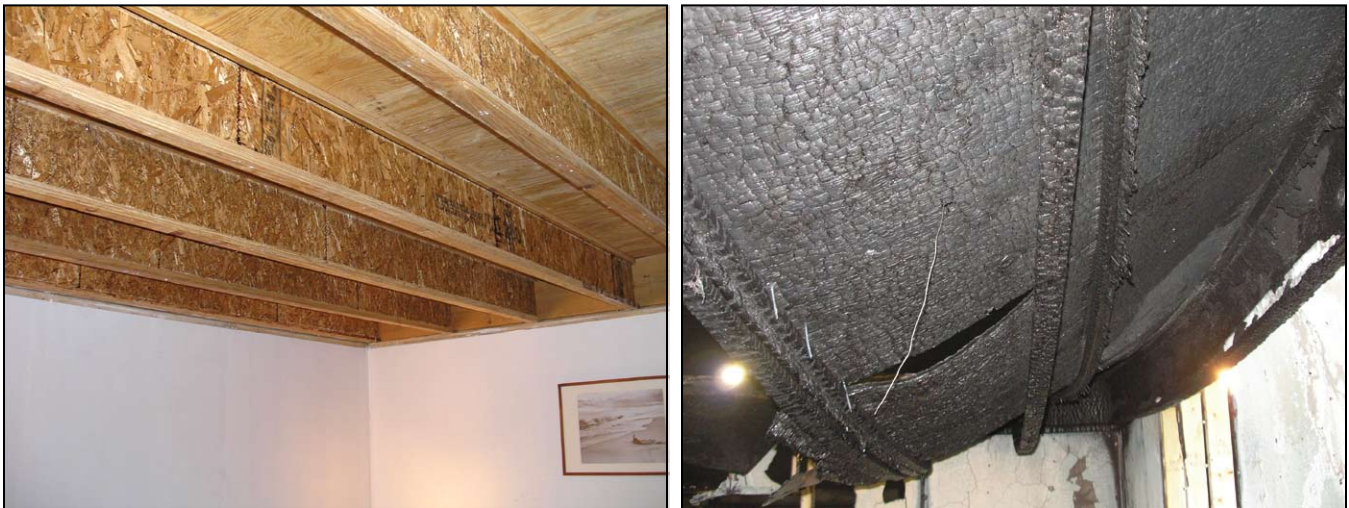
Figure 1: Composite wood joists before (left) and after fire exposure

Note how the composite wood joists exposed to a fire event have fallen apart due to the failure of the web, causing the ceiling to collapse. There is growing evidence that the materials employed in lightweight construction are more apt to weaken and fail much faster than conventional construction materials, resulting in sudden catastrophic collapse of ceiling and floor assemblies and an increased risk of injury or death to building occupants and firefighters.

One example of the difference in fire performance of a lightweight structural member compared to solid sawn lumber is the behavior of composite wood joists. When a composite wood joist is exposed to fire, the thin oriented strand board used as the web in the joist is quickly consumed, which results in an inability of the joist to carry load and ultimately a failure of the supported floor assembly. While a solid sawn joist behaves in much the same way, there is significantly more mass that must be consumed before the member reaches the critical point where it is no longer able to carry load. Due to the greater mass per unit of surface area of the solid wood joist, it will support the floor assembly for much longer than its lightweight alternative when exposed to equivalent fire conditions. Figure 1 demonstrates a typical composite wood joist before and after fire exposure.

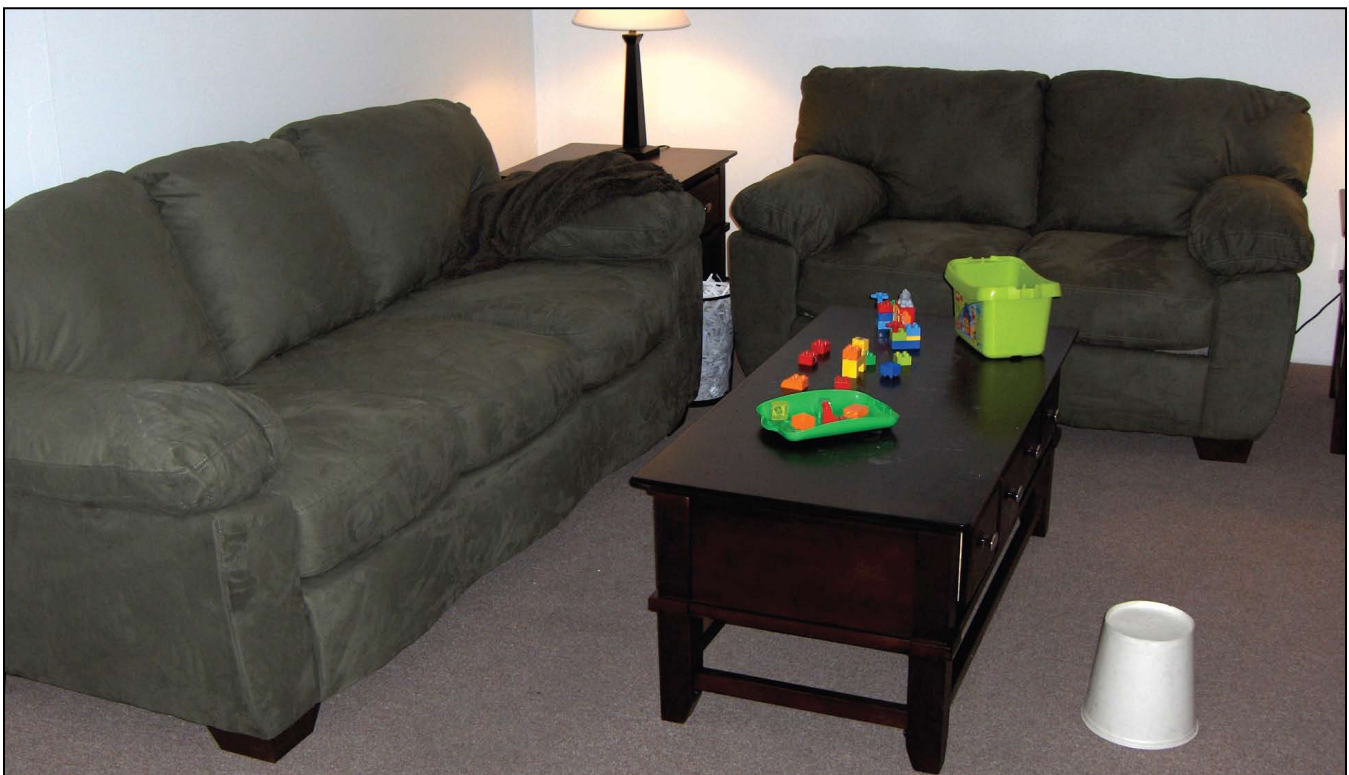
Figure 2: Fuel package used for all tests. White bucket on floor was used to protect floor radiometer during setup; the bucket was removed prior to each test.

Many of the firefighting deaths associated with lightweight construction occur as a result of a fire initiating in the basement area of a home. This scenario is particularly hazardous because firefighters frequently enter on the main level of the house, unaware of the exact location of the fire. Additionally, this is the one area of the structure where it is common to find likely sources of ignition including workshops, impromptu living areas and fuel fired equipment such as boilers and hot water heaters. Finally, in most cases the framing material is exposed, allowing fires to rapidly involve the structural members supporting flooring on the main level of the house. To simulate this scenario, the test setup represented a seating area that has been located in a basement. This scenario was selected since the large volume of synthetic material (i.e. furniture, carpet, etc.) is particularly challenging to the sprinkler system. However, any scenario that would lead to involvement of the structure and ultimately flashover of the compartment most likely would have generated equivalent results to this fuel package. The fuel package arrangement utilized is demonstrated in figure 2.

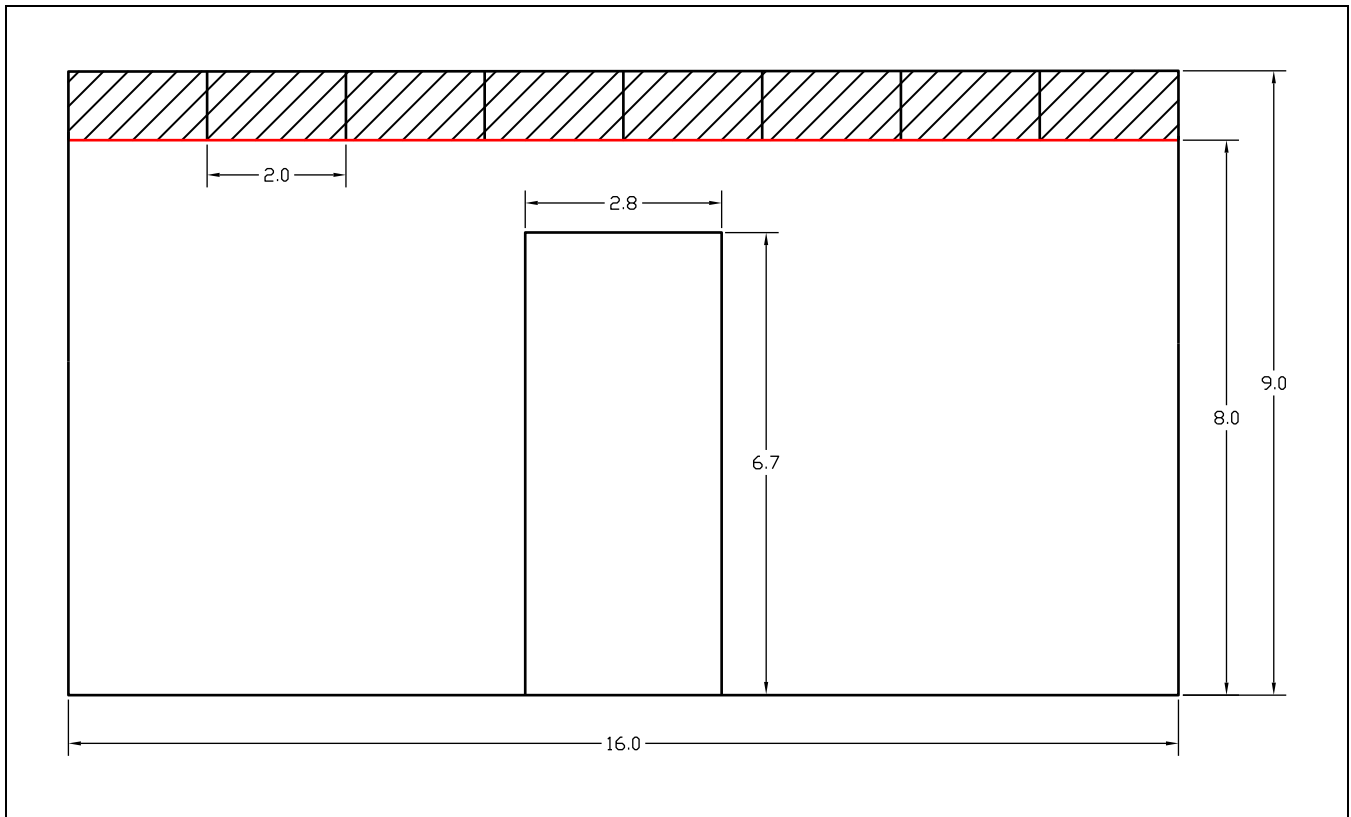
Figure 4: Test setup in elevation view. The horizontal red line represents the sheetrock on the ceiling (in exposed tests) or the bottom of the joists (in unexposed tests).

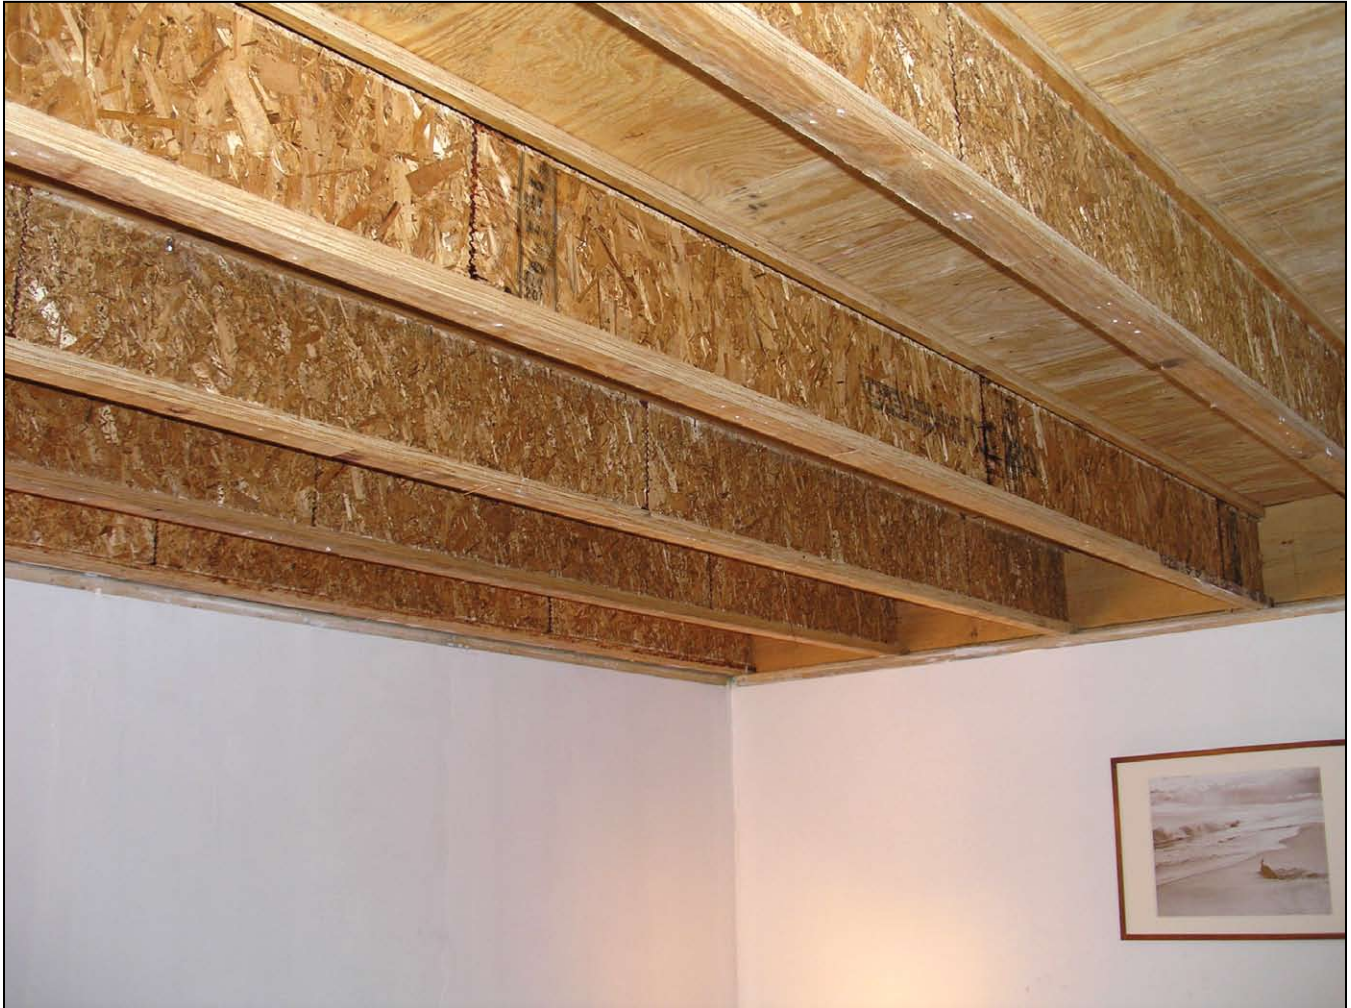
Figure 5: Exposed composite wood joists representing main level floor assembly

The ceiling was constructed of composite wood I-joists measuring 11-7/8 in. deep with 3 in. wide chords. The joists were spaced two feet on center (i.e. the typical maximum spacing for residential occupancies) and the bottom of the beams was eight feet above the floor. In one of the tests (Test 1), the bottom of the joists was also covered with two layers of ½ in. sheetrock; all remaining tests were conducted with the joists exposed as shown in figure 5.

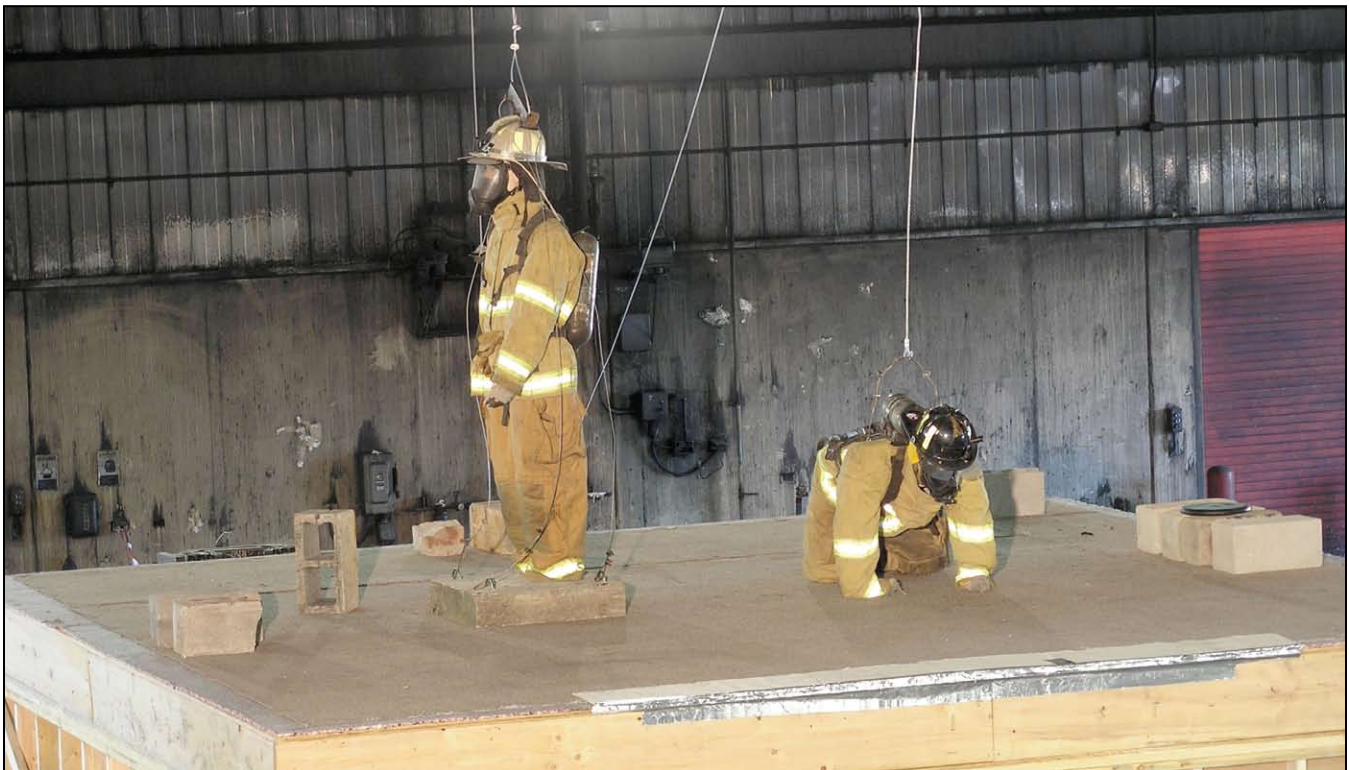
**Figure 6: Loading on top of enclosure**

To represent the main floor above the simulated basement, the composite wood joists were sheathed in 7/8 in. plywood subflooring. To accurately capture the heat transfer through the assembly, the floor was finished with a typical residential carpet pad and Berber carpeting. Concrete blocks were used in an effort to simulate a typical live load representing the furnishings above the test enclosure. These blocks were weighed and located to represent the same arrangement as the furniture package in the basement area below. Additionally, two fire fighter mannequins were positioned on top of the ceiling/floor assembly as shown in figure 6. The firefighter mannequins were outfitted with typical items including turnout gear, a helmet and a self contained breathing apparatus (SCBA). The standing mannequin, standing on a joist, weighed 300 pounds while the crawling mannequin, straddling a joist, weighed 380 pounds. The remainder of the cinder blocks totaled 600 pounds resulting in a total live load of 1280 lbs or about 5 lbs/ft<sup>2</sup>. The firefighters were attached to the ceiling with cables to permit them to be pulled from the burning compartment after the collapse of the ceiling/floor assembly.

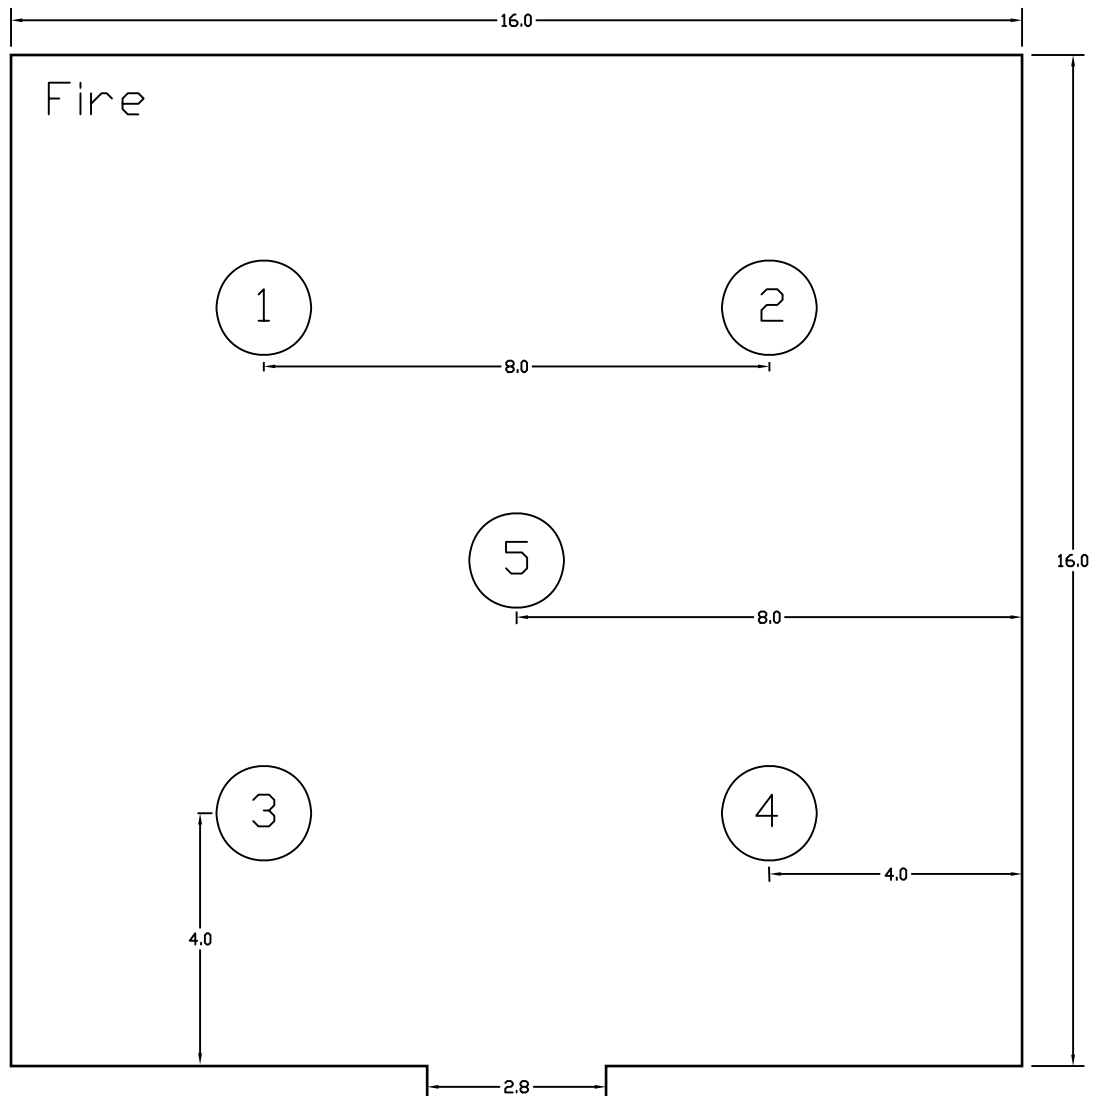
Figure 7: Additional thermocouple locations. Each location contained 20 thermocouples except for location 4, which had only 8 thermocouples.

In Test 5, additional instrumentation was added in an effort to better understand the method of collapse as well as to verify temperature readings from the thermal imaging camera from previous tests. Twenty thermocouples were added at five different locations for a total of 88 additional thermocouples with respect to the previous tests (the location farthest from the fire had only eight thermocouples due to restrictions from the data acquisition system). Thermocouples were located in the ceiling/floor assembly starting at the carpet on top of the structure all the way down to the plywood sheathing. Temperature measurements were also taken on each side of the joist and embedded into the joist at each location. The location of each thermocouple group and the arrangement of the thermocouples at each location is shown in figures 7 and 8, respectively.

For the second unsprinklered test, additional instrumentation including 88 more thermocouples (see figures 7 and 8 for location) was included to better understand the progression of the fire through the structure. The additional thermocouples were located in and around the joist as well as in the ceiling/floor assembly layers to understand the heat transfer through and failure mechanism of the ceiling/floor assembly. A Scott Health and Safety Eagle Imager® 160 Thermal Imaging Camera, a type commonly used by firefighters in structure fires, was used to measure the carpet temperature on the floor above. The readings from the thermal imaging camera are one source of information for an incoming firefighter that may provide some warning of impending collapse.

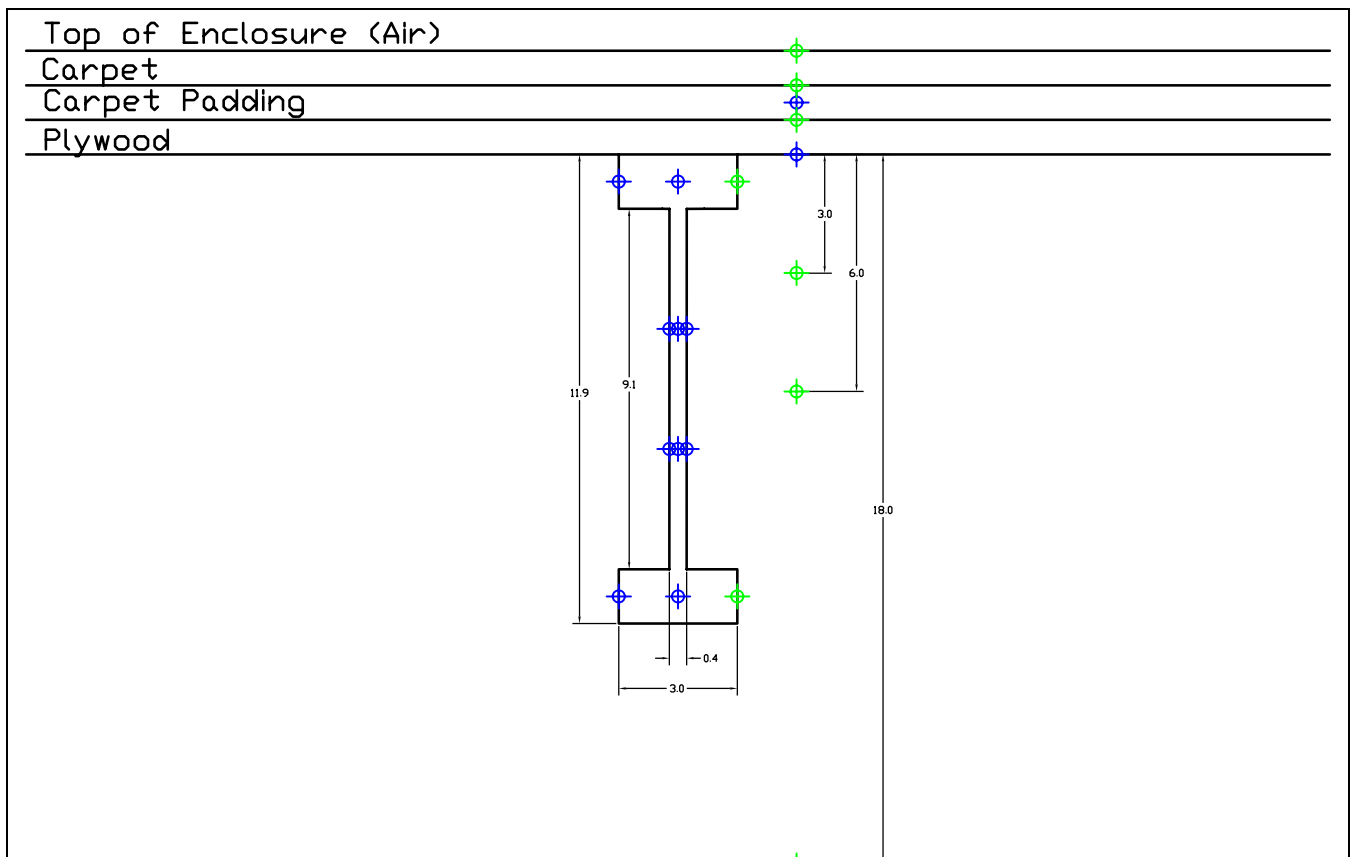
Figure 8: The thermocouple arrangement at each location. The green symbols represent thermocouples that were present at all 5 locations; the blue symbols represent the thermocouples that were at each location except location 4.

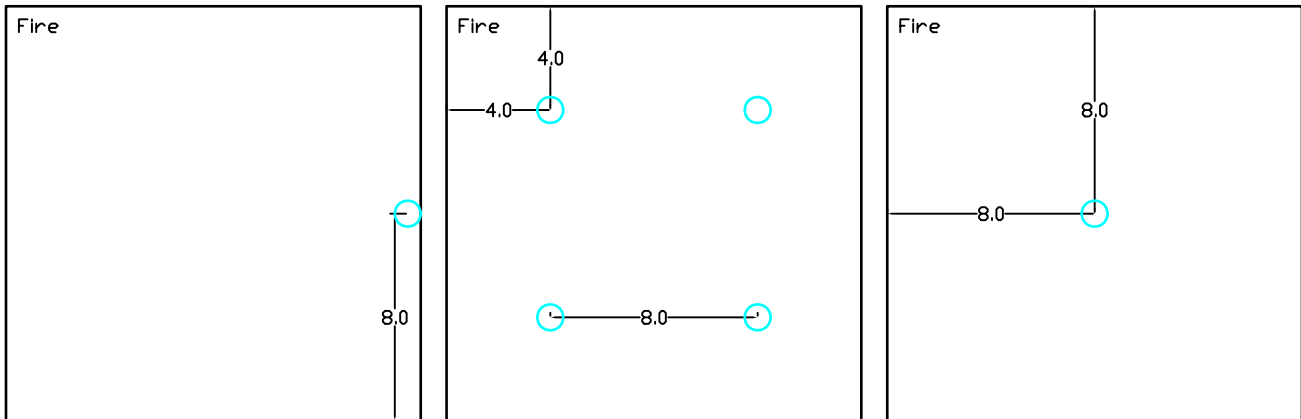
Figure 9: Sprinkler layouts for Test 1, Test 2 and Test 3 (from left to right)

Three sprinkler scenarios were evaluated as part of this program; including a single sidewall sprinkler, four pendent sprinklers and a single pendent sprinkler. Each scenario is demonstrated in figure 9 and the tests are described as follows.

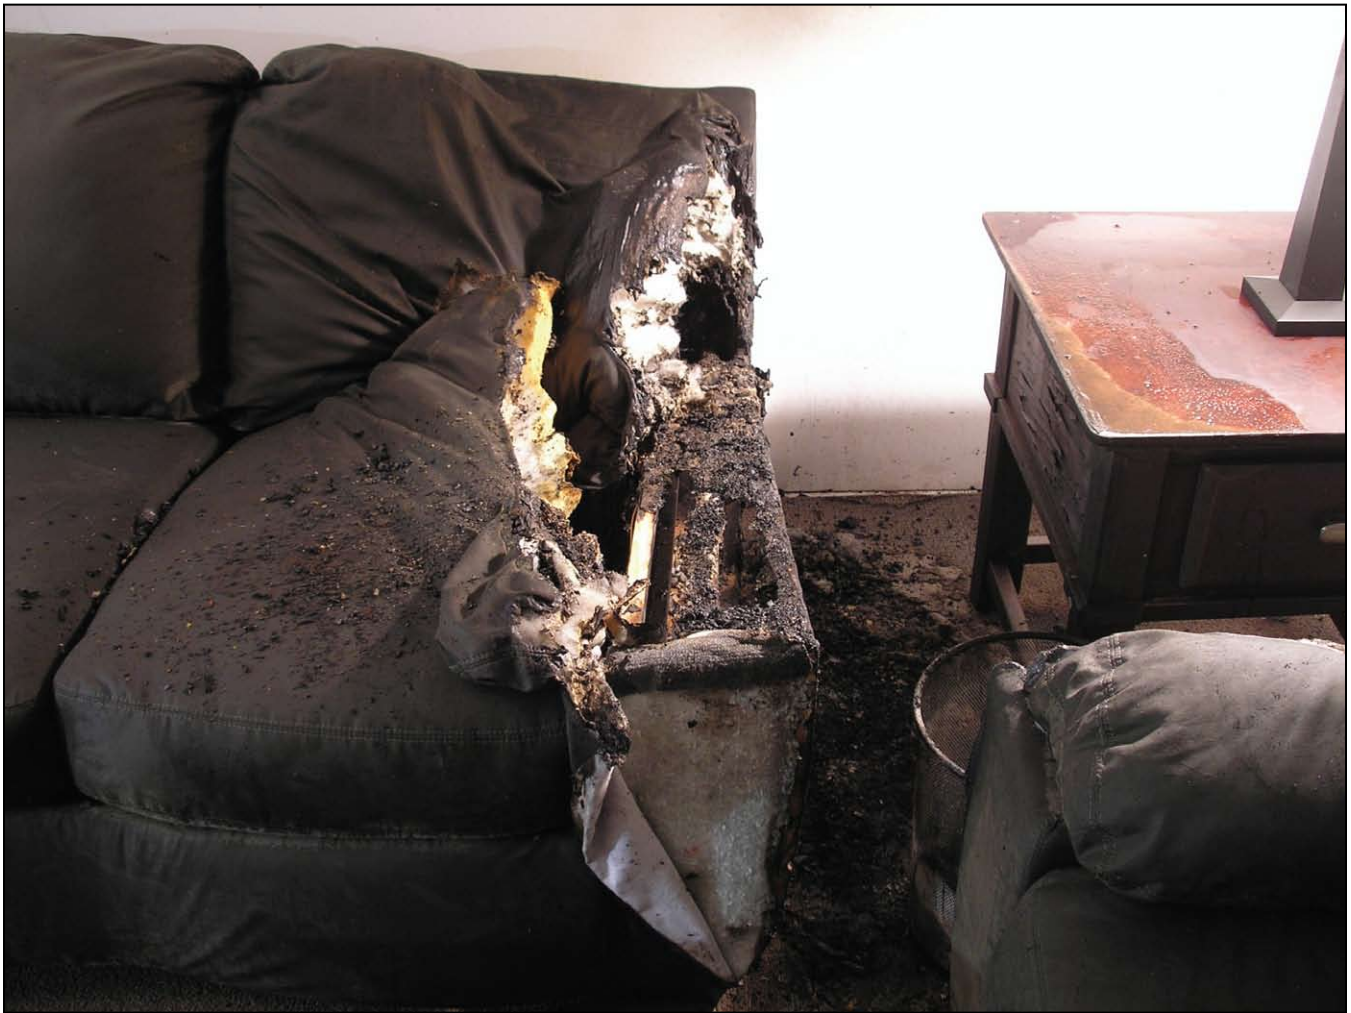
Figure 10: Test 1 Damage Assessment

In this test, the sprinkler operated 2:55 (min:sec) after ignition and control of the fire was achieved less than 2 minutes later. The damage, shown in figure 10, was limited to the items intimate with ignition.

The first test was considered successful due to the limited damage to the fuel package and the comparatively low temperatures that were maintained for the duration of the test. At no point during the test did the fire progress from the furniture into the structural portion of the test assembly.

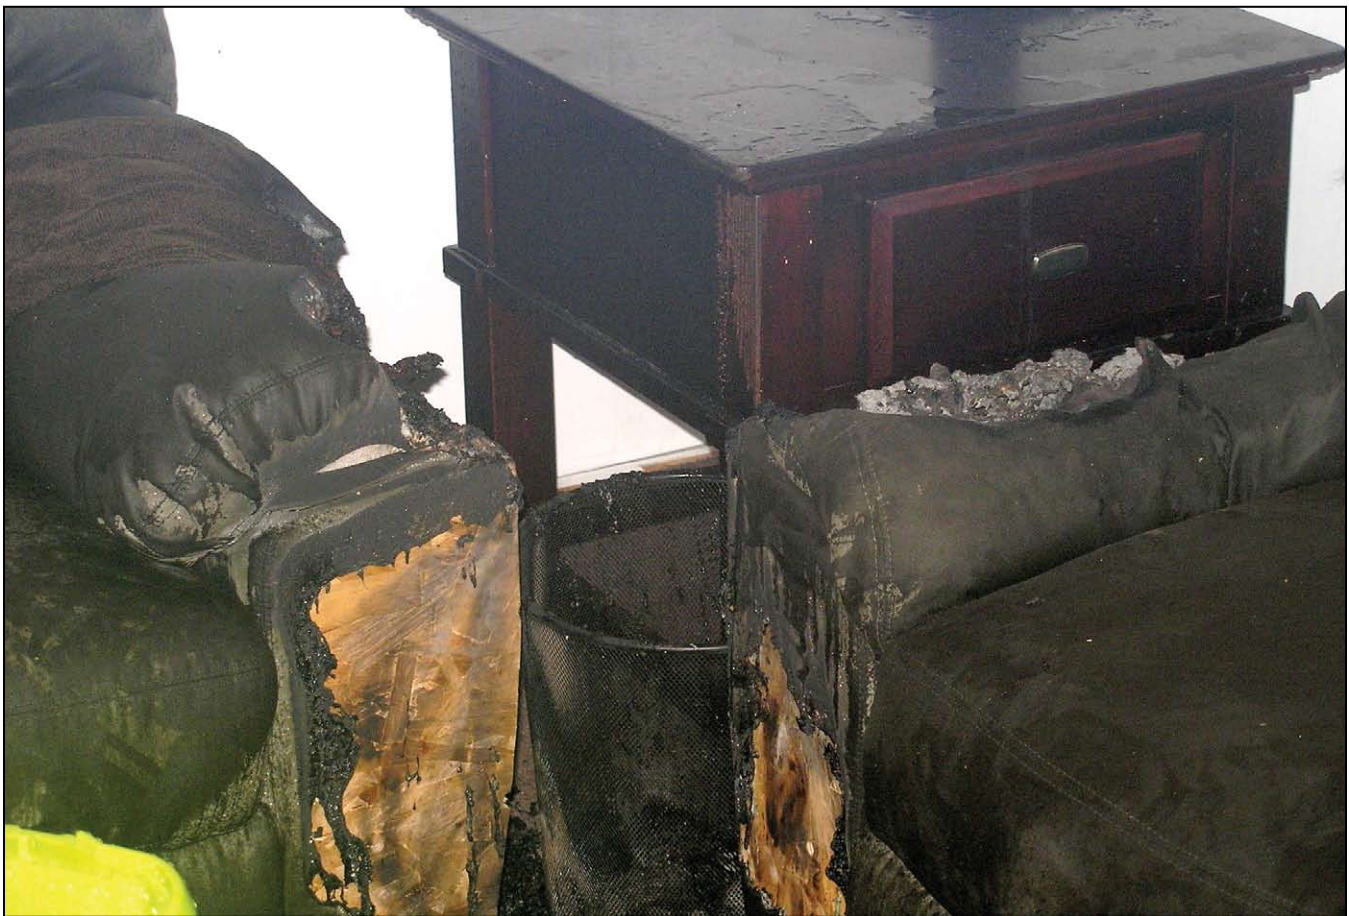
Figure 11: Test 2 Damage Assessment

Although there were four sprinklers in the room, a single sprinkler operated 1:13 from ignition and successfully controlled the fire within 3 minutes. The damage from the second test is demonstrated in figure 11.

The second test was considered a success due to the quick activation of the sprinkler limiting the damage to a small area of the room.

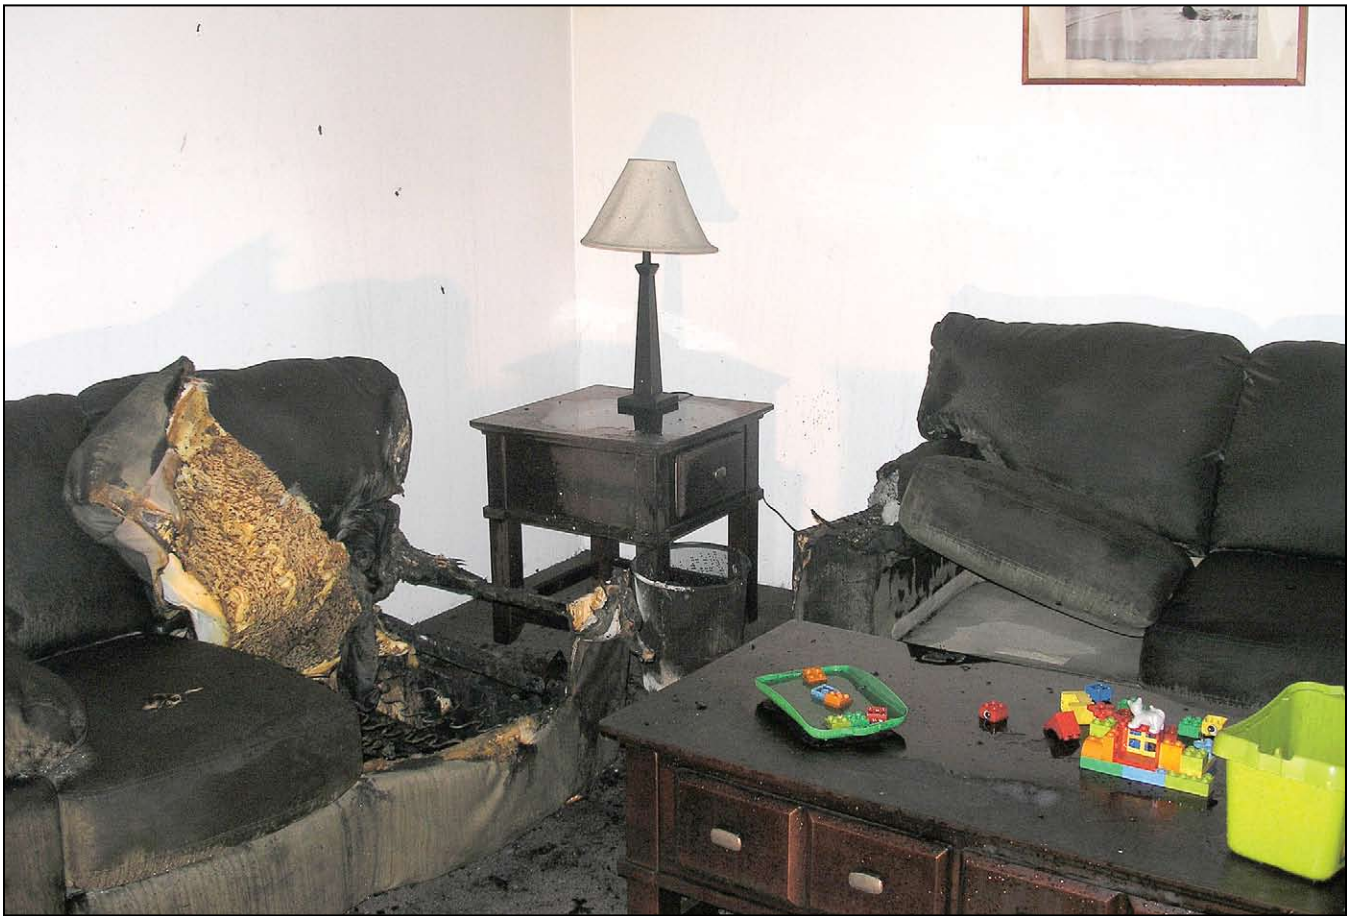
Figure 12: Test 3 Damage Assessment

The center sprinkler operated 3:19 from ignition and achieved control less than one minute later. The post-test damage is shown in figure 12.

This test was considered successful due to the relatively minor damage to the fuel package. At no point did the fire progress from the furniture to involve the structural elements of the test enclosure.

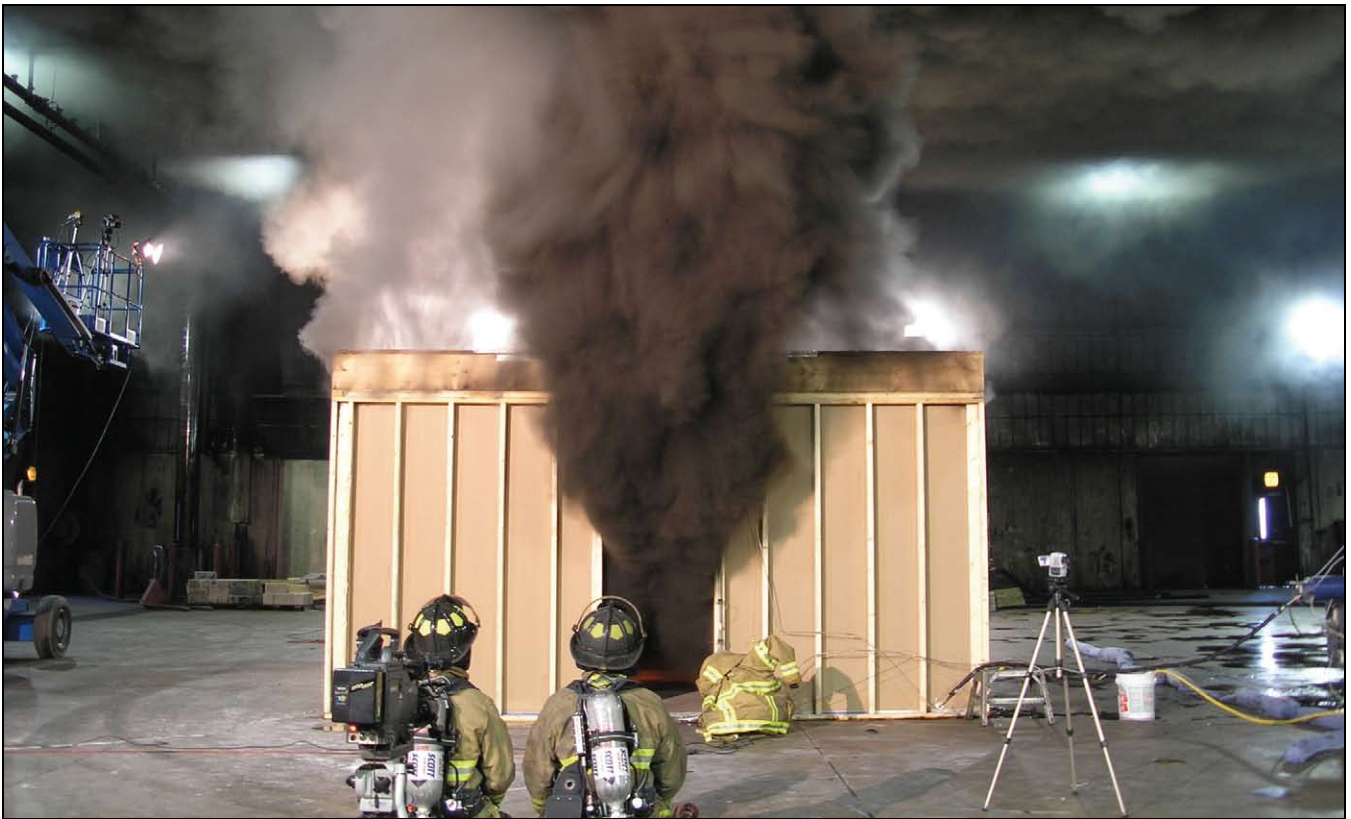
Figure 13: Test 4, first unsprinklered test, just before flashover

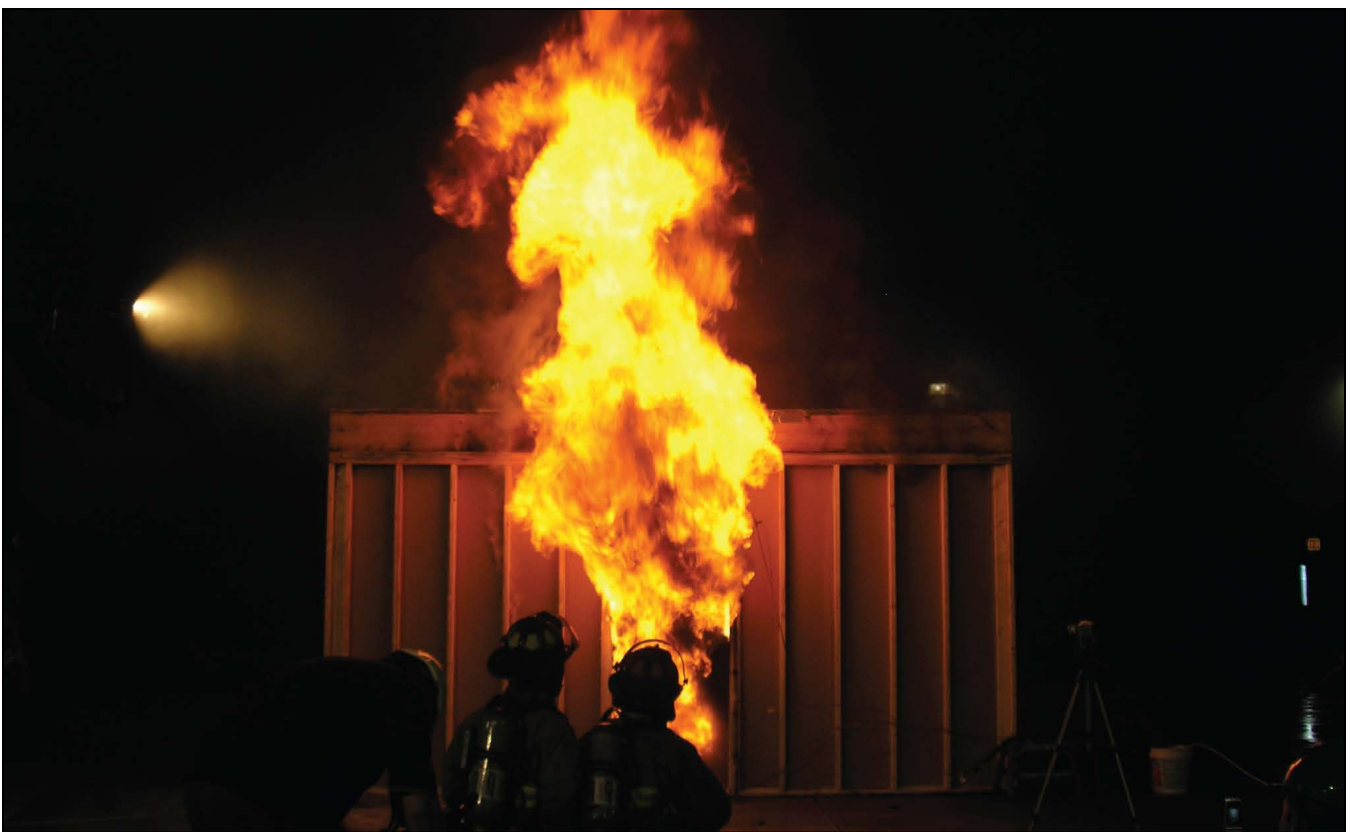
Figure 14: Test 4, first unsprinklered test, just after flashover

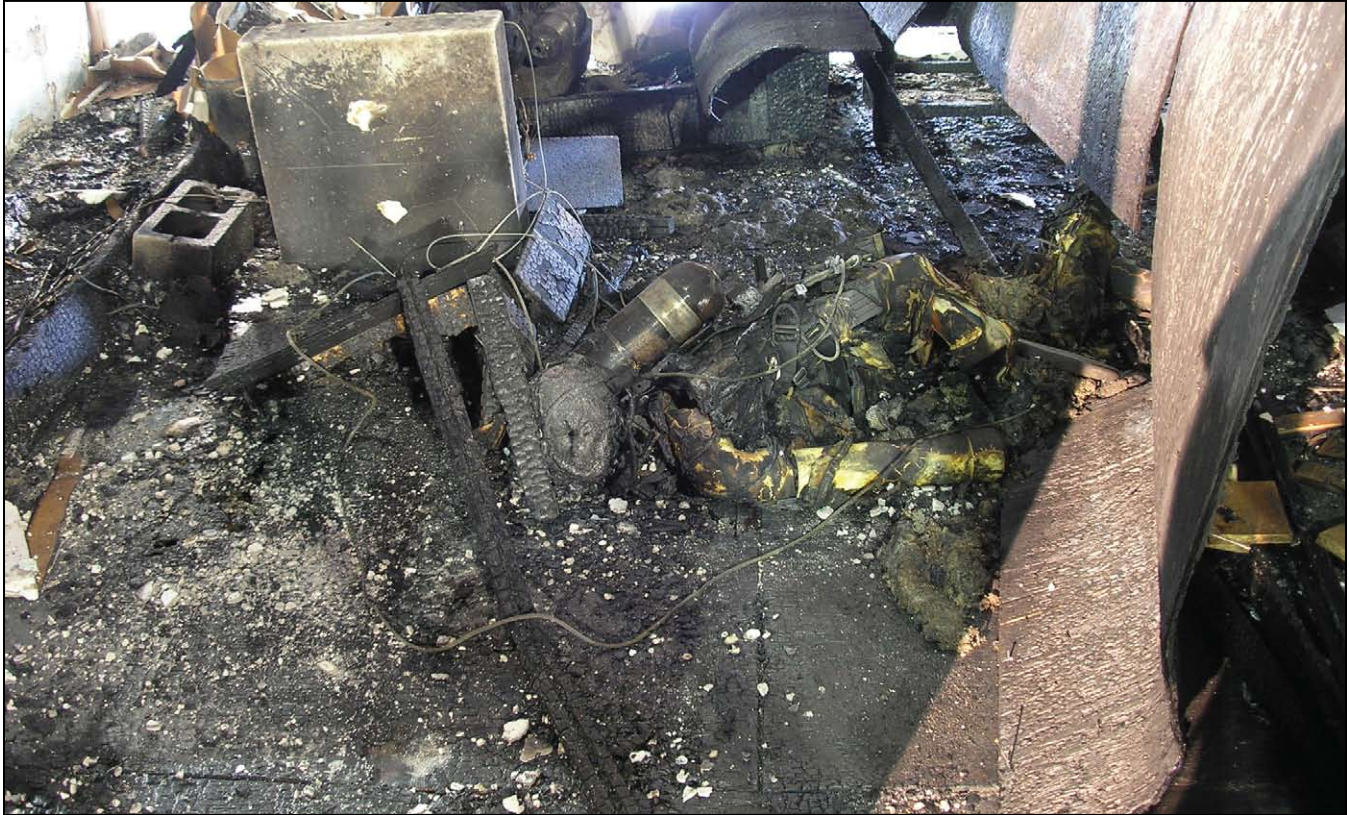
**Figure 15: Test 4, first unsprinklered test, damage**

Items that were on the floor above the fire room, including the cinder blocks and the firefighter mannequins, fell into the fire room and were severely damaged. The plywood subflooring that was above the joists on the ceiling fell in and can be seen on the right side of figure 15.

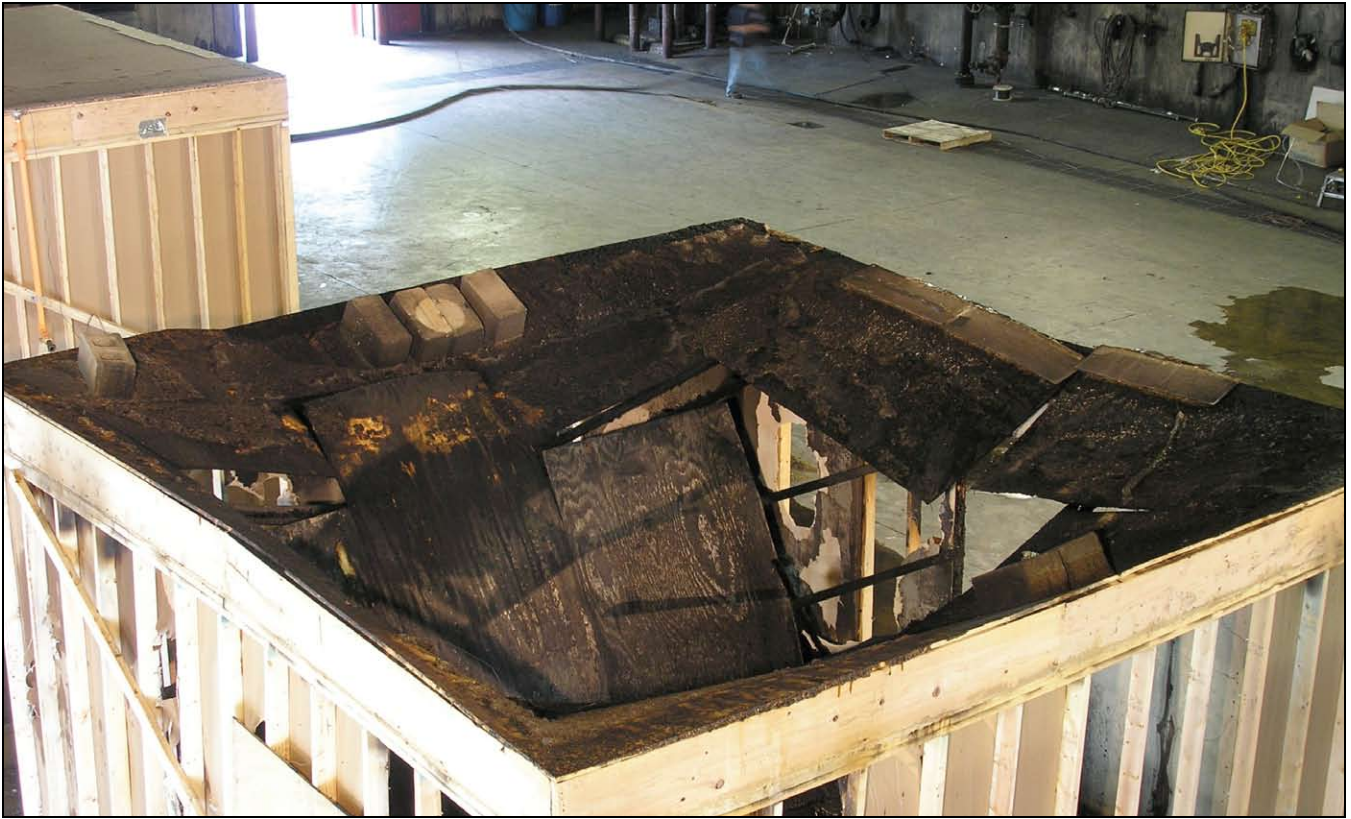
Figure 16: Test 4, first unsprinklered test, roof collapse of structure

The damage to the ceiling and the joists is shown in figures 16 and 17.

Almost the entire 16 ft. x 16 ft. ceiling collapsed into the test compartment in a near simultaneous event. The web in most of the composite wood joists was completely consumed by the fire prior to collapse. One of the engineered I-joists that retained a portion of its web is shown in figure 17. The web was almost entirely consumed in the middle and the joist itself was no longer capable of supporting a load, leading to collapse. Some examples of engineered I-joists with only the chords left can be seen under the collapsed plywood in figure 16.

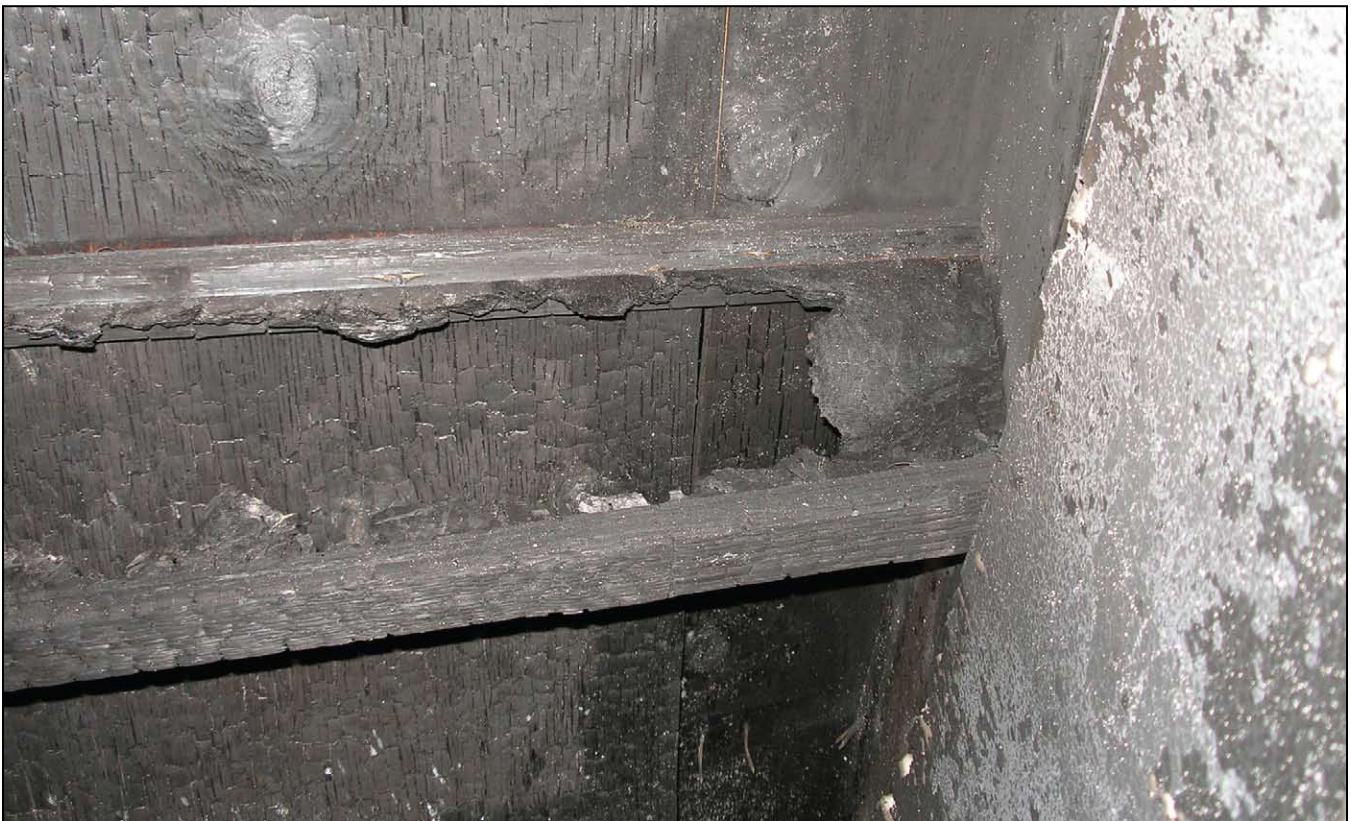
Figure 17: Test 4, first unsprinklered test, one of the few remaining engineered joists on the ceiling. Note how the webbing is almost entirely consumed.

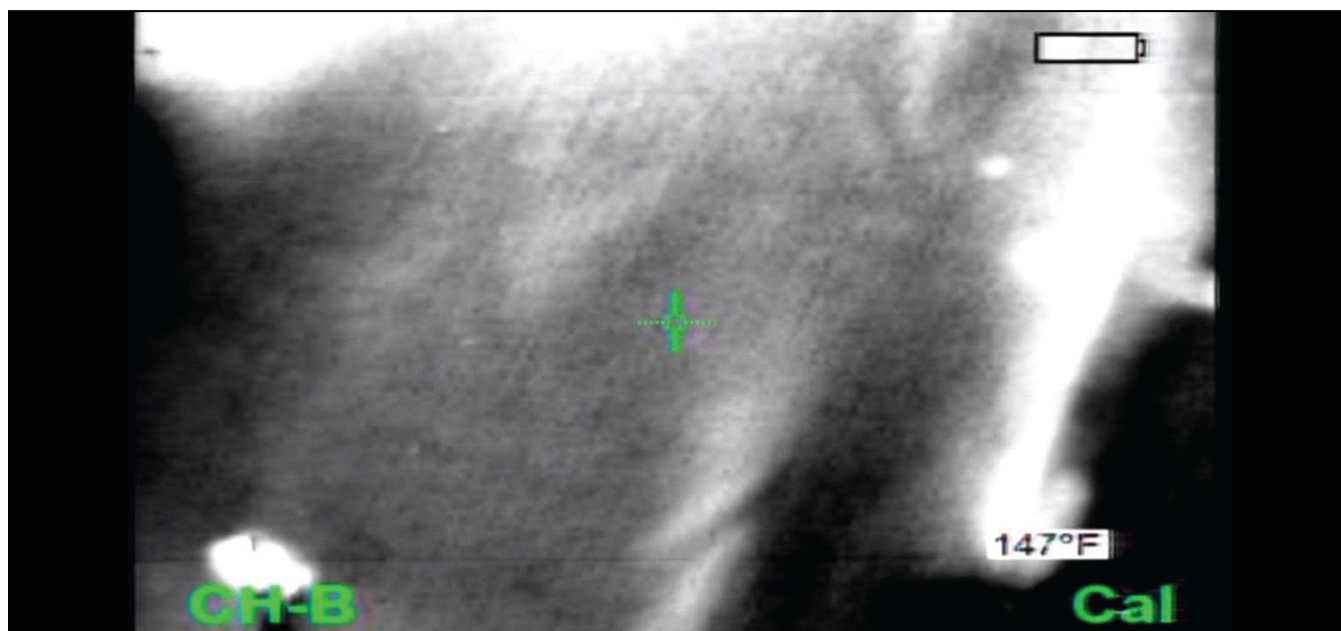
Figure 18: Test 5, second freeburn test, snapshot from the thermal imaging camera shortly before collapse of the structure

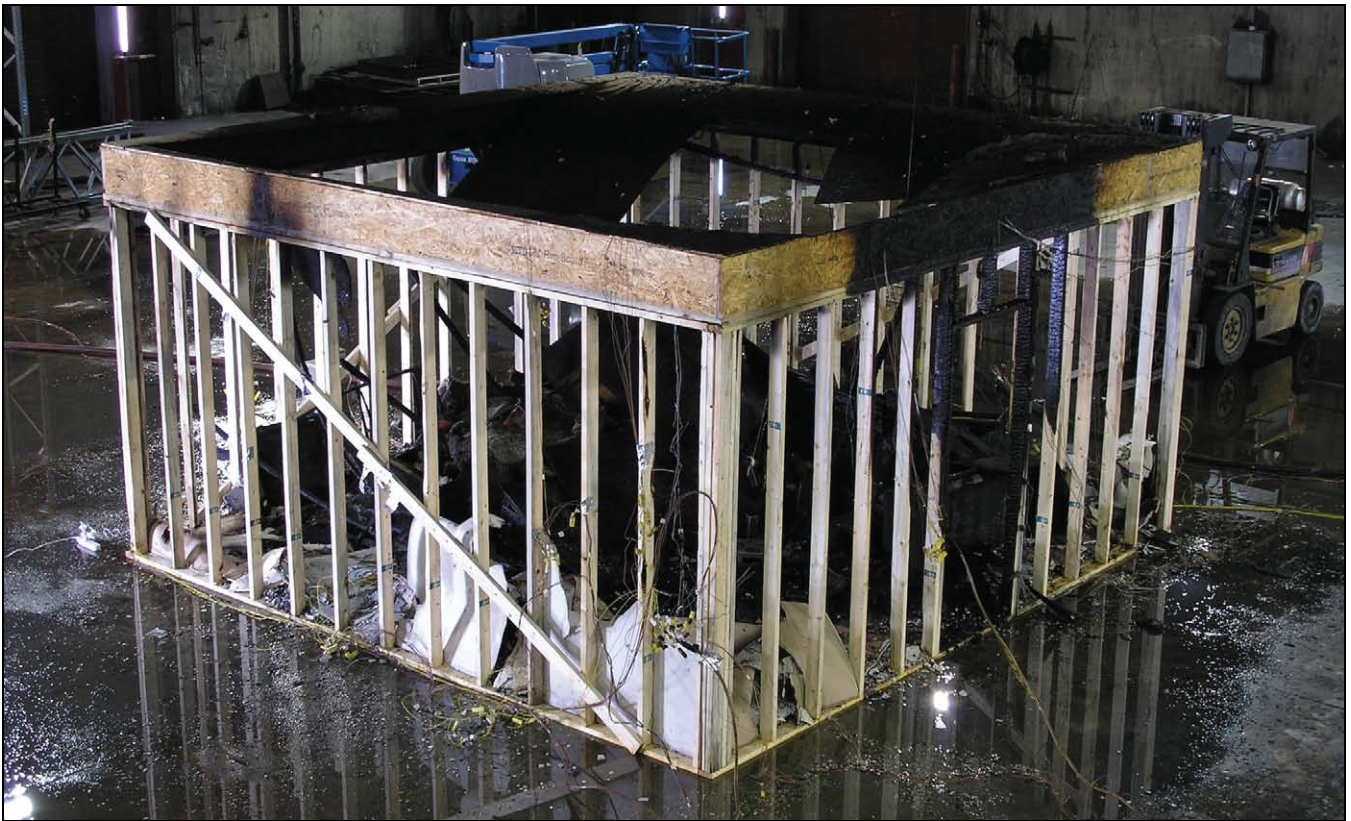
Figure 19: Test 5, second freeburn, damage

The fire damage was more extensive in the second freeburn as compared to the first as demonstrated in figure 19. The fire was so intense that although the mannequins were rapidly retrieved after falling through the simulated floor assembly, the turnout gear was destroyed and the underlying plastic forming the mannequin melted. The Scott Health and Safety thermal imaging camera that the standing mannequin was holding also did not transmit sensible data for more than 30 seconds after collapse and was destroyed.
