# **A Technical Analysis:** The Performance of Composite Wood Joists Under Realistic Fire Conditions

*Melissa Avila,*  
*Project Engineer,*  
*New Technology Group*  
**Tyco Fire Suppression &  
Building Products**

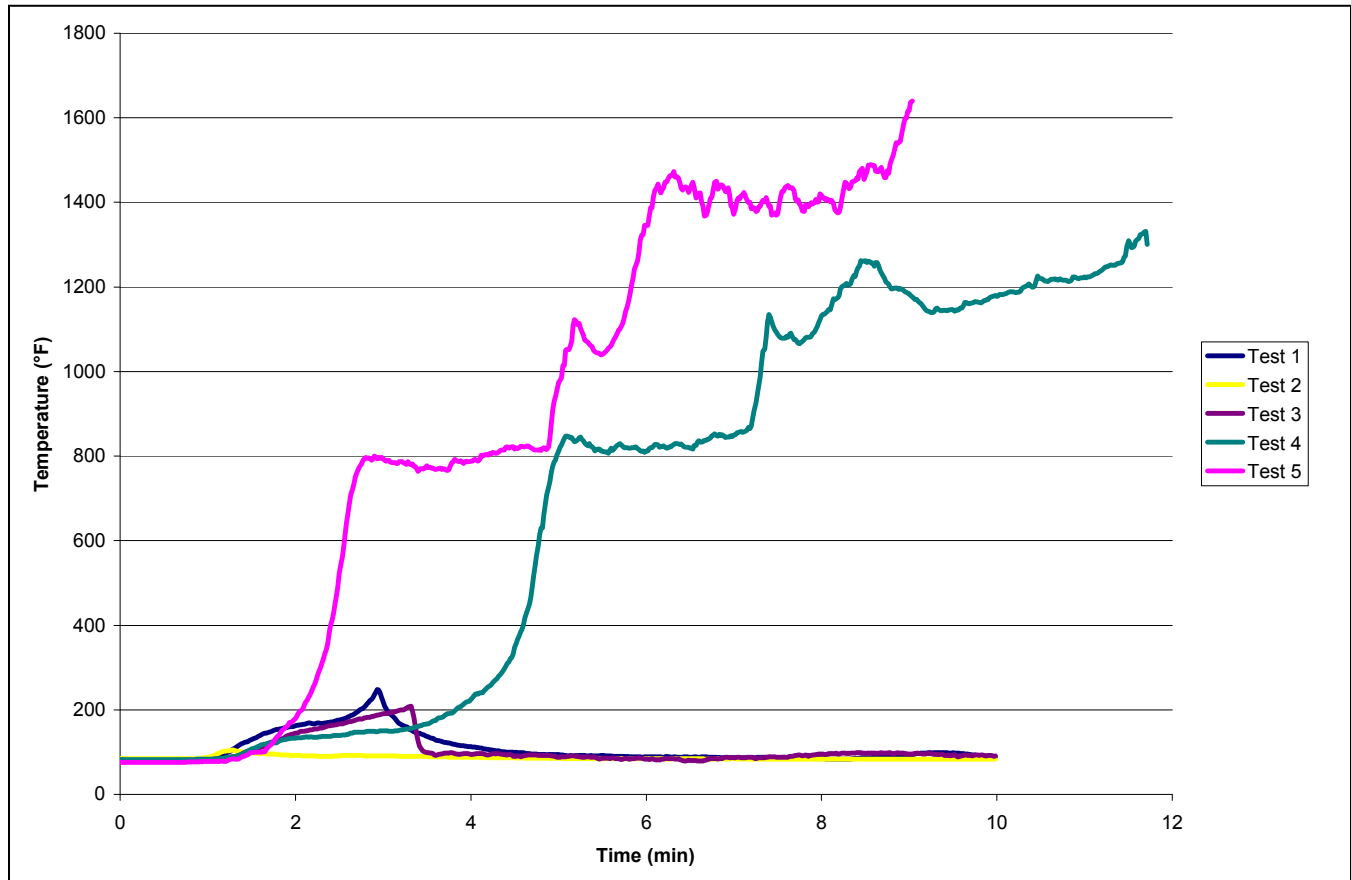
Figure 20: Comparison of temperatures 1 ft. below the top of the doorway

Temperature measurements were taken at 1 ft. intervals in the doorway. The thermocouples near the top of the doorway will record the highest temperatures since they are located in the smoke and, in the case of flashover, fire that exits the room. Figure 20 shows the highest temperatures out the exit as measured by the thermocouple located approximately 1 ft. below the top of the doorway.

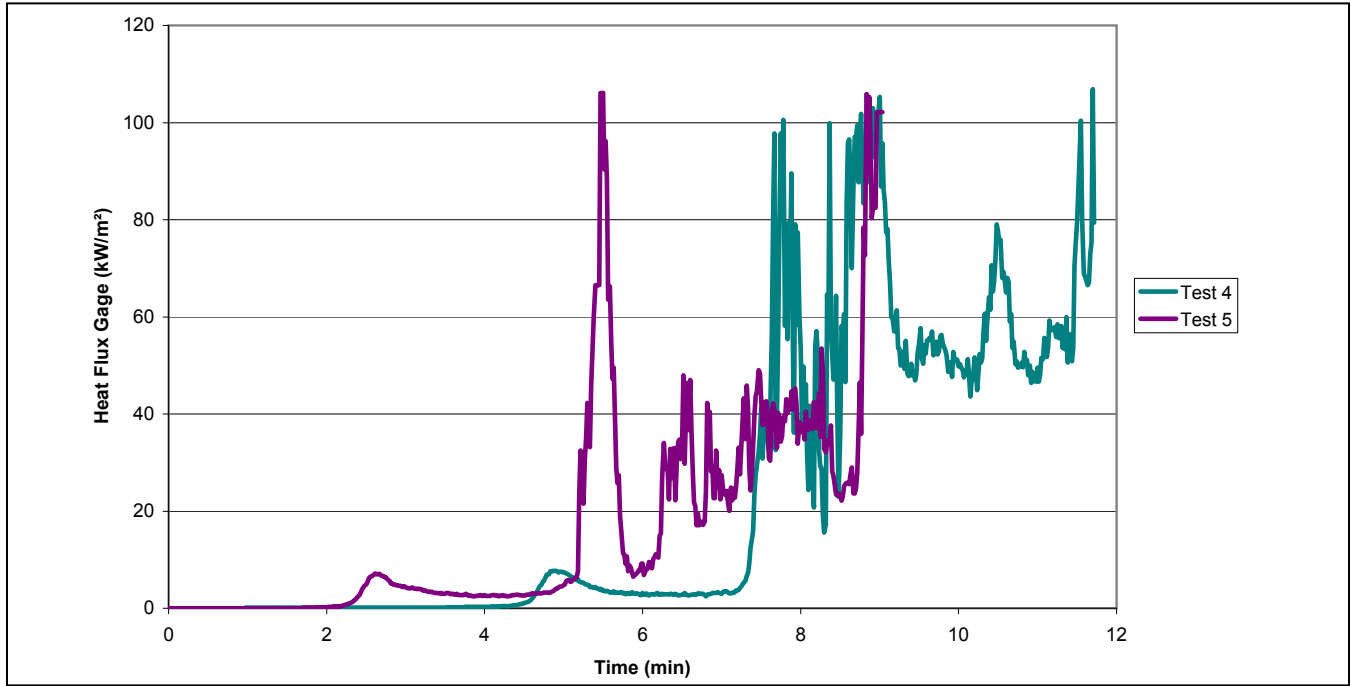
Figure 21: Reading from radiometer located on floor for both unsprinklered tests

One of the criteria to determine flashover is a reading of over 20 kW/m<sup>2</sup> from a floor mounted radiometer. A radiometer was installed in the floor next to the coffee table in the approximate center of the room with a field of view toward the ceiling for all five tests. The readings from the radiometer for the two unsprinklered tests and all of the sprinklered tests are shown in figures 21 and 22, respectively; note the difference in scale on the vertical axis.

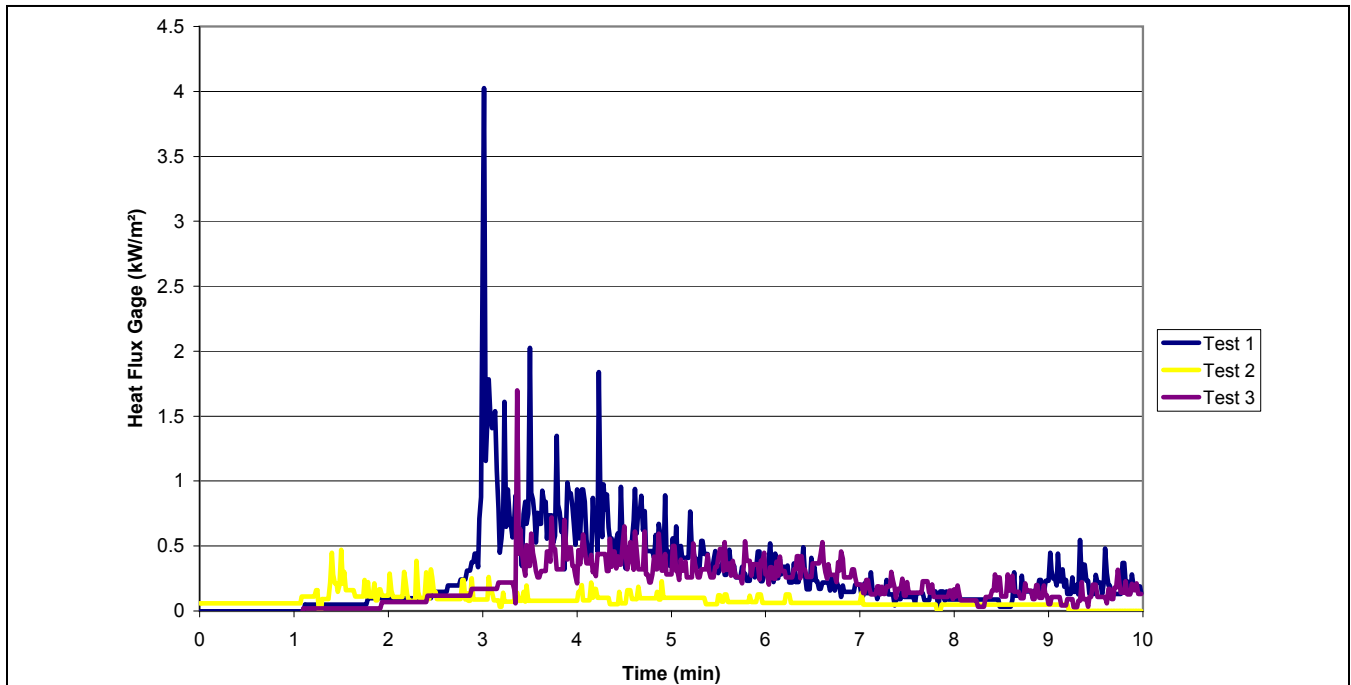
Figure 22: Reading from radiometer located on floor for all sprinklered tests

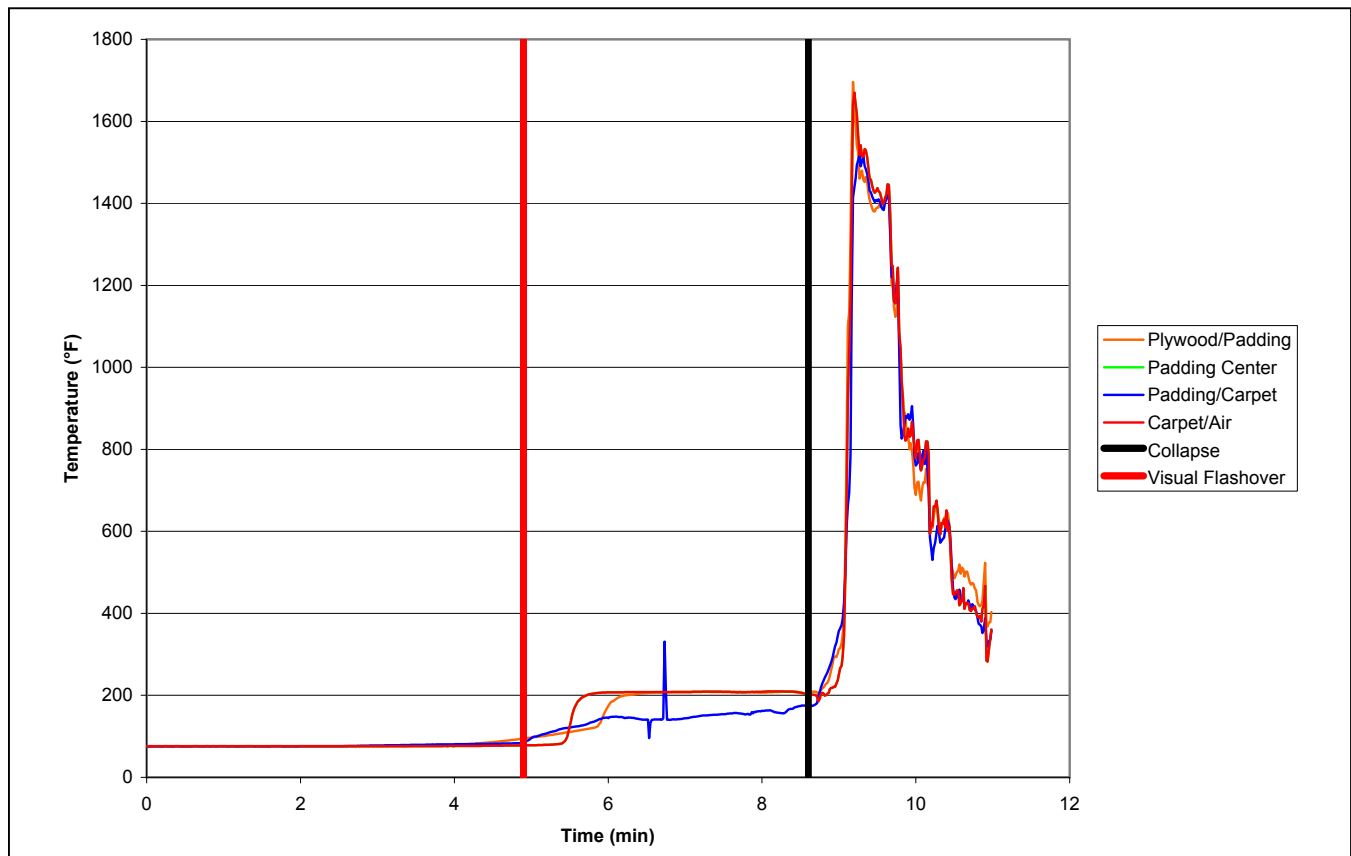
Figure 23: Ceiling/Floor assembly temperatures at the location closest to the fire

The additional instrumentation for the second freeburn test (Test 5) provided valuable information on the temperature rise through the ceiling/floor assembly. The ceiling/floor assembly temperatures did not vary significantly at the different locations (see graphs in Appendix A); the temperature traces for location 1 (closest to the fire) are shown in figure 23.

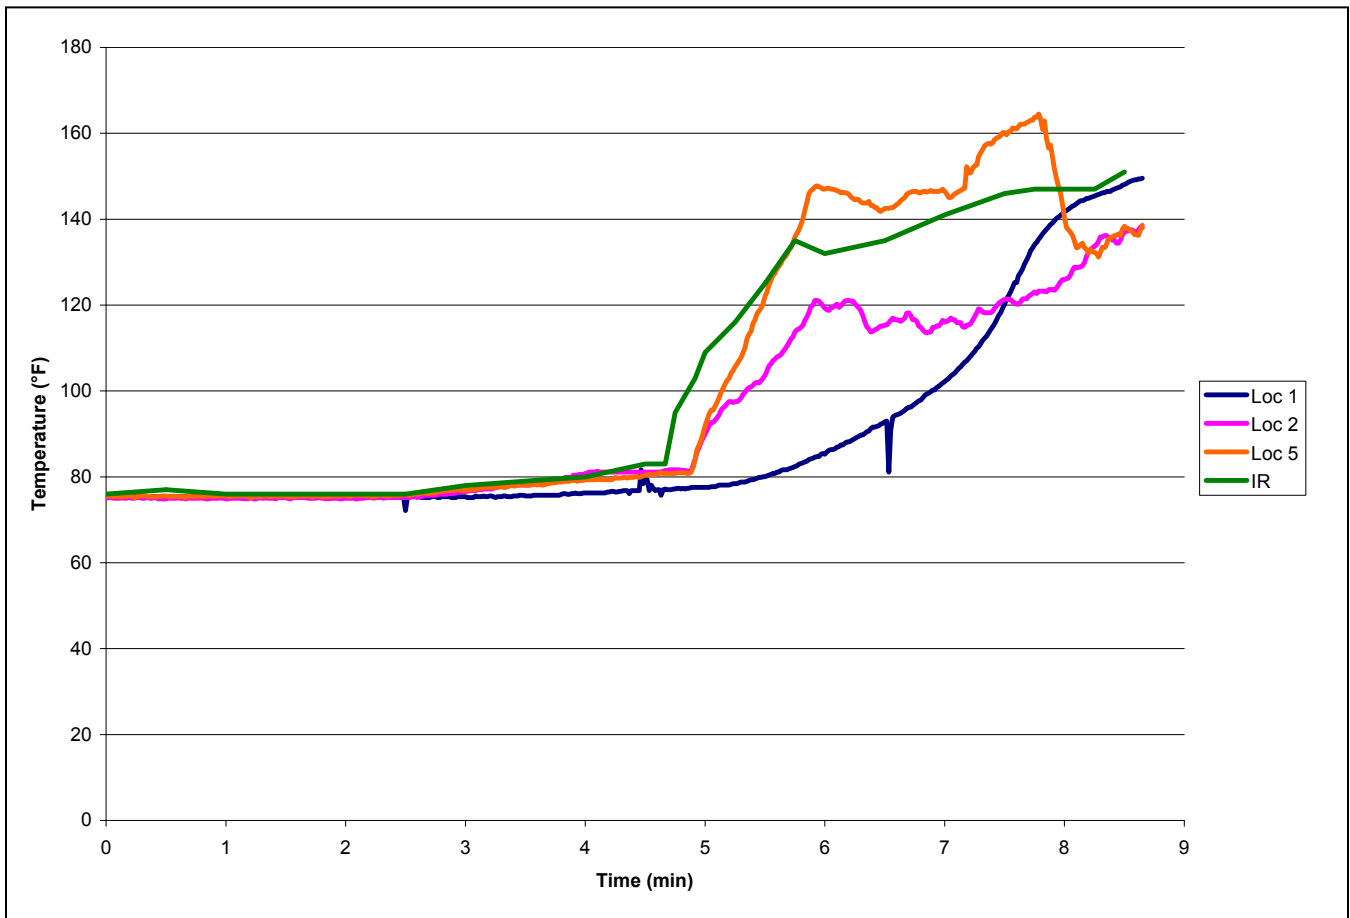
Figure 24: Comparison of temperatures recorded by the thermocouples and the thermal imaging camera on the top of the enclosure up to the point of collapse

Similar to the readings from the thermal imaging camera, the thermocouples did not report a temperature increase above ambient until after flashover and did not rise above 200°F until after collapse. The temperatures on the floor above the fire provide no indication of collapse, even immediately prior to the event.

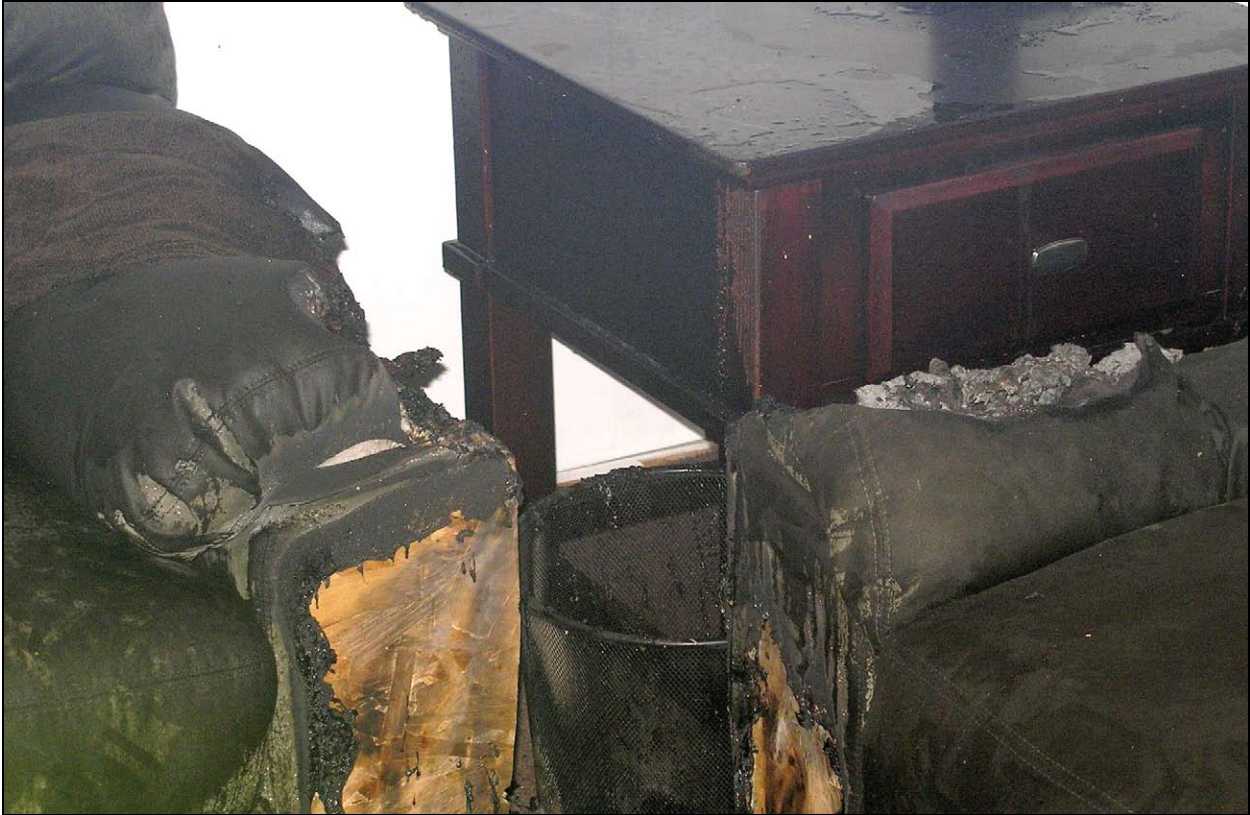
Test 2 Damage Assessment

- Exposed Joists
- Four pendent sprinklers
  - TY2234, 4.9K LFII residential
  - 155°F
  - 8 ft. spacing
  - 4 ft. from each corner
  - 13 gpm (7 psi)
- Only one sprinkler operated
- Sprinkler operated at 1:13
- Control achieved between 3-4 minutes after ignition
- Minor damage

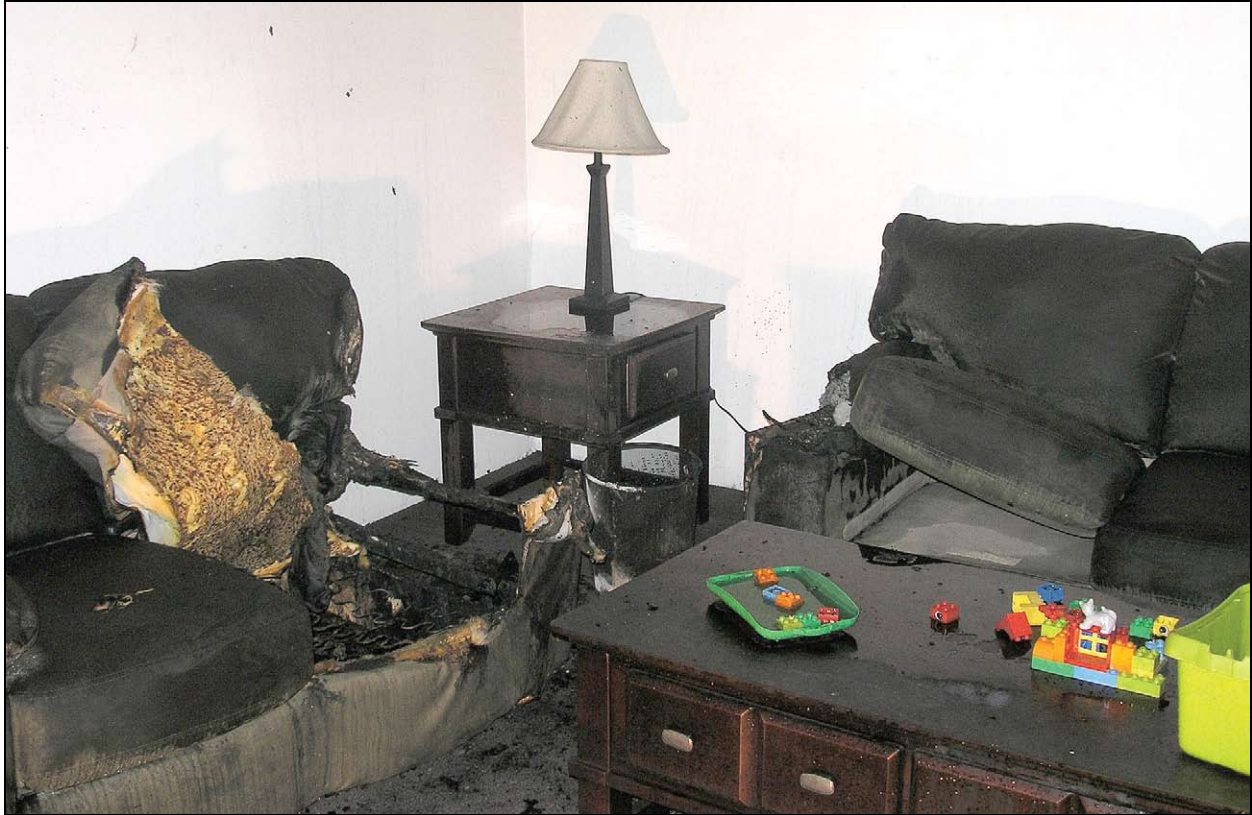
Test 3 Damage Assessment

- Exposed Joists
- One pendent sprinkler
  - TY2234, 4.9K LFII residential
  - 155°F
  - 6 ft. spacing
  - Center of the room
  - 22 gpm (20 psi)
- Sprinkler operated at 3:19
- Control achieved between 3:30-4:30 minutes after ignition
- Minor damage

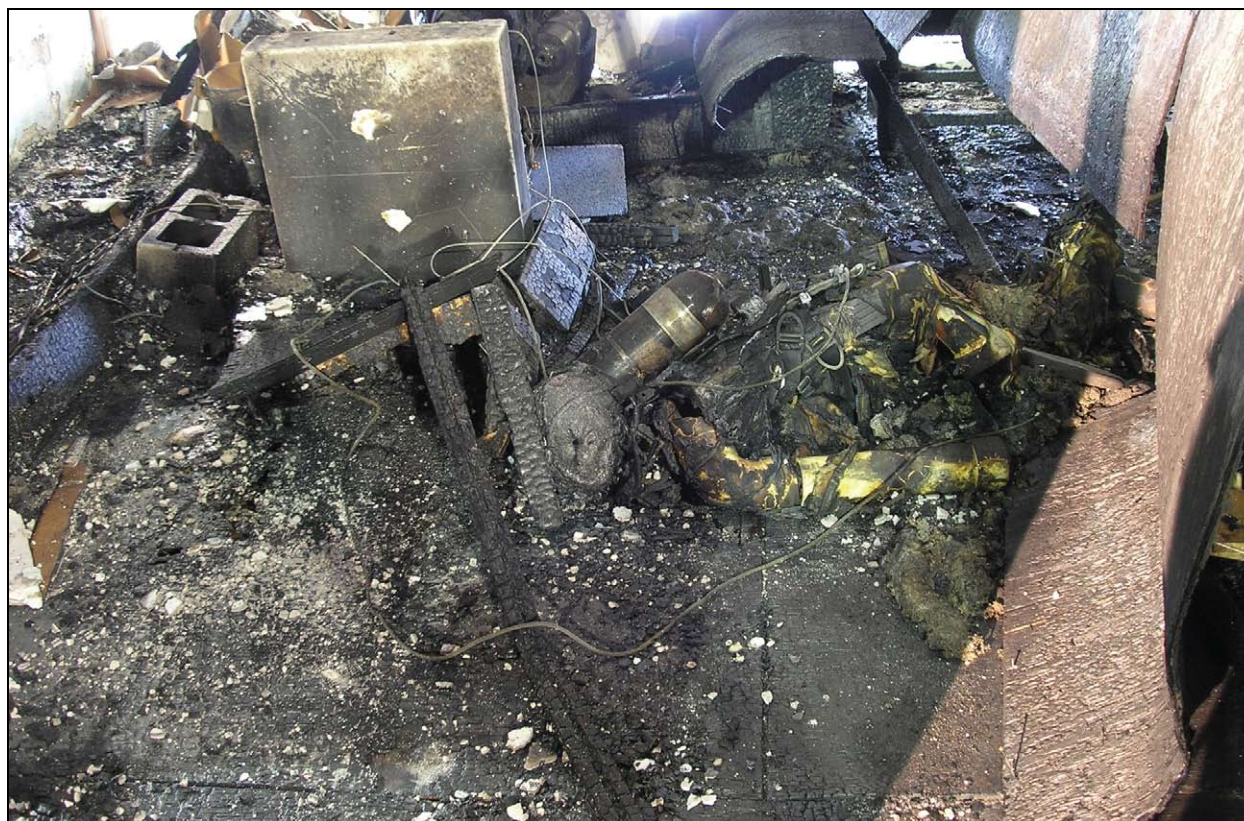
- July 17, 2008 at Underwriters Laboratories, Northbrook, IL
- Exposed Joists
- No sprinkler protection
- Room brought until collapse
- Flashover occurred at 7:09 from ignition
- Collapse occurred at approximately 11:30 from ignition
- Excessive damage, roof collapse

Test 4 First Unsprinklered Test, Damage

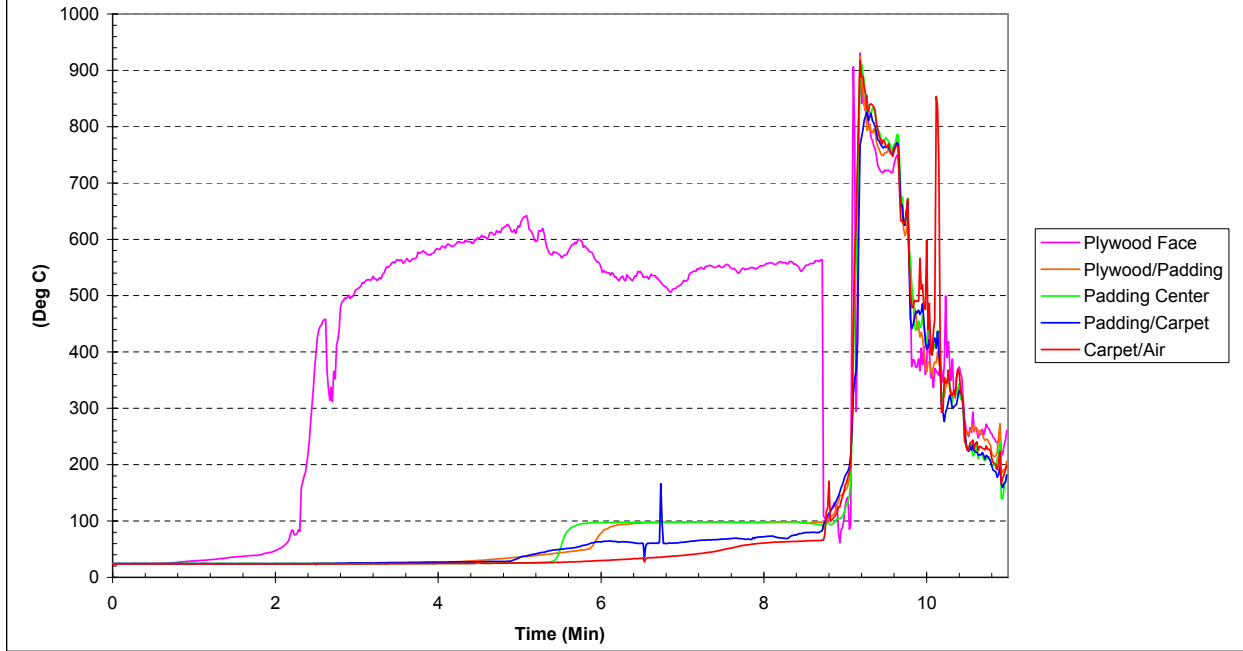
Tyco Fire & Building Products  
Lightweight Construction Test No. 5  
Location # 2 - 2nd Story TC Bundle

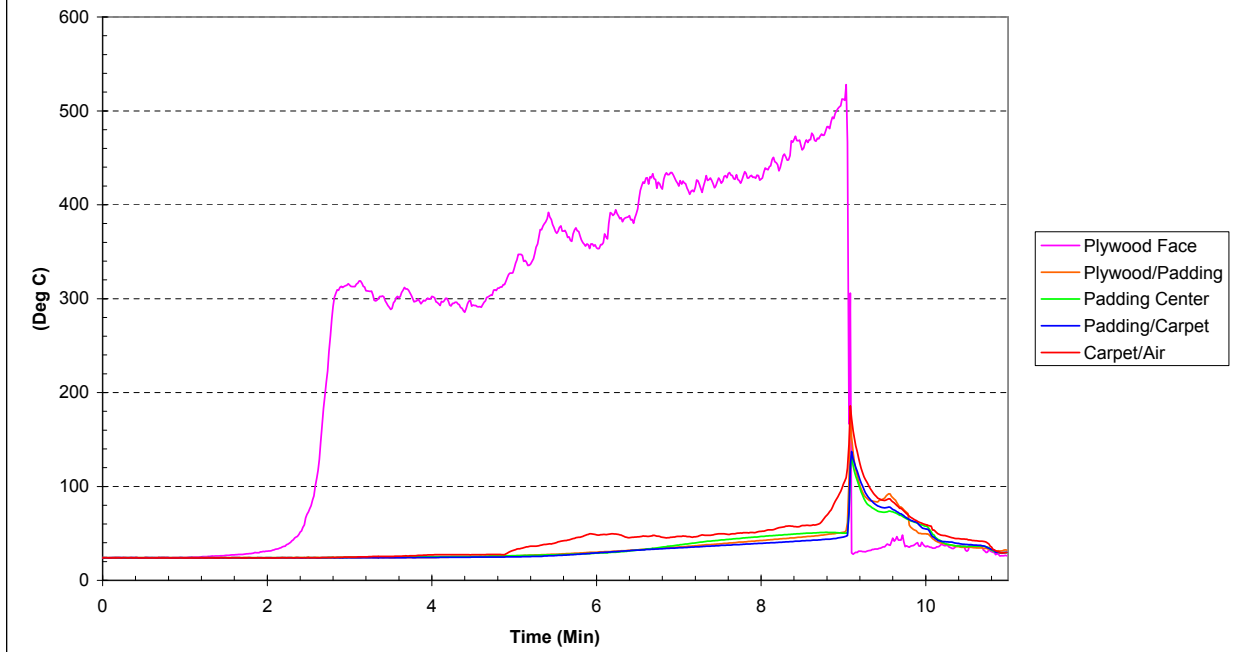
Tyco Fire & Building Products  
Lightweight Construction Test No. 5  
Location # 5 - 2nd Story TC Bundle

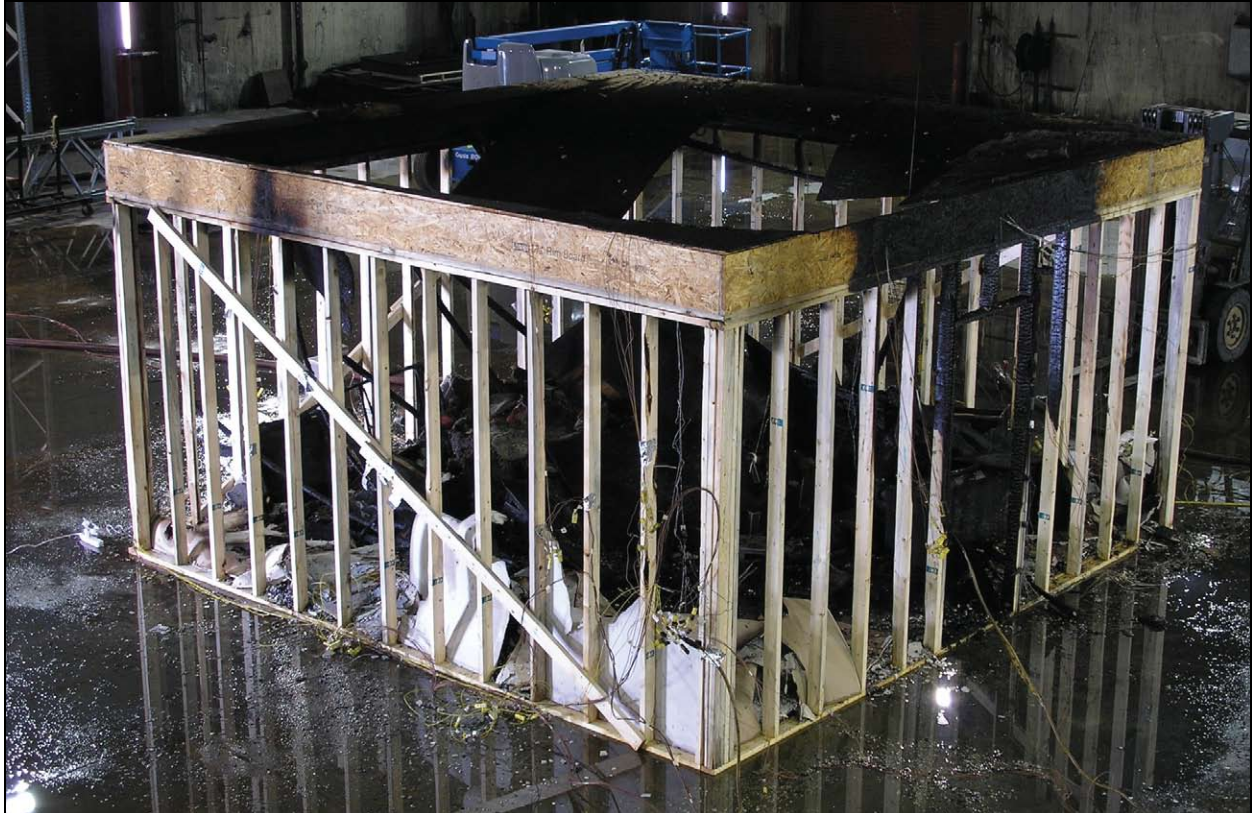
- August 8, 2008 at Underwriters Laboratories, Northbrook, IL
- Exposed Joists
- No sprinkler protection
- Room brought until collapse
- Flashover occurred at 5:15 from ignition
- Collapse occurred at approximately 8:34 from ignition
- Excessive damage, roof collapse
- Out of the 88 thermocouples added, only those thermocouples located in the ceiling/floor assembly are shown in the graphs below

Test 5 second freeburn, damage

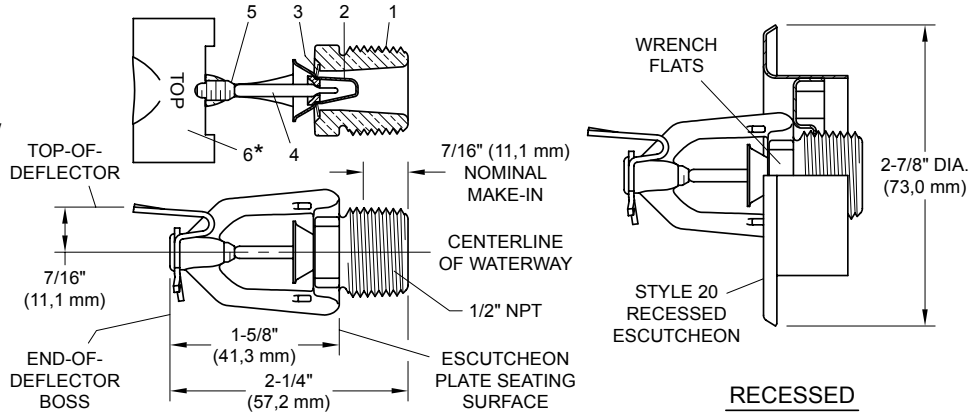
**FIGURE 1**  
**SERIES LFII (TY1334) RESIDENTIAL**  
**HORIZONTAL SIDEWALL AND RECESSED HORIZONTAL SIDEWALL SPRINKLERS**

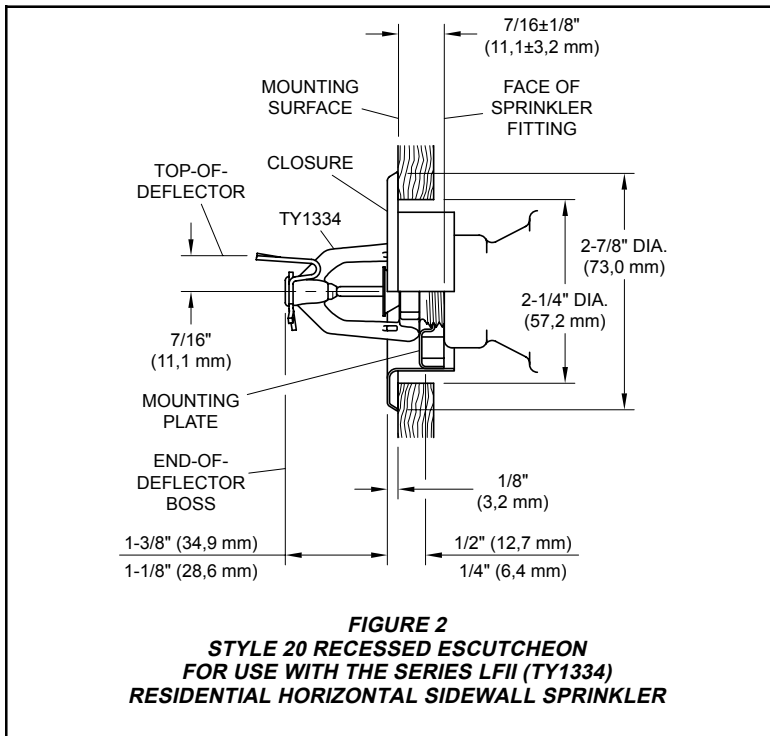
**FIGURE 2**  
**STYLE 20 RECESSED ESCUTCHEON**  
**FOR USE WITH THE SERIES LFII (TY1334)**  
**RESIDENTIAL HORIZONTAL SIDEWALL SPRINKLER**

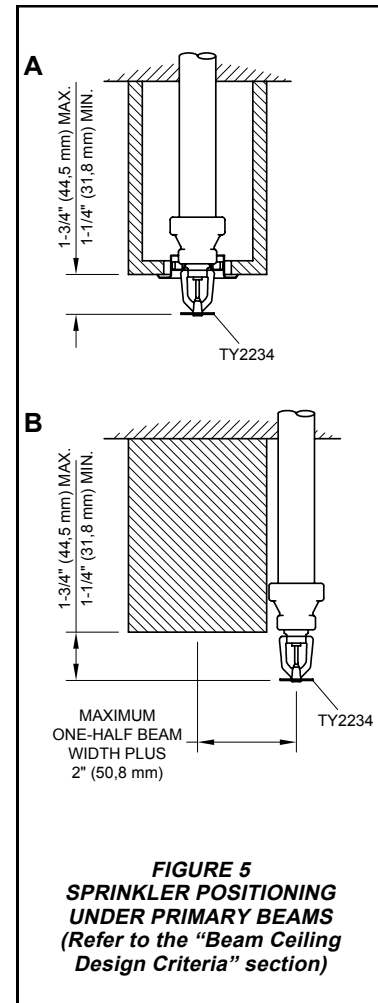
**FIGURE 5**  
**SPRINKLER POSITIONING**  
**UNDER PRIMARY BEAMS**  
(Refer to the "Beam Ceiling Design Criteria" section)

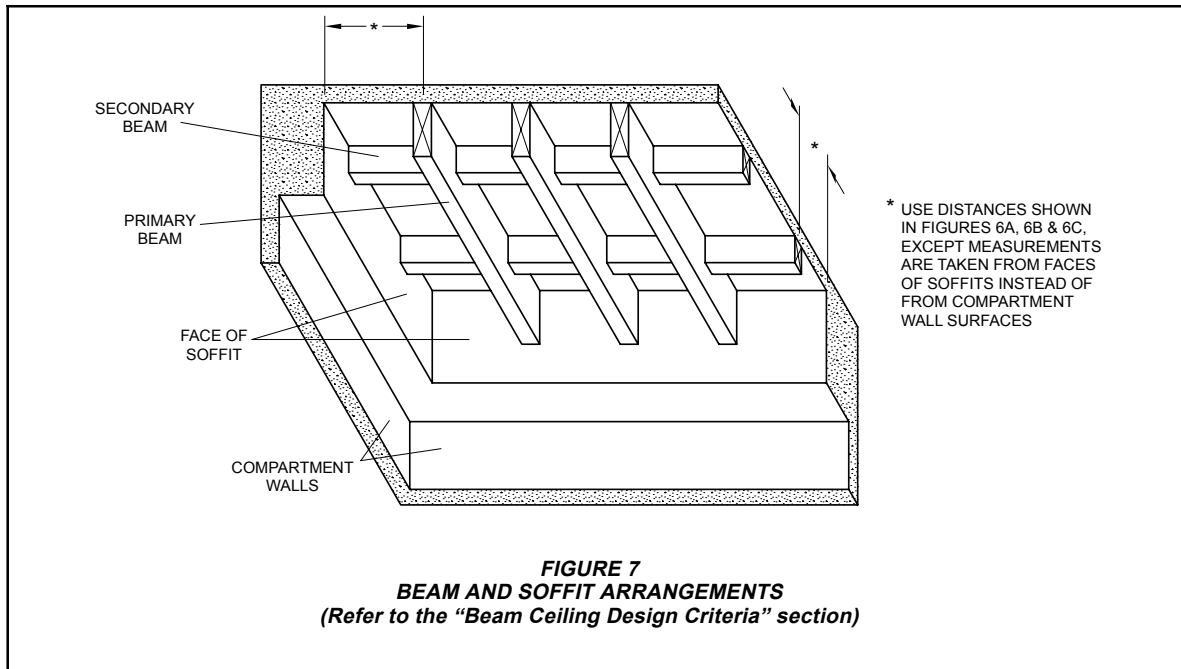
**FIGURE 7**  
**BEAM AND SOFFIT ARRANGEMENTS**  
 (Refer to the "Beam Ceiling Design Criteria" section)
